Table of Contents

3850 E Antelope Rd
Oregon, AC +/-

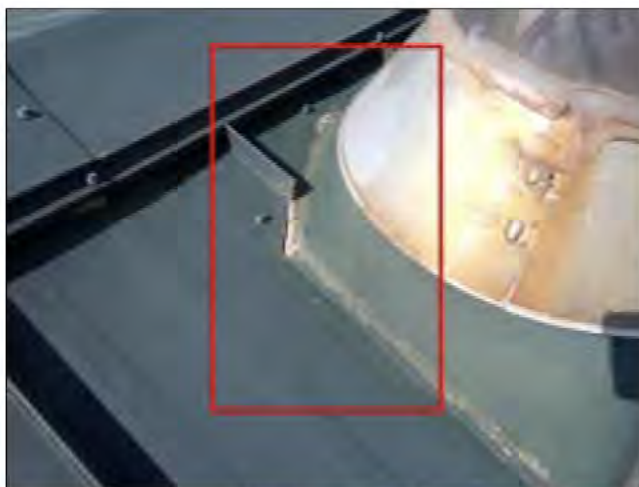
1.1 (Picture 1)

Gap noted at sealant on base of chimney. Recommend having area checked and repaired as needed by a qualified roofing contractor.

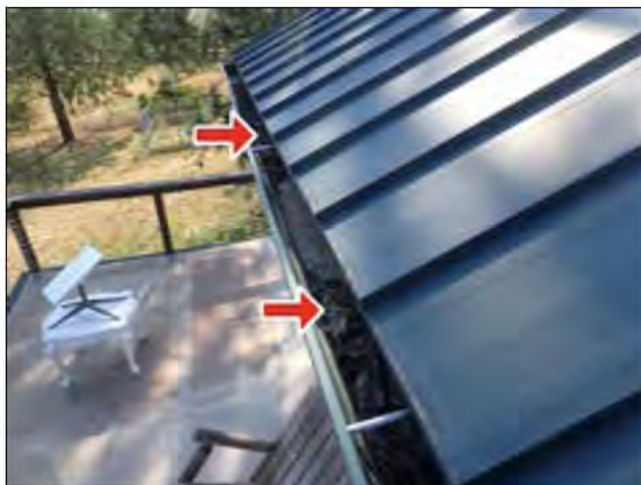
1.3 (Picture 1)

Build up of leaves/debris in gutters. Recommend cleaning now and on a routine basis for proper function.

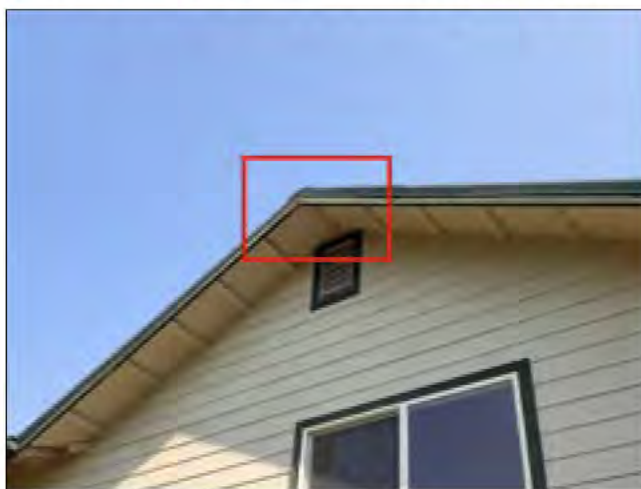
1.5 (Picture 1)

Wood rot, peeling paint and signs of wood destroying insects observed on fascia boards at multiple locations around home. Most notably on gable areas. Recommend having all fascia and soffits checked and repaired as needed by a qualified contractor. Prep, prime and paint to ensure proper protection.

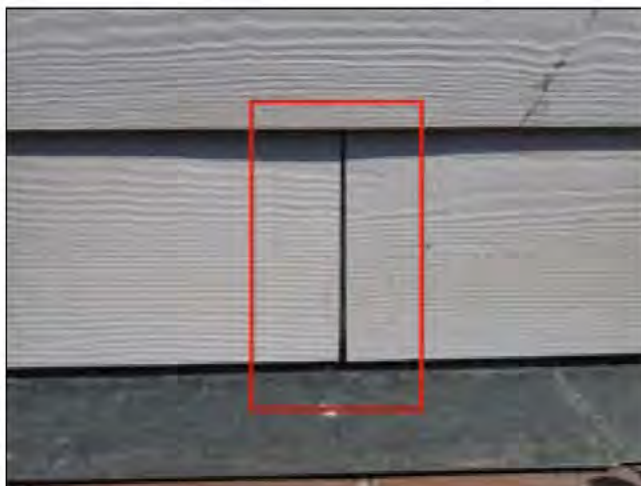
2.0 (Picture 1)

Concrete lapped siding is rated in fair condition based on age and general wear. Gaps observed between cut ends. Recommend prep, prime and paint to ensure proper protection. Additionally, trim back all loose vegetation to preclude moisture absorption issues.

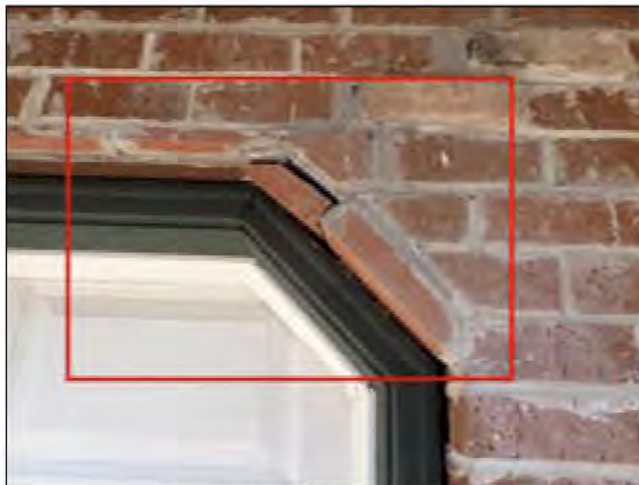
2.1 (Picture 1)

Excessive cracking and shifting observed on brick work at front of home and over garage area. See related comments in Section 9. Recommend having area checked and repaired as needed by a qualified contractor.

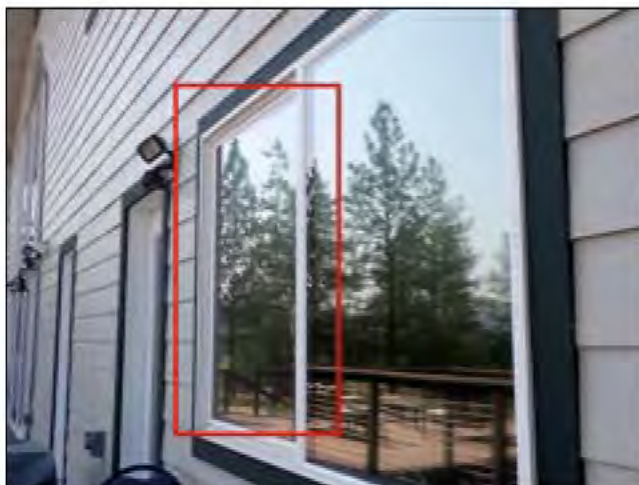
2.2 (Picture 1)

Several windows are missing screens around home. Additionally, some units are damaged. Recommend having all screens added or repaired as needed to ensure proper operation.

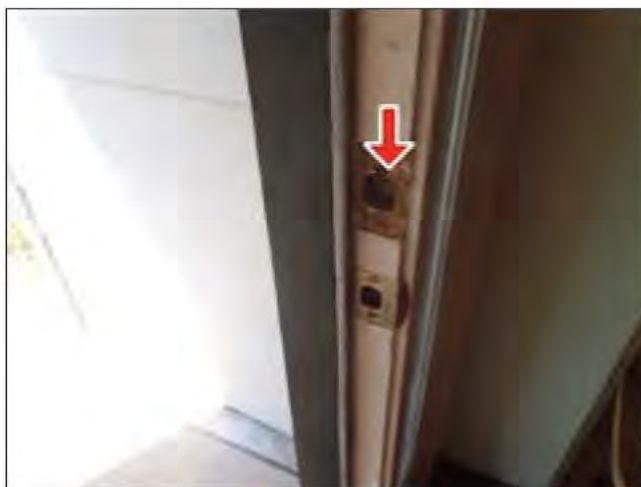
2.3 (Picture 1)

Strike plates are missing on multiple entry doors. Recommend adding as needed to ensure proper operation and safety.

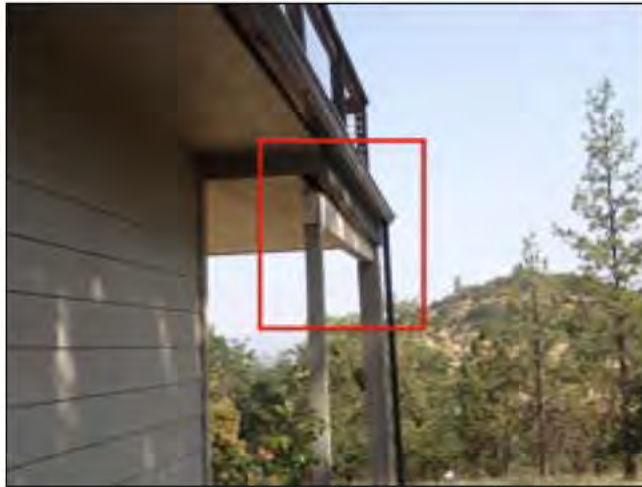
2.4 (Picture 1)

inspection. Gap and separation observed at beam and support on right side of deck. Several step stringers are cracked and damaged. Some separation observed on decking. Additionally, membrane material is torn at top of steps. Due to current conditions, recommend having all deck structures further evaluated by a qualified contractor to determine repairs needed and associated cost.

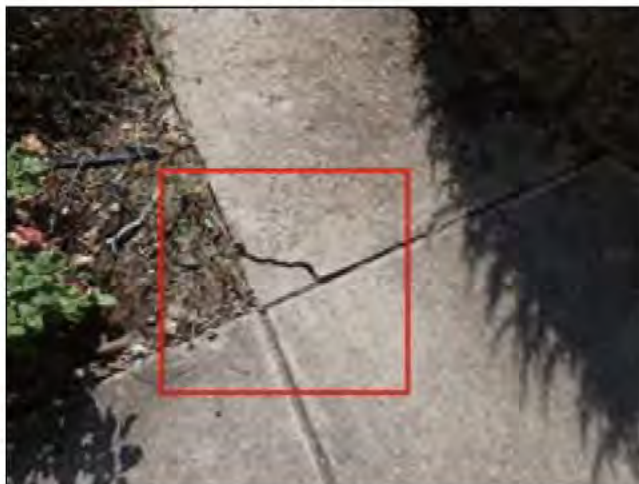
3.0 (Picture 1)

Walkways have cracked and settled at multiple locations. Some areas are considered a tripping hazard. Recommend repair and seal as needed by a qualified contractor.

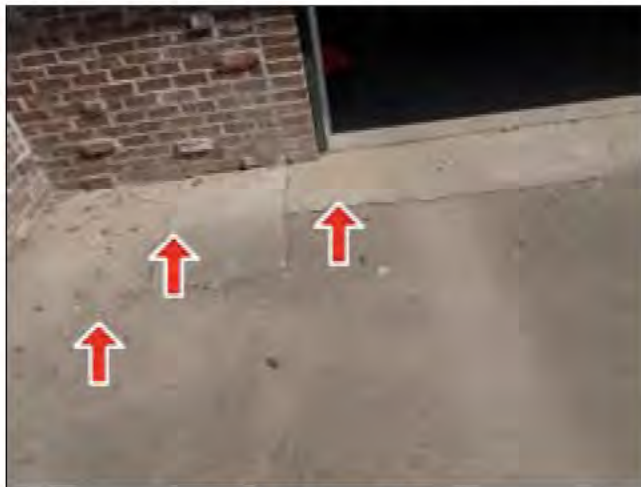
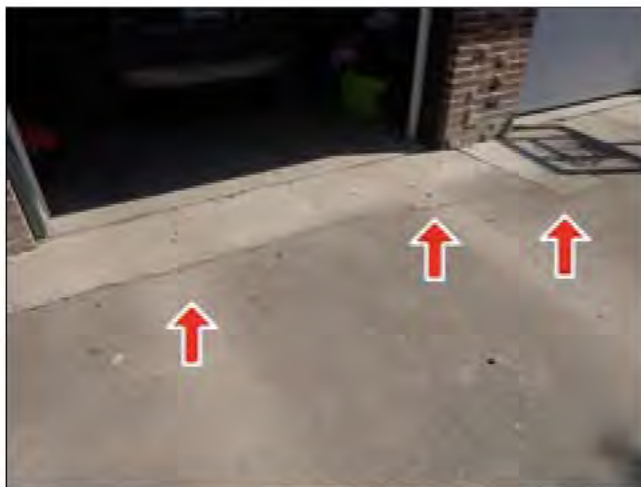
Cracking noted on driveway surface at multiple locations. It appears that some sections of driveway drain towards foundation of home and garage area. This could cause moisture absorption issues if not corrected. Recommend having slab checked and repaired as needed by a qualified contractor.

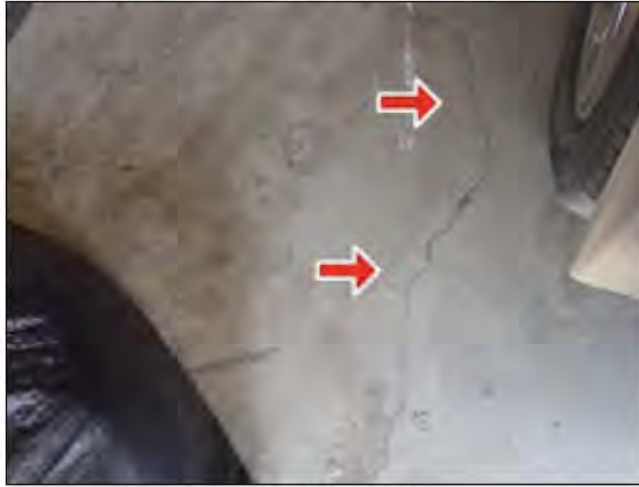
4.1 (Picture 1)

Cracking of floor slab noted; recommend sealing to prevent further deterioration.

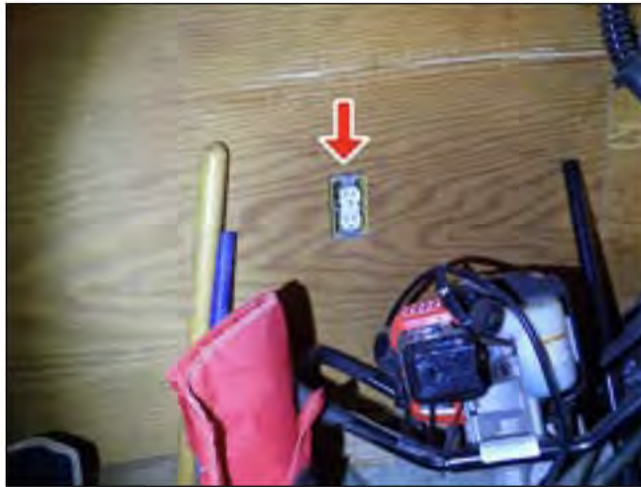
4.5 (Picture 1)

Recommend replacing outlet covers as a general safety upgrade.

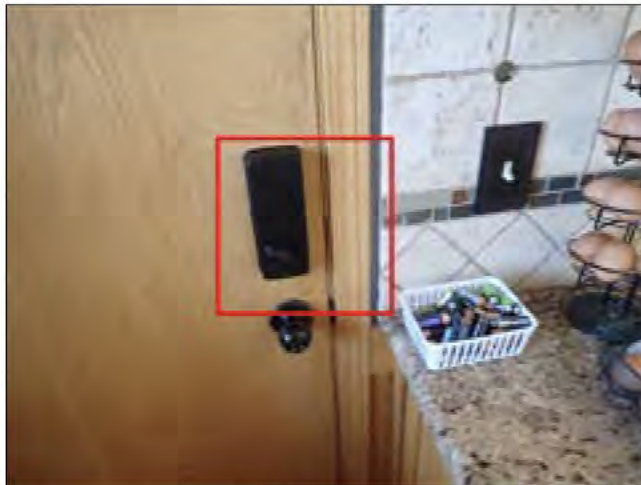
4.6 (Picture 1)

Deadbolt lock was difficult to engage. Additionally weather stripping is worn. Recommend repair or adjustment as needed by a qualified contractor.

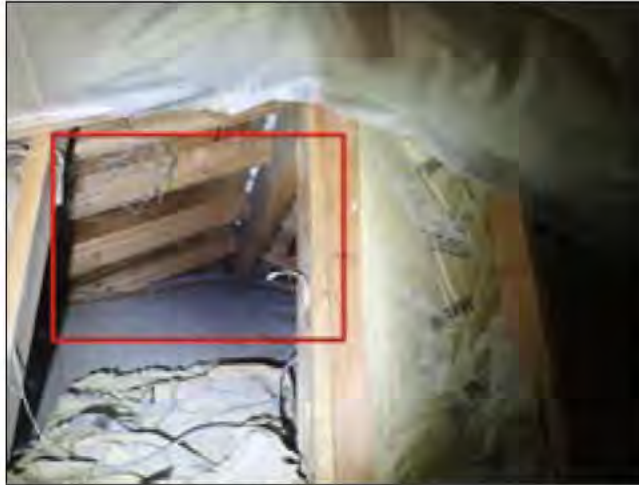
5.0 (Picture 1)

Limited end bearing noted on framing hip over left side of home. While no major shifting has occurred, recommend having framing in area further evaluated and repaired as needed by a qualified contractor.

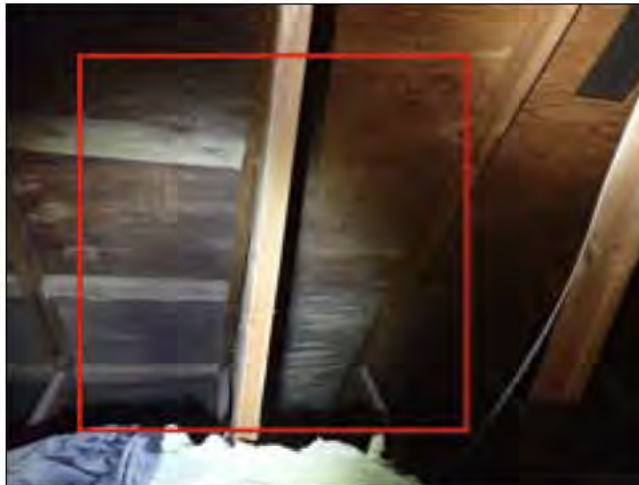
5.2 (Picture 1)

Evidence of suspect mold is present on ceiling in several areas in attic over right side of home. We did not inspect, test or determine if this is a health hazard/structural concern. Recommend contacting a qualified mold inspector or expert for investigation or correction if needed.

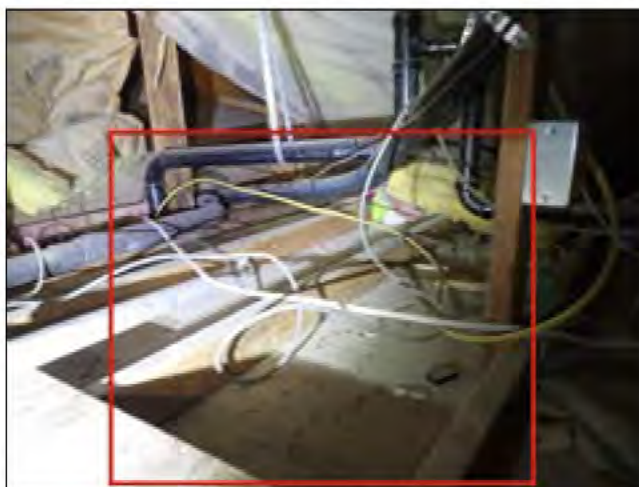
5.3 (Picture 1)

Limited insulation observed over right side of home. Recommend adding to ensure best efficiency.

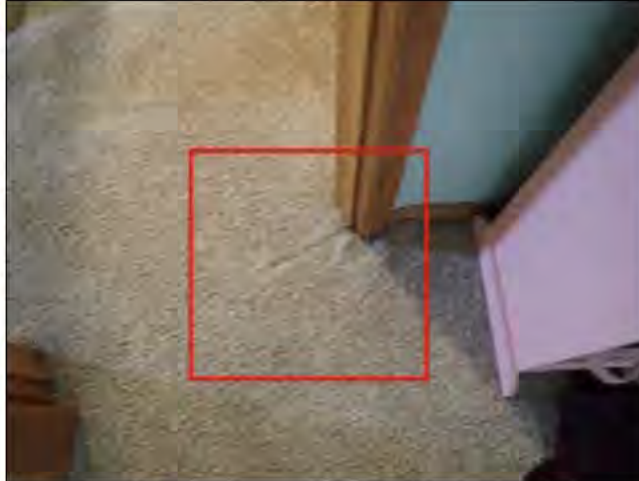
6.2 (1) General wear noted on carpets in upper level of home. Recommend repair or replacement as needed by a qualified contractor.

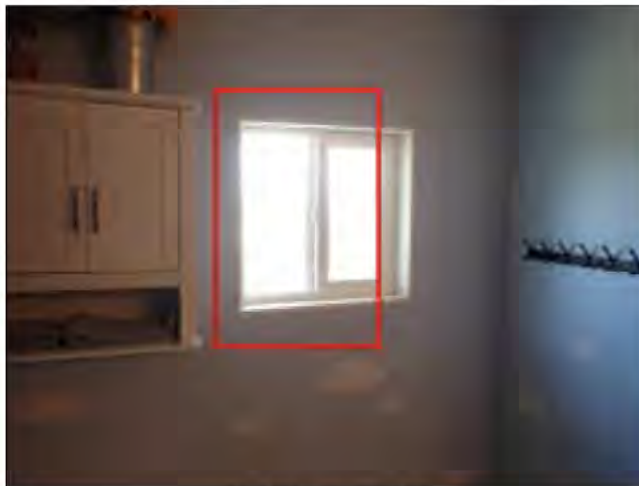
6.4 (Picture 1)

Evidence of the failure of the seal on insulated window in upper level bathroom. While not readily apparent at the time of inspection, other insulated-glass units may have also failed. Recommend a check of all units to determine extent of repair/replacement work required.

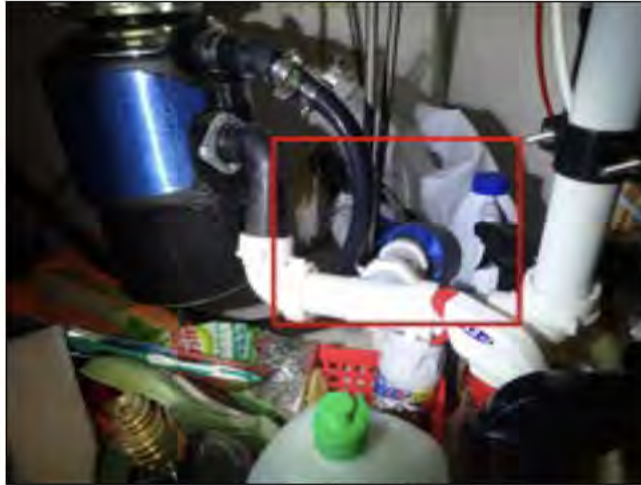
7.0 (Picture 1)

Flex line used for under sink drain line; recommend replacing with solid wall piping to reduce potential for blockage.

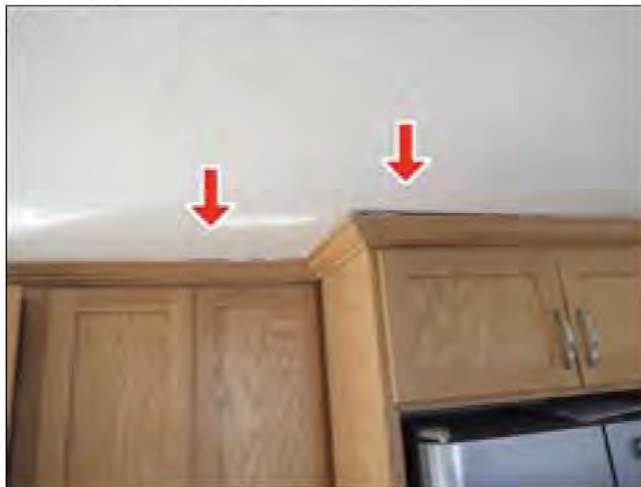
7.1 (Picture 1)

Gap noted between ceiling and cabinetry. This could be the result of settlement issues in area. See related comments on siding and foundation. Recommend conditions be further evaluated by a qualified contractor to determine repair needs and associated cost.

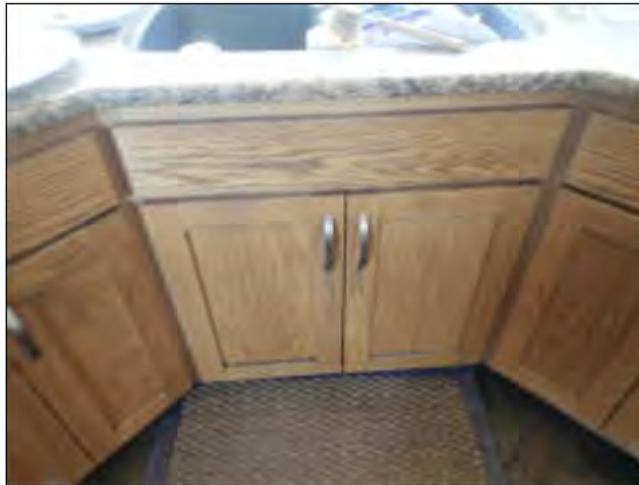
7.7 (Picture 1)

Functional with some cosmetic damage consistent with age. Refinish as desired.

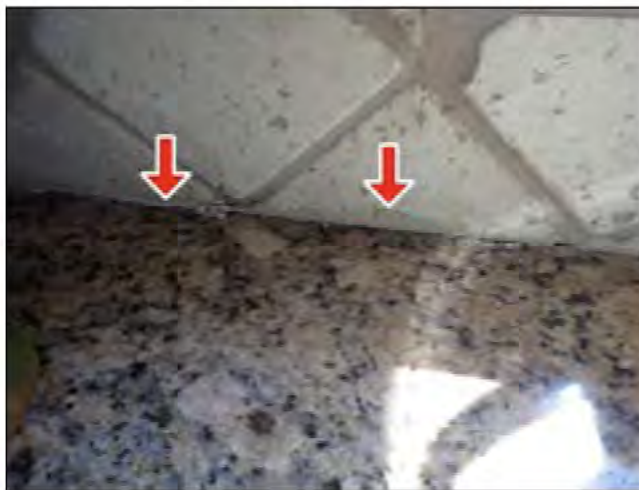
7.8 (Picture 1)

Gaps between countertop and back splash noted. Recommend caulking to prevent water intrusion.

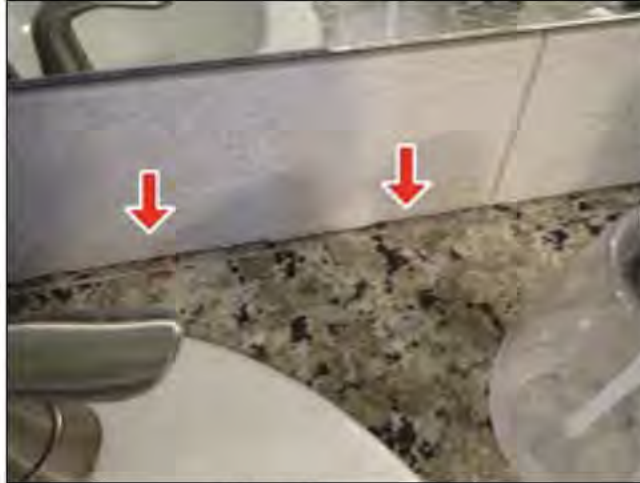
8.0.A (Picture 1)

Recommend caulking at junction between countertop and back splashes to prevent moisture intrusion concerns.

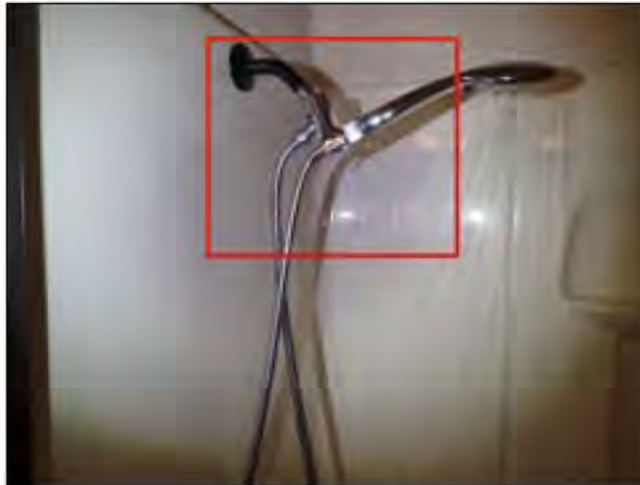
8.0.B (Picture 1)

Shower head leaks/sprays at connection to plumbing neck. Recommend repair to preclude damages to surrounding area.

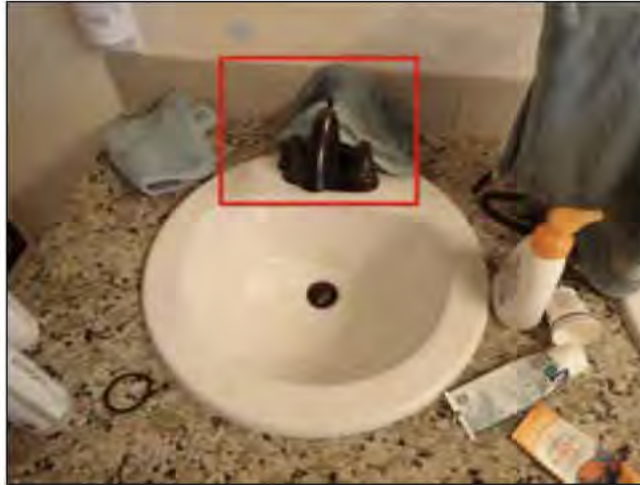
8.1.B (Picture 1)

Left side sink was not operational at time of inspection. Recommend restoring water pressure and testing prior to close.

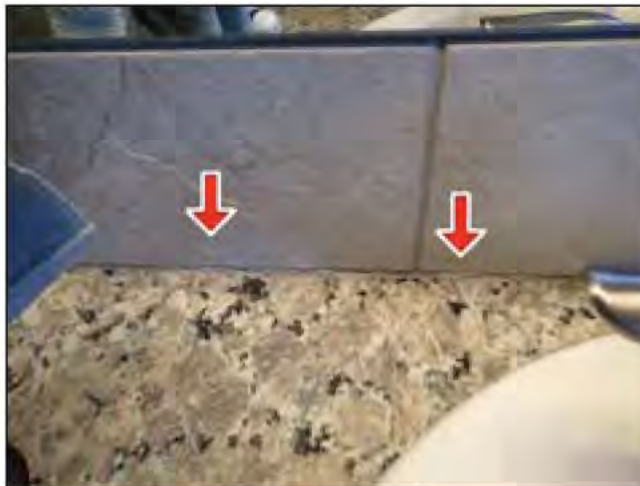
8.0.C (Picture 1)

Recommend caulking at junction between countertop and back splashes to prevent moisture intrusion concerns.

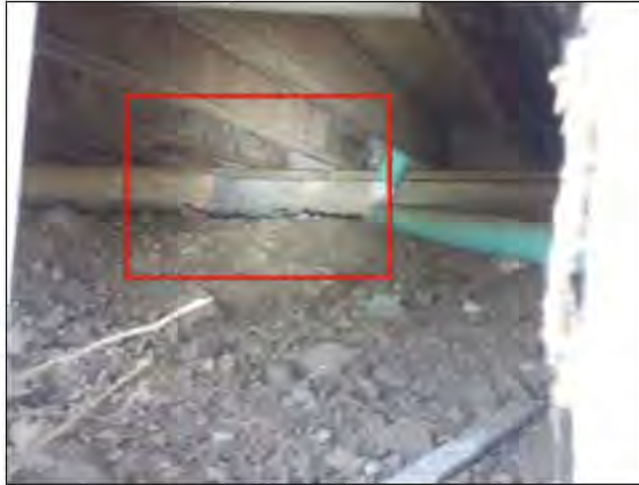
9.0 (Picture 1)

Due to home design, most of slab exterior was not visible at time of inspection. However, area of slab has been notched out under back of house utility room. Framing in area is not properly supported. Recommend having slab and framing further evaluated and repaired as needed by a qualified contractor.

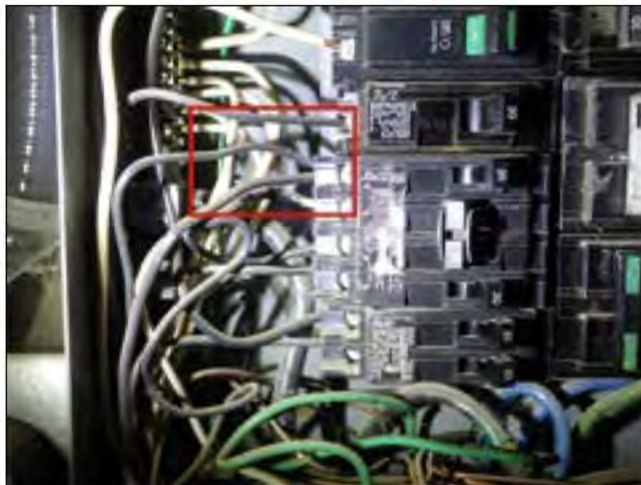
10.3 (Picture 1)

Doubled up breaker observed. Generally, only one conductor (wire) should be connected at circuit breaker or panel lug. If the panel is near/at capacity, an upgrade may be necessary to correct this condition. Additionally, multiple sized wires observed at connection point. Recommend conditions be further evaluated and repaired as needed by a qualified electrical contractor.

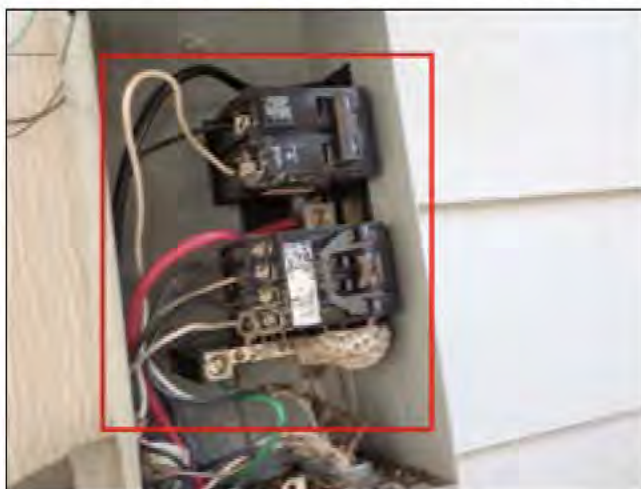
10.4 (Picture 1)

Interior panel cover is missing. Recommend replacing as a general safety upgrade.

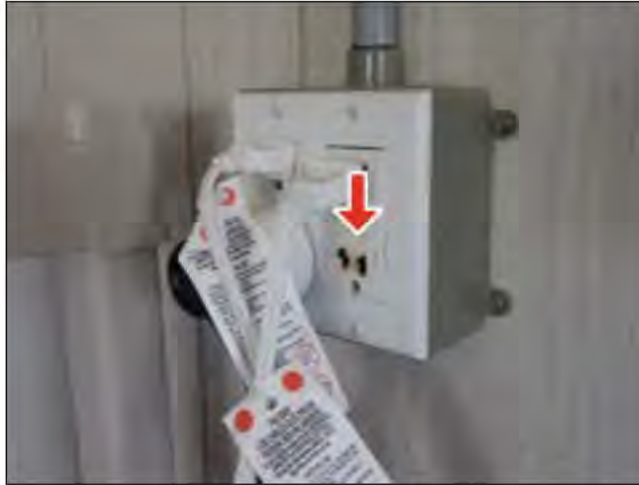
10.6 (Picture 1)

Outlet is scorched in back of house utility room. Recommend replacement as needed by a qualified electrician.

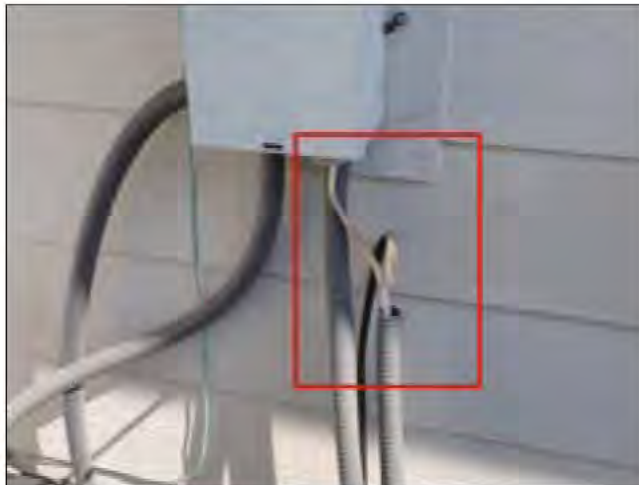
10.7 (Picture 1)

Loose conduit noted below upper level sub panel at front of home. Recommend securing as needed by a qualified electrician.

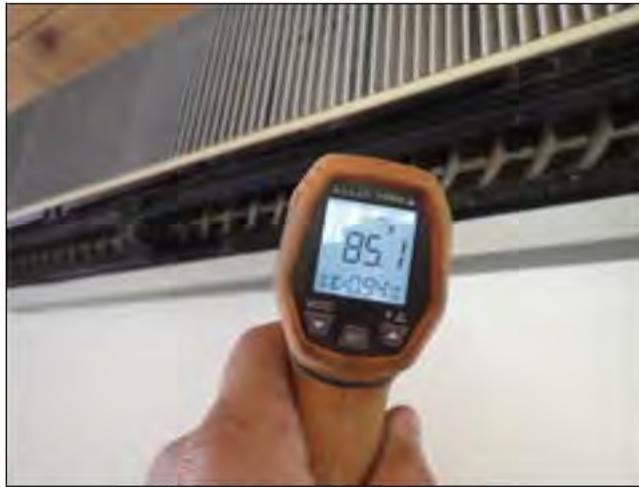
11.3 (Picture 1)

Minimal temperature split noted at air handler. System is older and past its normal design life. Recommend conditions be evaluated by a qualified HVAC contractor to determine remedial action required and associated costs.

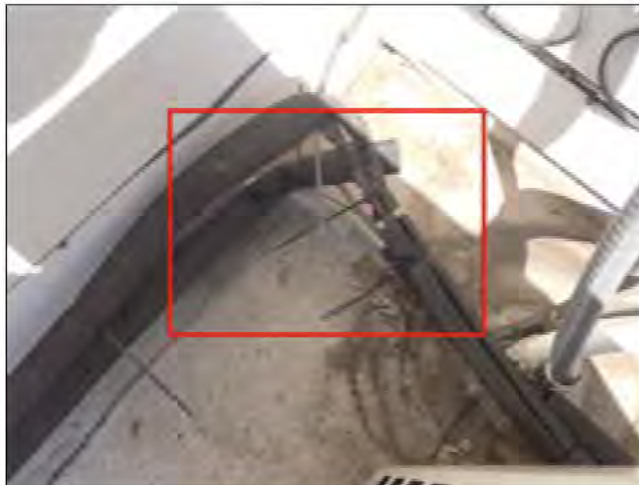
11.4 (Picture 1)

See 11.3, insulation on coolant lines is deteriorated. Recommend repair or replacement to ensure best operation.

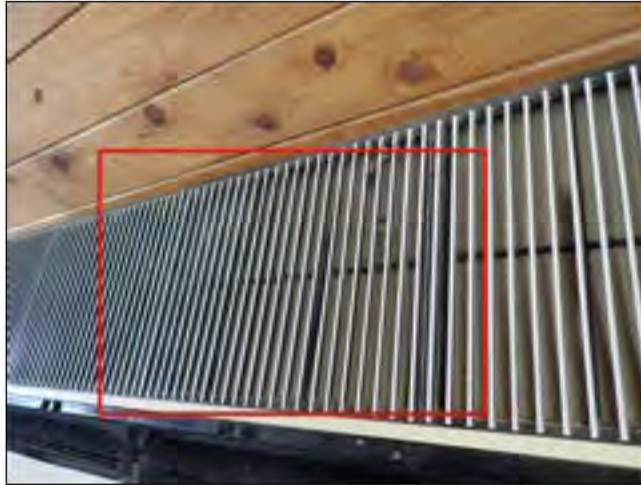
11.5 (Picture 1)

See 11.3, filter is dirty, recommend cleaning as needed.

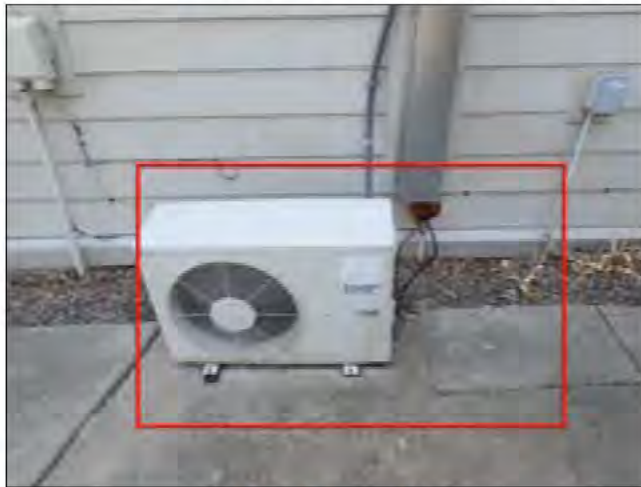
11.7 (Picture 1)

Fan on exterior unit did not turn when system was operating. Additionally coolant line installation is missing. Recommend further evaluation and repair as needed by a qualified HVAC contractor.

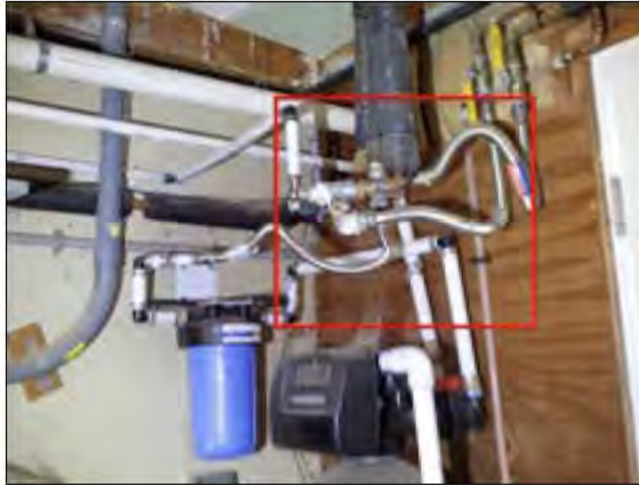
12.0 (Picture 1)

Corrosion noted at supply piping connections in garage area of home. Dissimilar metals observed in area. Recommend further evaluation and repair as needed by qualified plumbing contractor.
