Mapping

1321 Falcon Crest
Oregon, AC +/-

Cover Page	1
Table of Contents	2
Intro Page	3
1 ROOFING	6
2 EXTERIOR ELEMENTS	10
3 SITE ELEMENTS	12
4 GARAGE	13
5 ATTIC	15
6 INTERIOR ELEMENTS	16
7 KITCHEN	18
8(A) BATHROOM 1	20
8(B) BATHROOM 2	22
8(C) BATHROOM 3	23
8(D) BATHROOM 4	25
9 FOUNDATION / SUBSTRUCTURE	26
10 FOUNDATION AREA WATER PENETRATION	28
11 ELECTRIC SYSTEM	31
12 HEAT PUMPS	33
13 PLUMBING SYSTEM	34
14 HOT WATER SUPPLY	35
General Summary	36
Invoice	55
Attachments	56

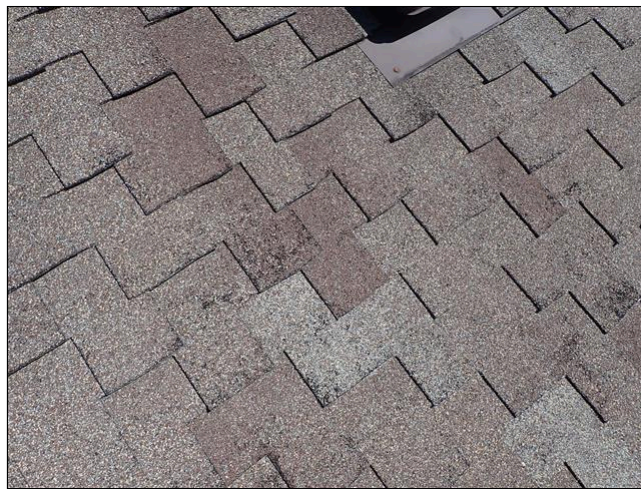
1.0 (Picture 1)

Roof covering is rated in fair condition based on age and general wear. Some granular loss observed. Additionally, multiple ridge caps are cracked and damaged. Due to current conditions, recommend having roof further evaluated and repaired as needed by a qualified roofing contractor.

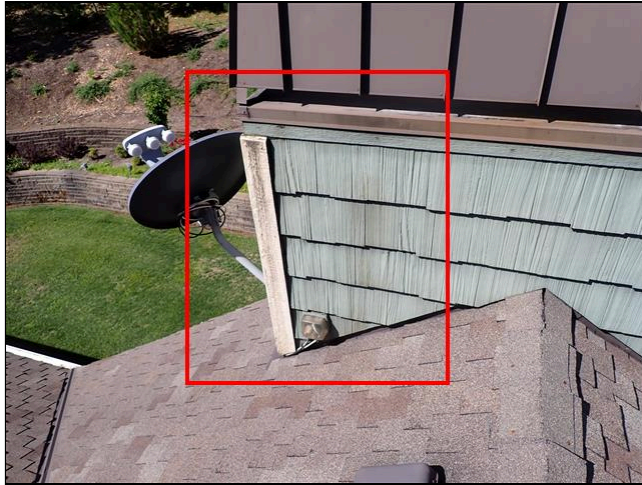
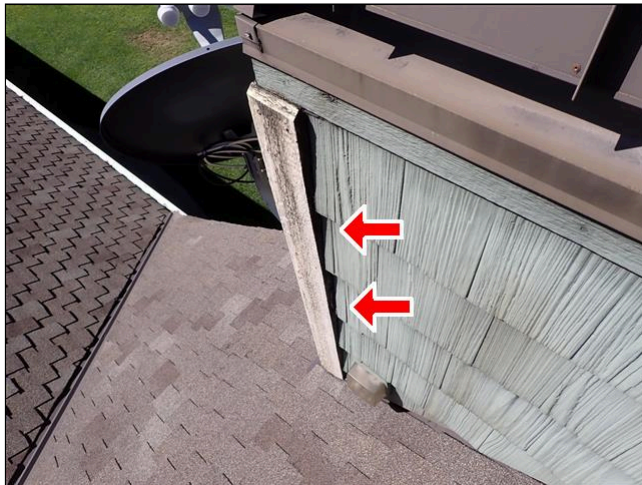
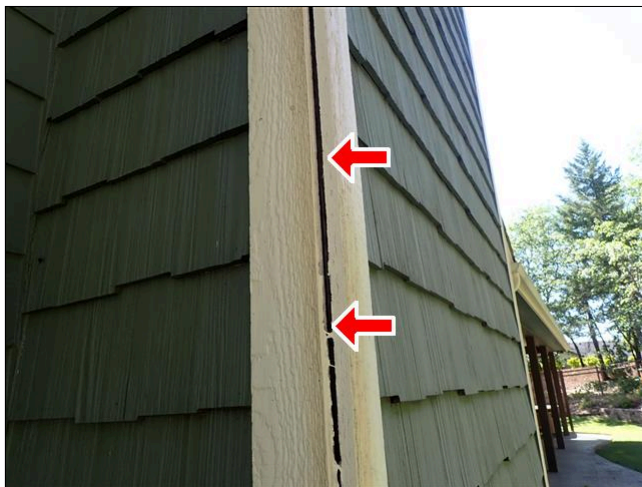
1.1 (1) Siding around chimney enclosure is rated in fair condition due to numerous gaps and worn paint. Recommend repairs where needed by a qualified contractor. Prep, prime and paint to ensure proper protection.

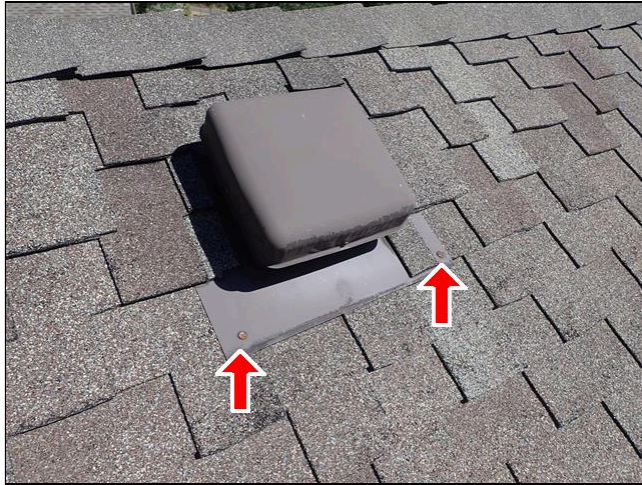
1.4 (Picture 1)

Nails were used to secure ventilation cover flashings to roof. As preventative maintenance, exposed nail heads should be sealed with a roofing compound to prevent moisture intrusion.

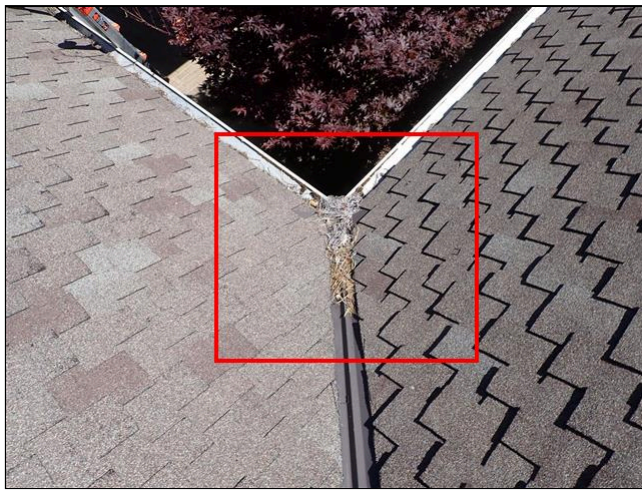
1.6 (1) Build up of leaves/debris in gutters and roof valleys. Recommend cleaning now and on a routine basis for proper function.

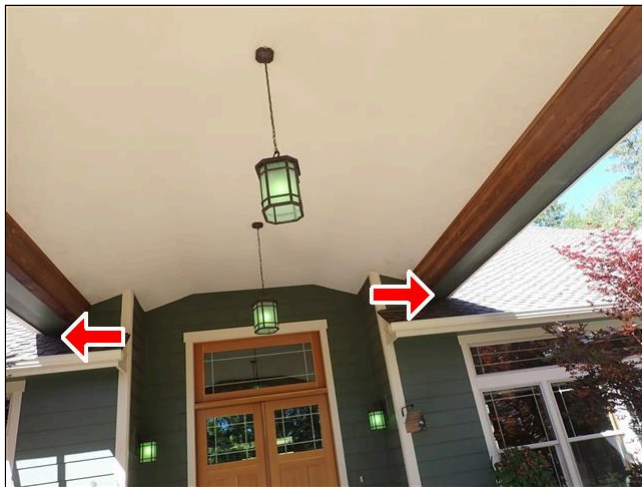
1.6 (2) Gutters drain onto lower roof. May cause extra roof wear and increase potential for leakage. Recommend adding extensions to lower gutters.

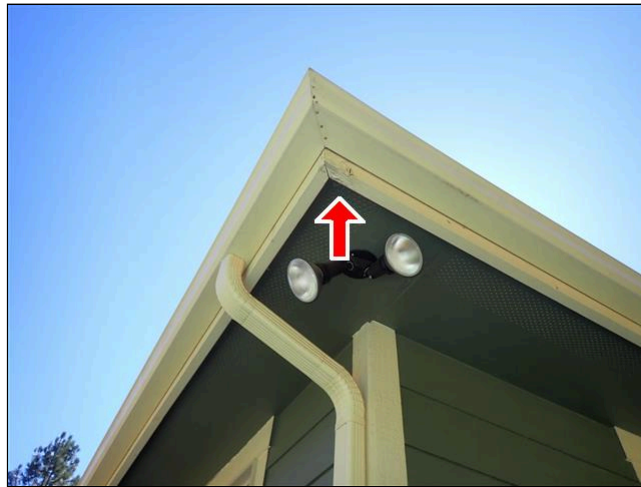
1.8 (Picture 1)

Moisture stains noted on fascia board at back right of home. Recommend having gutter in area checked and sealed. Repair any damaged

wood as needed.

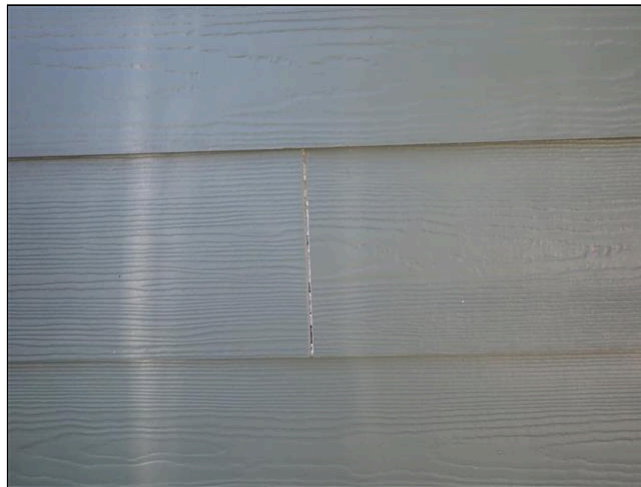
2.0 (Picture 1)

Siding is rated in fair condition due to age and general wear. Recommend prep, prime and paint as desired. Additionally, vegetation noted growing up side of house. Recommend trimming/maintaining at least 6 inches away from home as they can contribute to moisture infiltration and insect infestation.

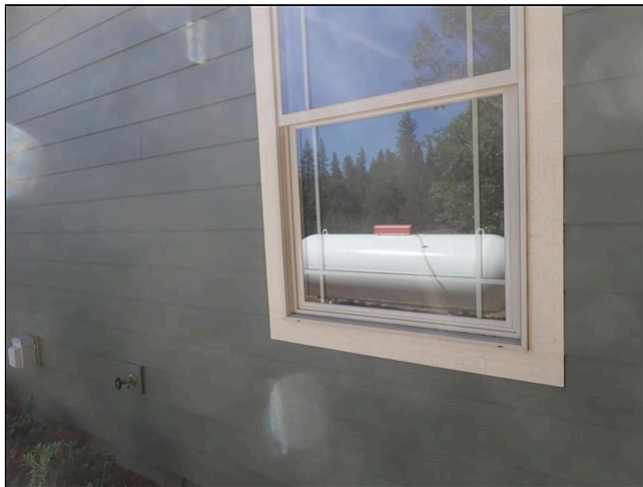
2.1 (Picture 1)

Several window screens around home and shop are missing. Recommend replacing to ensure proper operation.

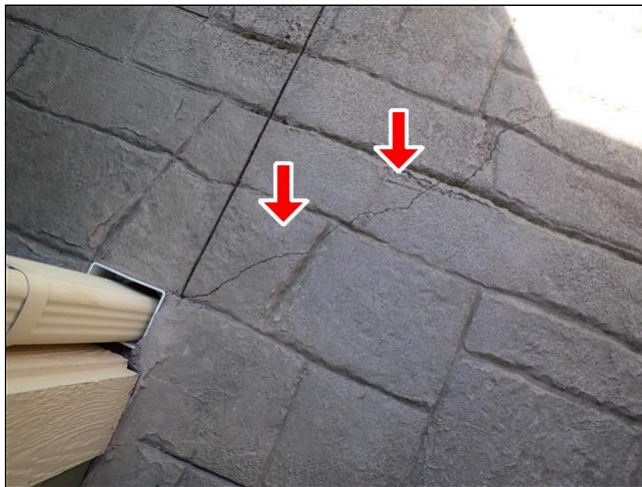
3.0 (Picture 1)

Cracking noted; recommend sealing cracks to prevent further deterioration.

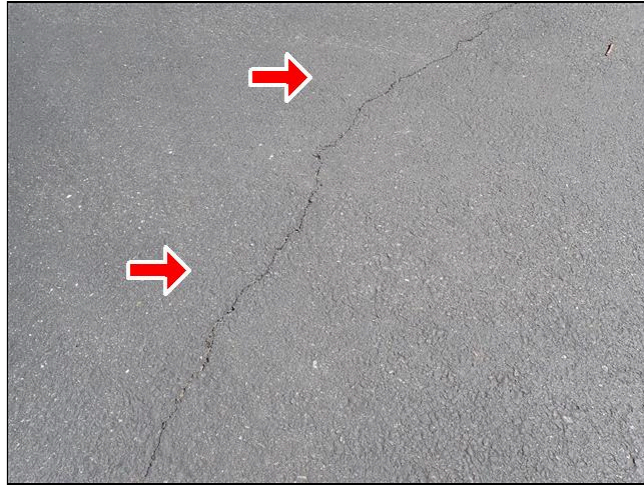
3.2 (Picture 1)

Cracking noted; recommend seal cracks. Periodic sealing is recommended for asphalt surfaces.

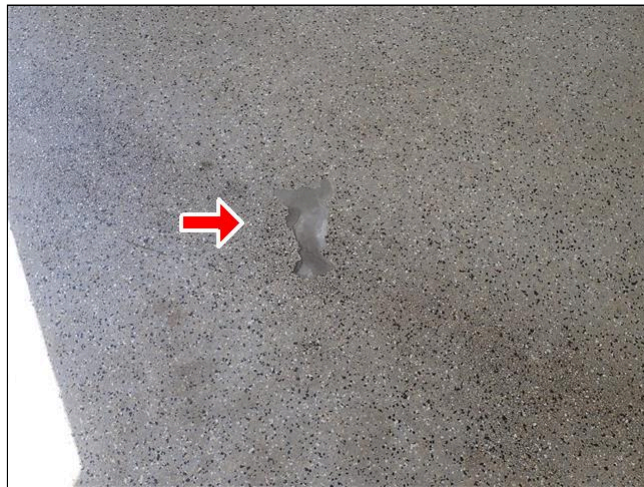
4.0 (Picture 1)

Floor sealant is starting to deteriorate in several areas. Recommend repair as needed by a qualified contractor.

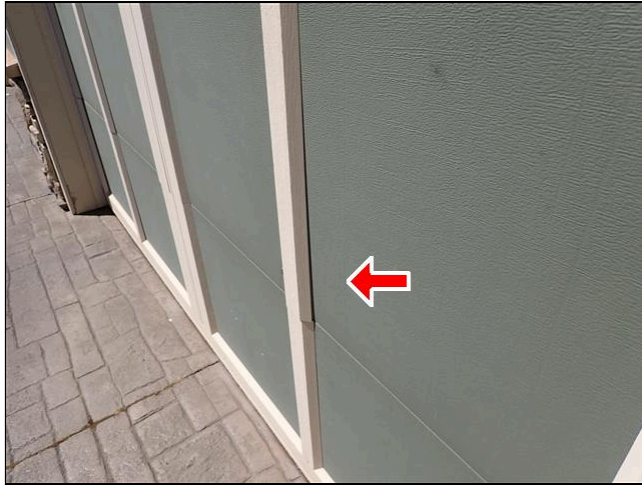
4.3 (Picture 1)

Several door trim pieces are loose or starting to detach. Recommend repair as needed by a qualified contractor.

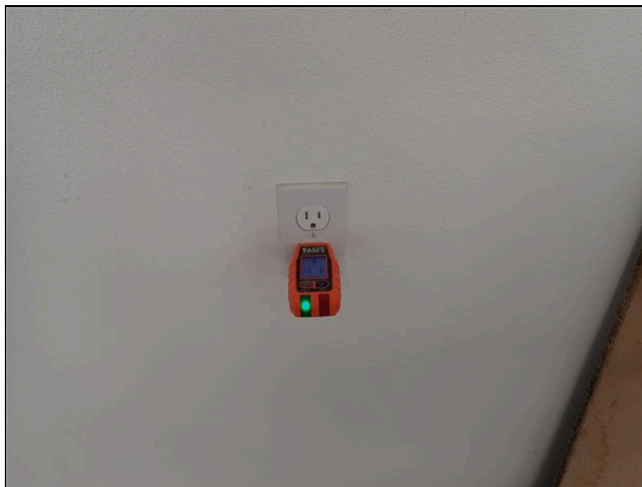
4.5 (Picture 1)

Garage area outlets are not GFCI protected. Recommend replacing as a safety upgrade.

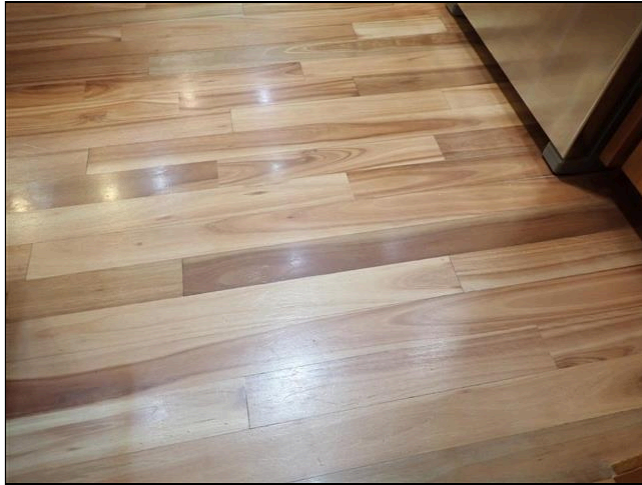
6.2 (Picture 1)

Wood floors are worn/scratched throughout home. Recommend repair and refinish as needed by a qualified contractor.

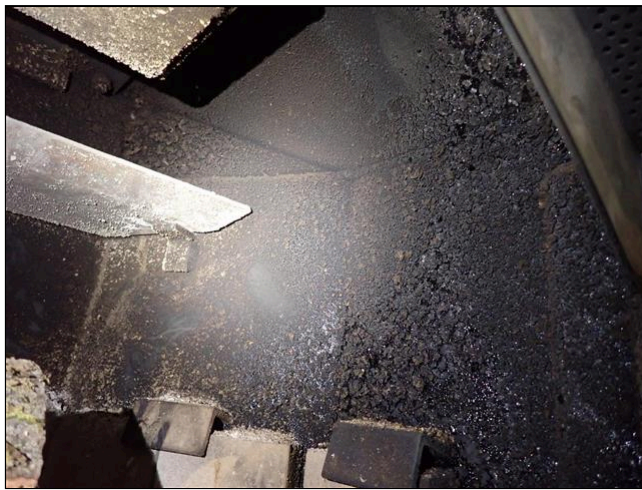
6.6 (Picture 1)

Heavy creosote build-up noted at fireplace. Recommend a qualified chimney sweep clean and inspect for safety.

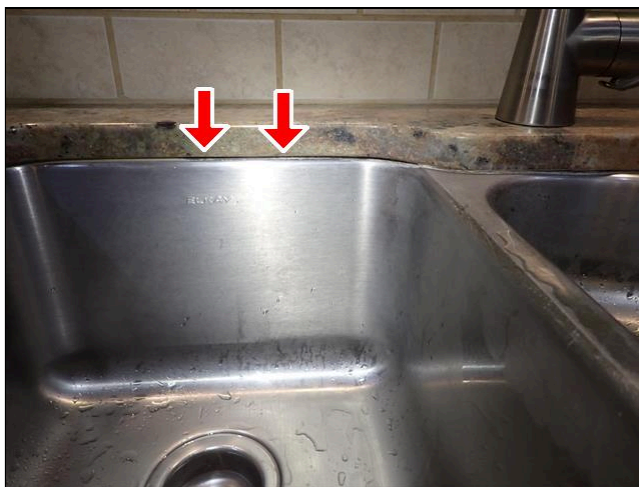
7.0 (Picture 1)

Caulking between sink and countertop is deteriorated and potential source of water leakage; recommend re-caulking.

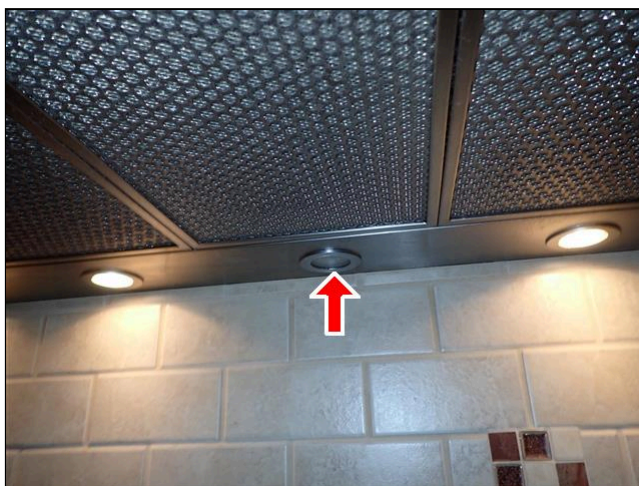
7.5 (Picture 1)

Vent light is out. Replace bulb as first course of action. If problems persist, contact a qualified electrician or appliance repair person.

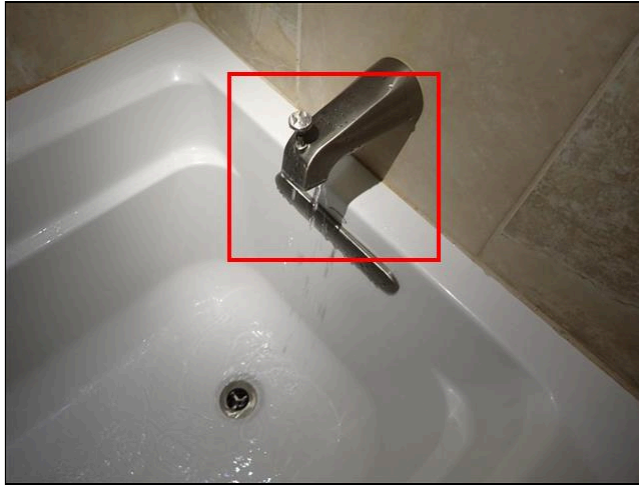
8.0.A (Picture 1)

Operation of the bathtub/shower diverter does not direct full water flow to the showerhead. Repair or replacement may be required to provide full flow. Additionally, shower head leaks/sprays at connection to plumbing neck. Recommend repair to preclude damages to surrounding area.

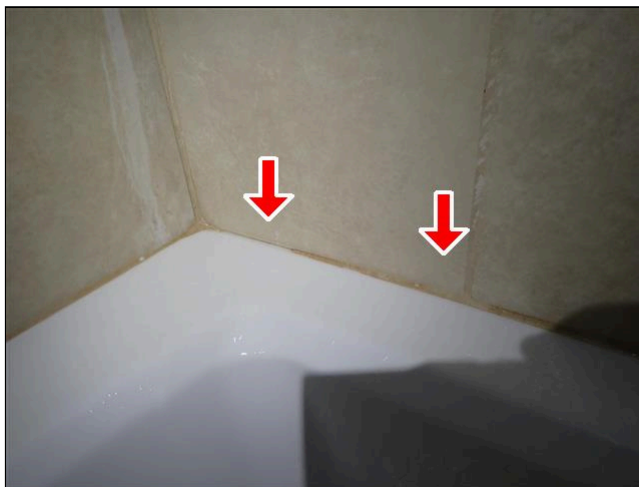
8.3.A (Picture 1)

Deteriorated grout/caulking; recommend repair to prevent water intrusion concerns.

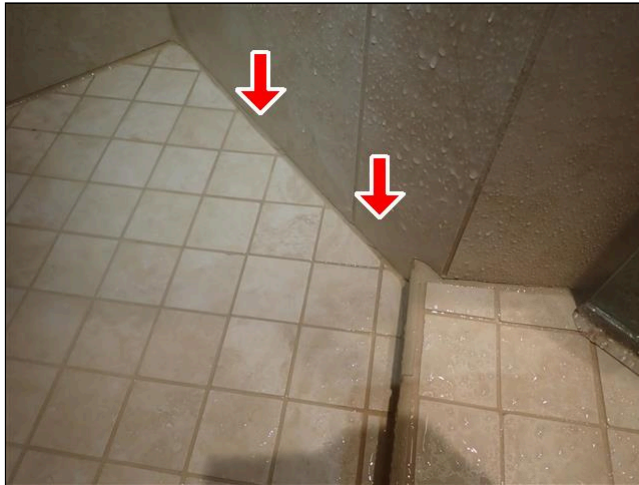
8.3.B (Picture 1)

Deteriorated grout/caulking; recommend repair to prevent water intrusion concerns.

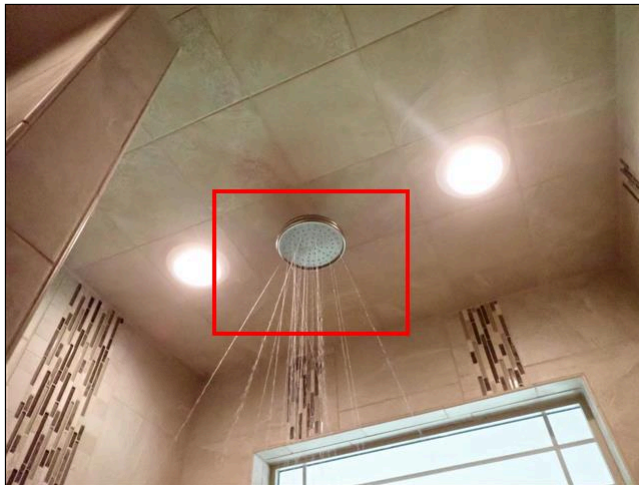
8.3.C (Picture 1)

Shower spray is irregular. Recommend cleaning or replacement to return back to normal pattern.

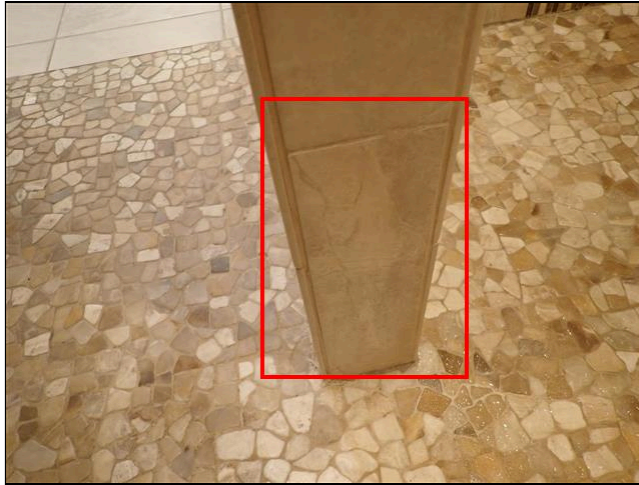
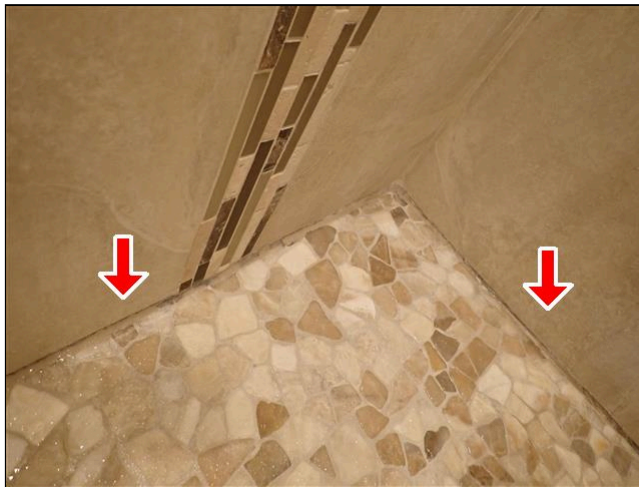
Caulking and/or grouting work is required to maintain the watertightness of tile and the shower enclosure. Check for substrate damage if surface damage or leakage is present, and when performing regular maintenance.

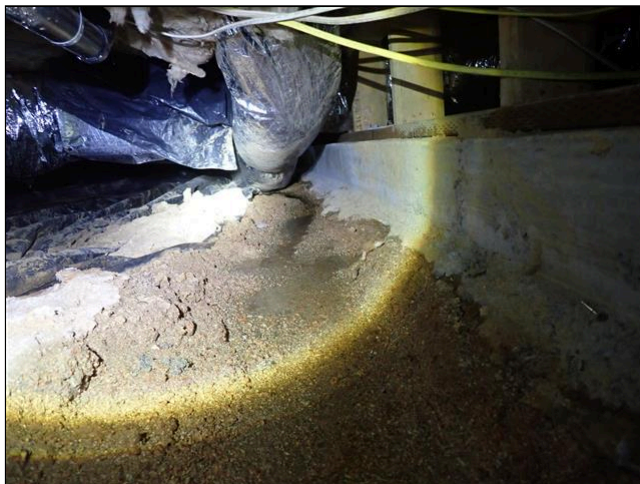
9.2 (Picture 1)

Vapor barrier is displaced in multiple locations due to water in areas. See related comments in Section 10. Advise adding or redistributing barrier to help control moisture levels in living area.

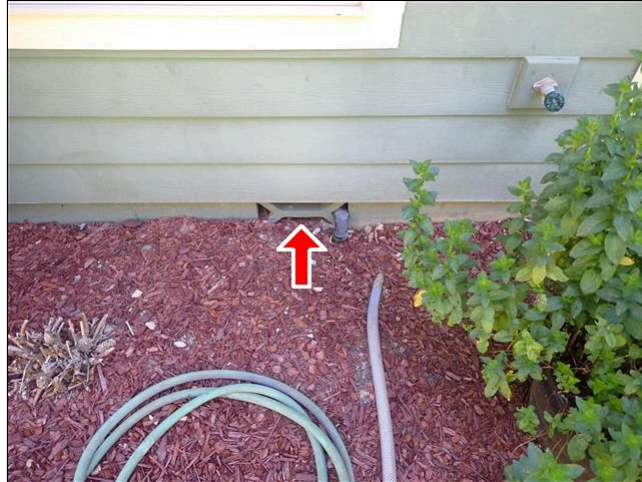
9.3 (Picture 1)

Several crawlspace vents are full of debris. Recommend checking and clearing all vents to ensure best provisions are in place.

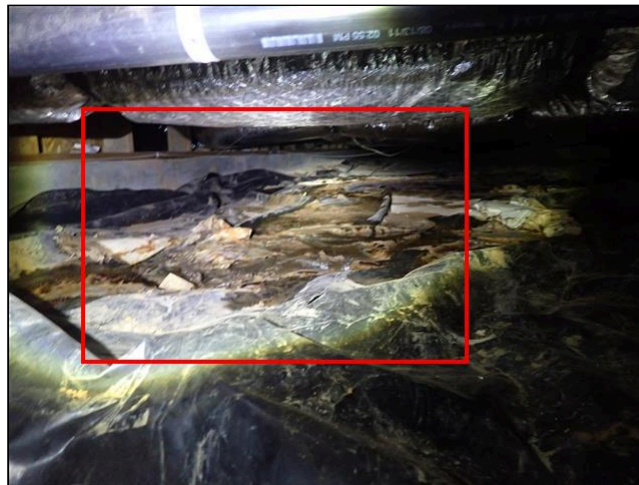
Standing water noted on crawlspace floor at multiple locations under home. Most significant areas of water was observed at back right, front right and front left corners of home. Water could be related to over irrigation or house being located on hill (ground water). Recommend conditions be further evaluated by a qualified specialist to determine repair needs and associated cost.

10.0 (Picture 1) Right Section

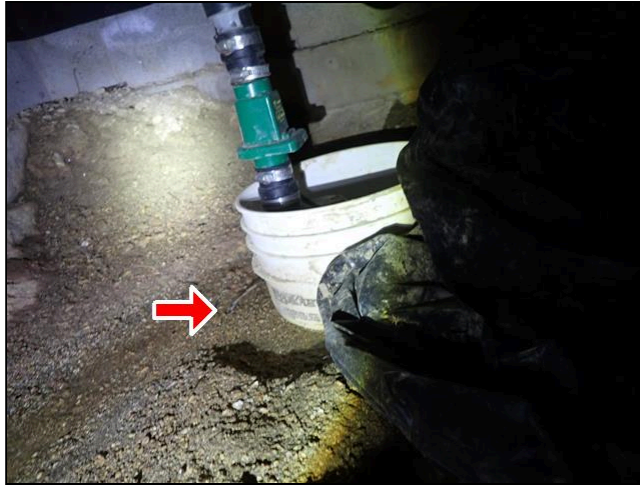
10.2 (Picture 1)

Sump pump was present and operational at time of inspection. However, installation appears substandard. Sump pit is surrounded by dirt with large openings allowing sediment into bucket. Additionally, water terminates from hose on exterior of home near foundation. Due to current conditions, recommend having sump pit checked and repaired as needed by a qualified specialist.

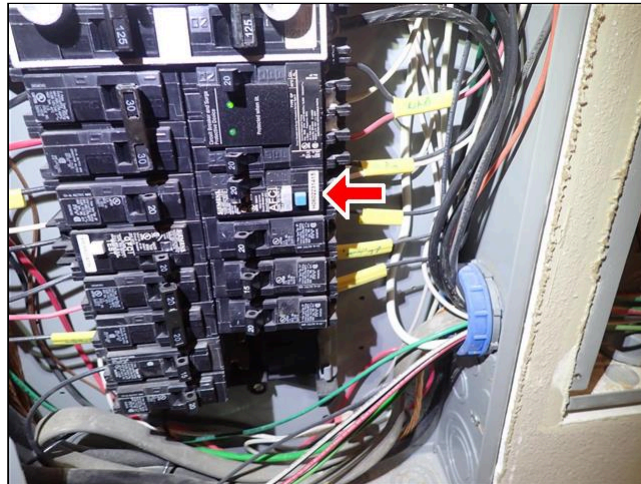
11.1 (Picture 1)

This home is equipped with Arc-fault Circuit Interrupters (AFCIs) located in the distribution panel. These provide additional safety measures for the home. There was a recall of AFCIs with blue test buttons. Unit in left side panel did not trip at time of inspection. As a precaution, recommend further evaluation and repair as necessary by qualified electrician.

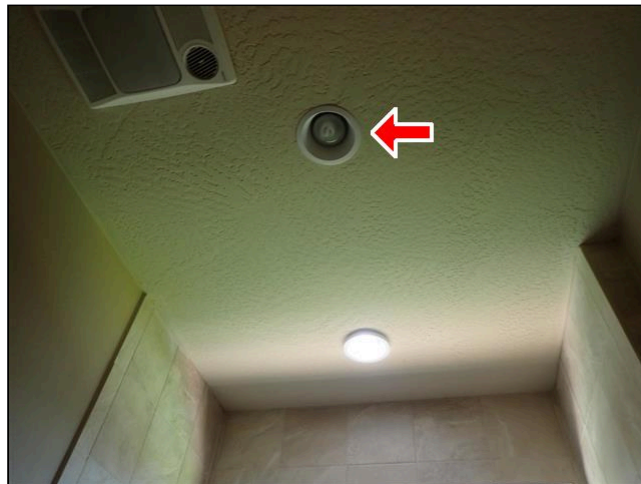
Several lights were not operable. Any inoperative unit may be due to a defective fixture or bulb. Replace bulbs as first action; contact qualified electrician if issue persists.

11.5 (Picture 1) Hallway Bath

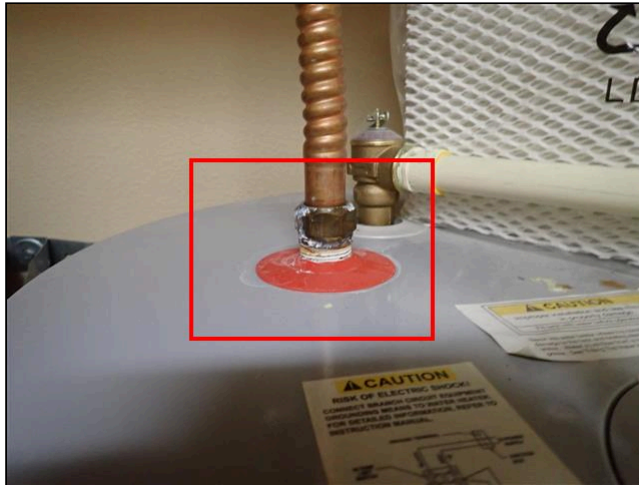
14.0 (Picture 1)

Hot water heaters were functional at time of inspection. However, they are near the end of their normal design life. Corrosion noted at tank/water supply connections. Recommend monitoring for changing or worsening conditions. Repair or replace as needed.
