INSPECTION REPORT

2564 Old Military Rd
Central Point, OR 97502

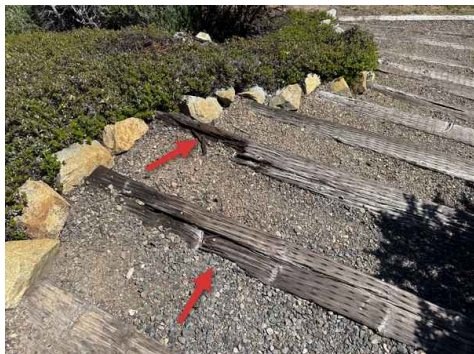
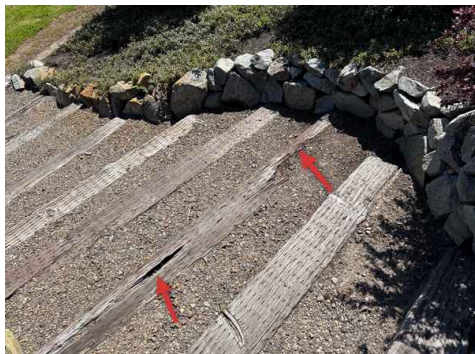
STAIRS - ROT / DECAY

There was moisture damage observed at the stairs/steps. Recommend repair by a qualified professional.

Contact a qualified professional.

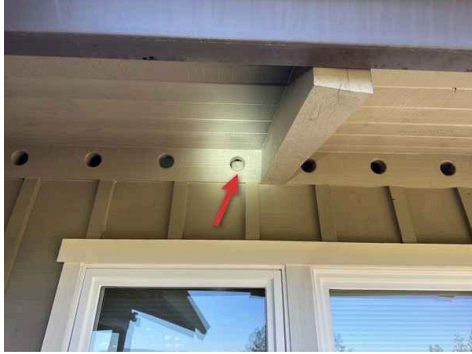
Back Of Home

SOFFIT VENT - DAMAGE

The were damaged soffit vent(s) observed. Recommend repair/replacemend to help prevent pests from entering the attic.

Contact a qualified professional.

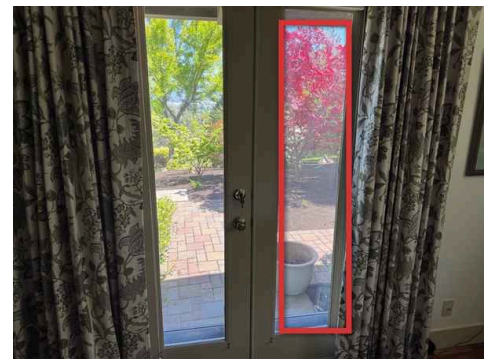
Back Right Bedroom

DOOR - GLASS FAILED SEAL

The glass in the exterior door(s) appeared to have a failed hermetic seal. Recommend a qualified professional replace glass.

Contact a qualified professional.

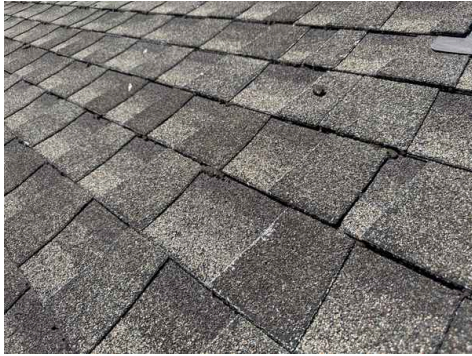
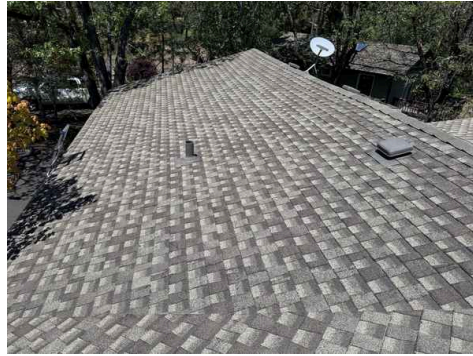
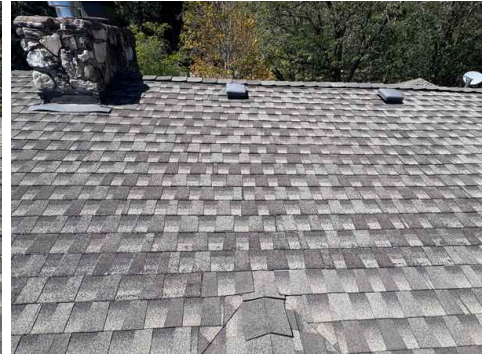
There was moderate granule loss observed at the roof shingles. This is a normal process as the roof ages. Recommend monitoring for significant granular loss, at which point the shingles may need to be replaced.

Recommend monitoring.

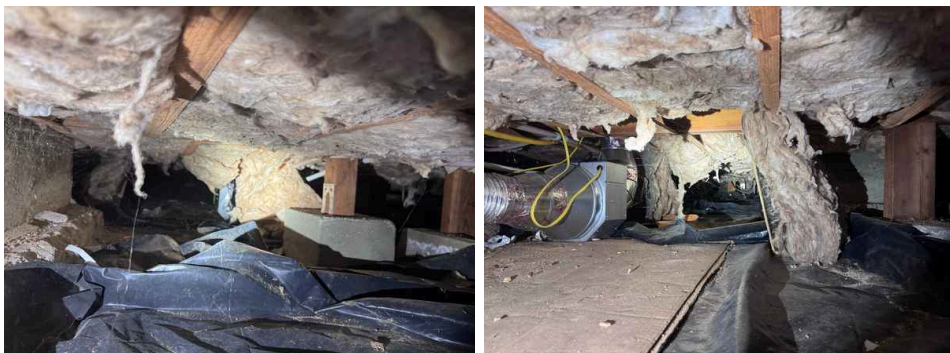
The insulation has fallen in areas of the crawlspace. Recommend repair by a qualified professional.

Contact a qualified professional.

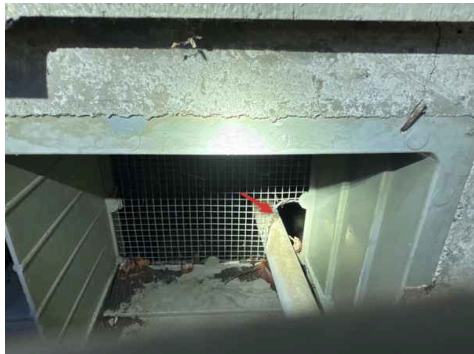
Back Of Home

VENTS - SCREEN DAMAGE

There were damaged crawlspace vent screen(s) observed. Rodent or pests can enter the crawl space and nest, die and/or leave feces and urine. Rodents often damage under-floor insulation too. Recommend that a qualified person install or replace screens as necessary using 1/8-inch to 1/4-inch wire mesh.

Contact a qualified handyman.

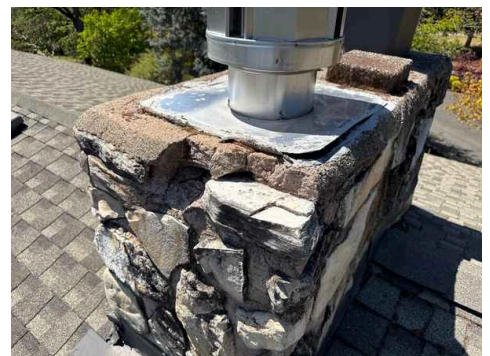
CHIMNEY - DETERIORATION (REPAIR)

The chimney was deteriorated. This can cause the chimney to be unstable. Recommend evaluation and repairs as necessary by a qualified chimney repair contractor.

Contact a qualified chimney contractor.

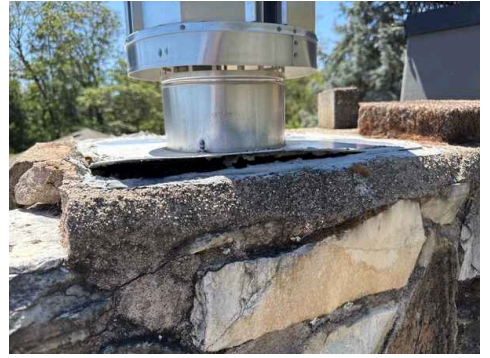
FLASHING - LOOSE / SEPARATED

The chimney flashing was loose/separated, which can lead to moisture intrusion. Recommend a licensed roofing professional repair.

Contact a qualified roofing professional.

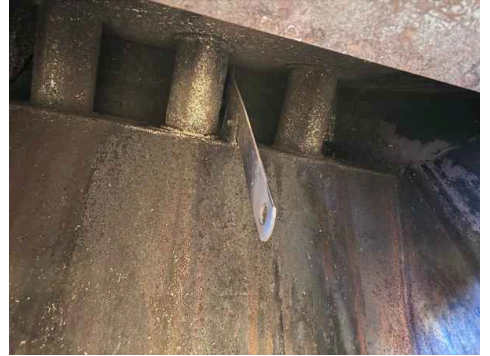
WOOD FIREPLACE - DAMPER INOPERABLE

The fireplace damper was inoperable at time of inspection. Recommend repair as necessary by a fireplace contractor.

Contact a qualified fireplace contractor.

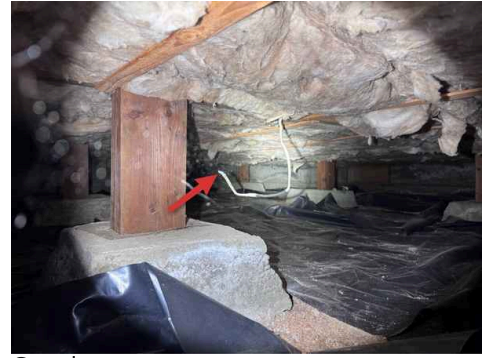
Crawlspace

There were exposed wiring terminations/exposed wire ends present at the referenced area(s). Any exposed wire termination (live or not) in the home is recommended to either be removed, or terminated into a junction box by a licensed electrician.

Contact a qualified electrical contractor.

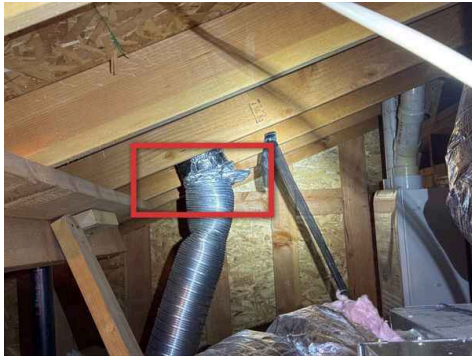
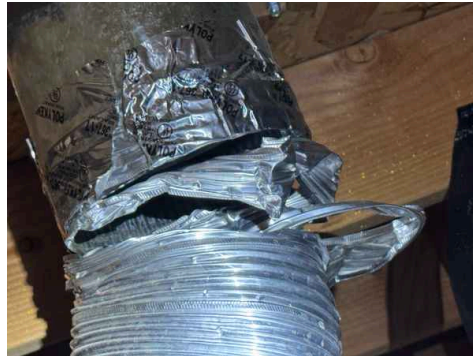
Above Master Bathroom

An exhaust vent is disconnected in the attic. Recommend repairs by a qualified professional.

Contact a qualified professional.

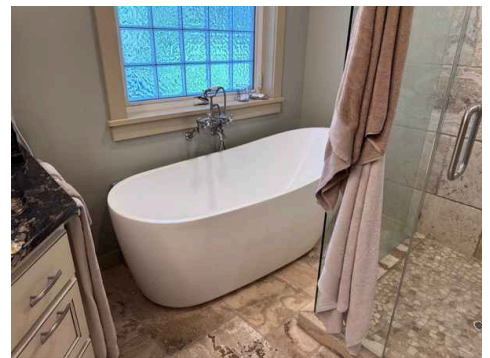
Master Bathroom

The free standing bathtub has excessive movement and is not properly secured. In order to prevent leaks in the drain lines from movement, I recommend having the tub evaluated and properly secured by a qualified contractor.

Contact a qualified professional.

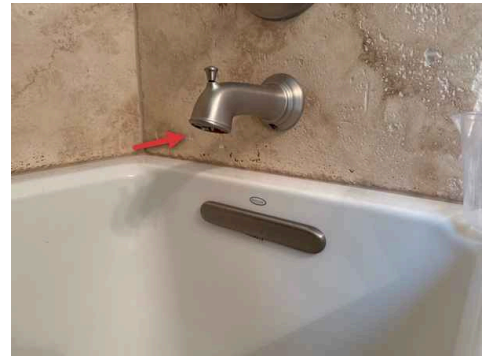
Hallway Bathroom

VALVE - LEAKS WHILE OFF

The valve was leaking while off. Recommend evaluation and repair by a plumbing contractor.

Contact a qualified plumbing contractor.

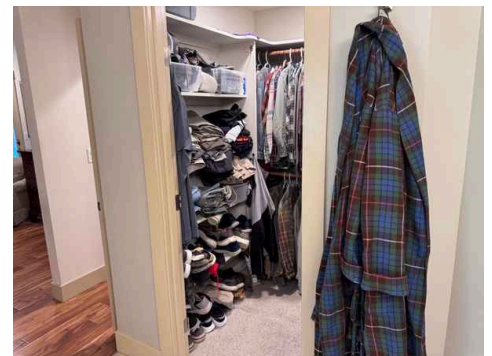
Master Bathroom Closet

DOOR - MISSING

There were door(s) that were missing at the time of inspection. Recommend doors be installed in any missing areas as desired.

Contact a qualified handyman.

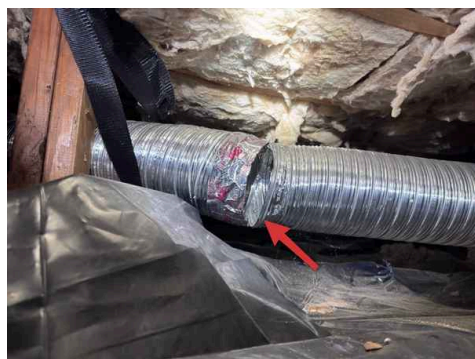
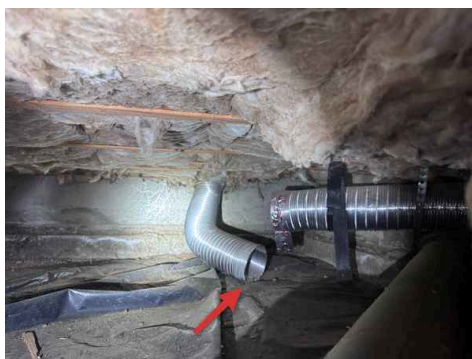
The cooking exhaust duct was separated/disconnected. This may allow exhaust fumes to escape. Recommend repair by a qualified professional.

Contact a handyman or DIY project

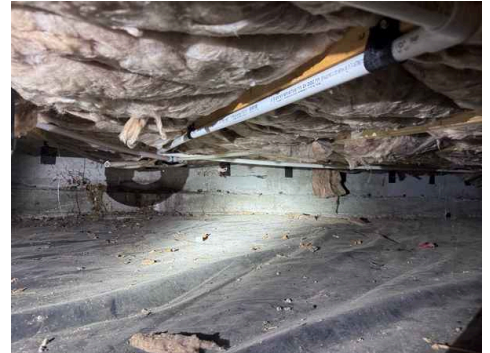
There were signs of minor rodent activity observed. Recommend sealing any potential access points and baiting/trapping as needed.

Contact a handyman or DIY project

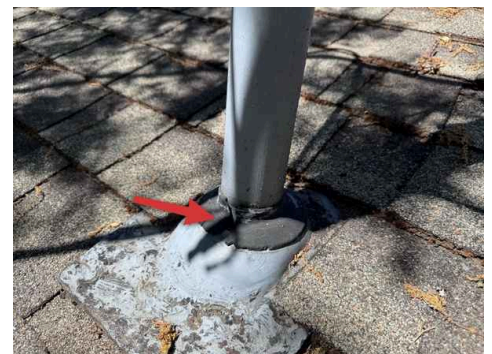
VENT BOOT - CRACKED

Contact a qualified roofing professional.
