# Table of Contents

Mapping.....	2-11
Tax Records & Title Report.....	12-30
Floor Plan.....	31-32
Seller's Property Disclosures.....	33-34
Home Inspection.....	35-88
Well Information.....	89-93
Septic Information.....	94-102
Water Rights.....	103-111
Solar Reports.....	112-113

# 8489 Redwood Hwy Oregon, AC +/-

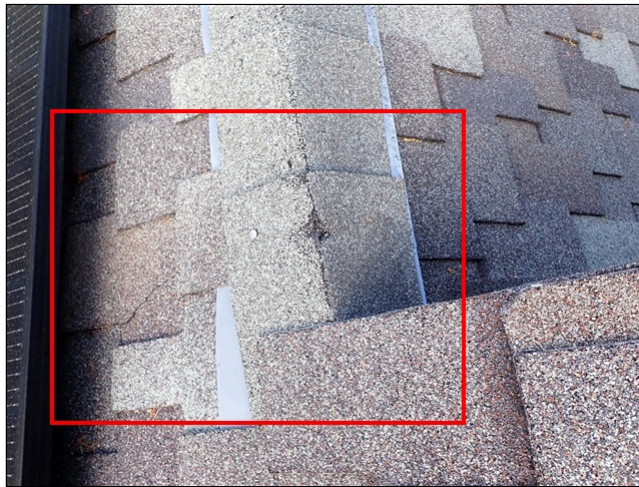
1.0 (Picture 1)

Roofing material is rated in fair condition based on age and wear. Several cracked or damaged shingles observed. Most notably near upper ridge of home. Additionally, excess moss and debris buildup observed. Recommend having roof checked and serviced or repaired as needed by a qualified roofing contractor.

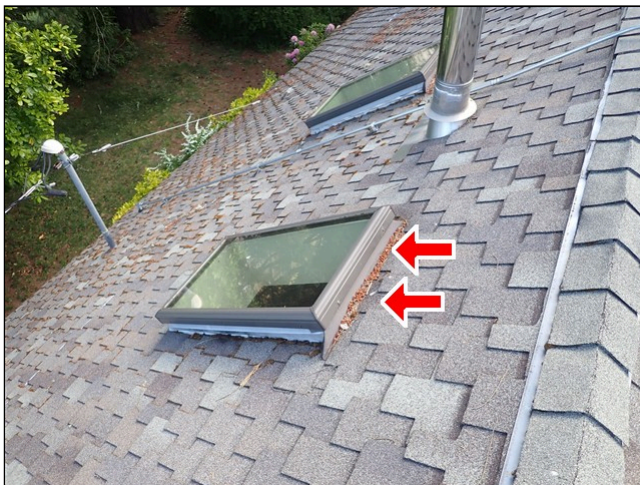
1.3 (Picture 1)

Build up of silt/debris behind skylight. This condition will result in retaining moisture around the skylight and can contribute to leakage. Recommend regular maintenance to keep area clear for proper flow of water.

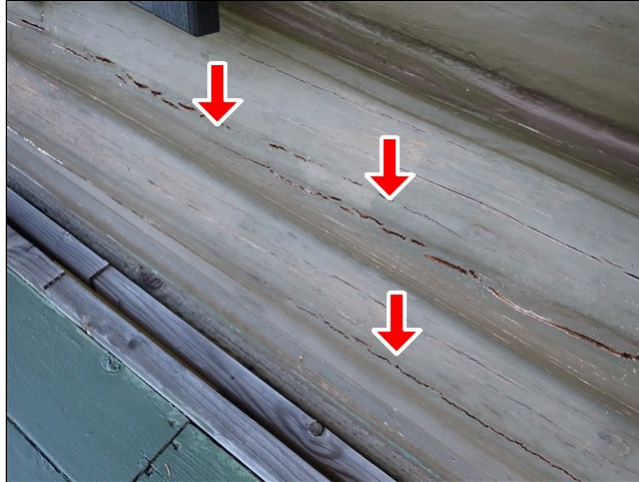
2.0 (Picture 1)

Multiple materials observed around home. Timber siding is older and showing signs of age. Several areas of previous cracking and repair noted. Recommend monitoring for changing or worsening conditions. Additionally, exit holes from wood destroying insects observed. Treat and repair as needed. Paint around home is showing signs of age and is faded. Prep, prime and paint to ensure proper protection. Trim back all loose vegetation to preclude moisture absorption issues.

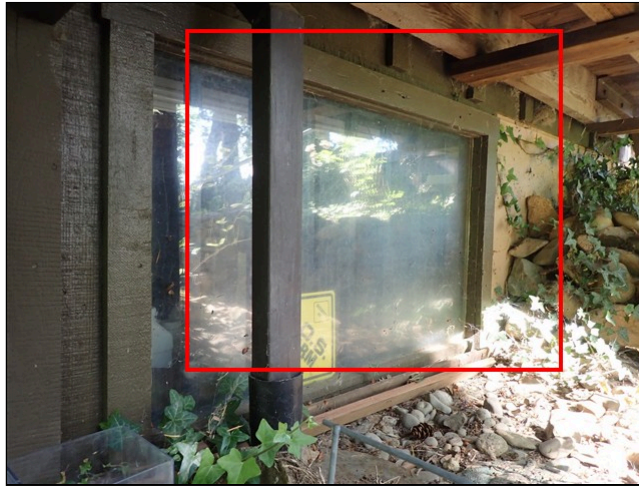
2.1 (Picture 1)

Window is cracked on lower level storage room. Recommend repair or replacement as needed by a qualified contractor.

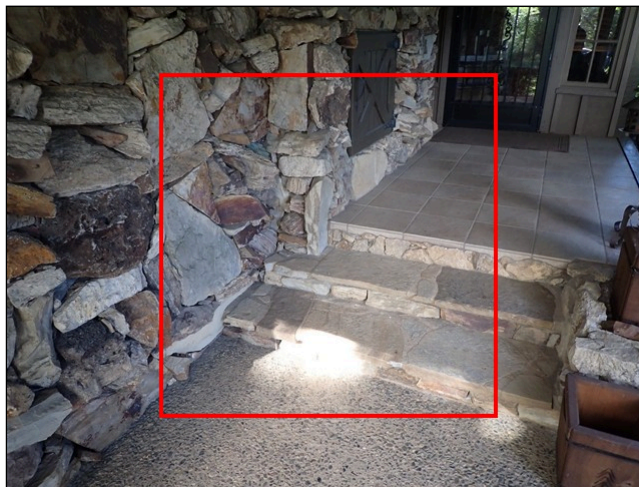
2.3 (Picture 1)

Recommend adding graspable hand railings on front of house porch step areas to bring up to current safety standards.

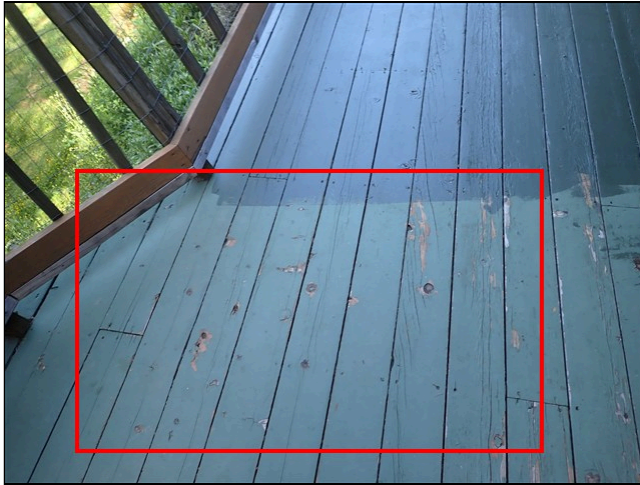
2.4 (Picture 1)

Deck structure is older and showing signs of age. Decking paint is worn and faded. Additionally, ledger board is missing flashing and lag bolts at connection to home. Recommend repairs where needed by a qualified contractor. Prep, prime and paint or stain to ensure proper protection.

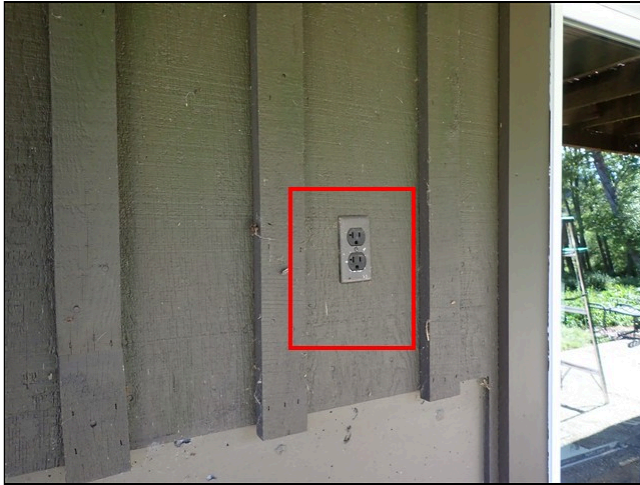
2.5 (Picture 1)

Exterior electrical system is not GFCI protected. Additionally, several outlets are not outdoor rated. Recommend repair and upgrade as needed by a qualified electrician to bring up to current safety standards.

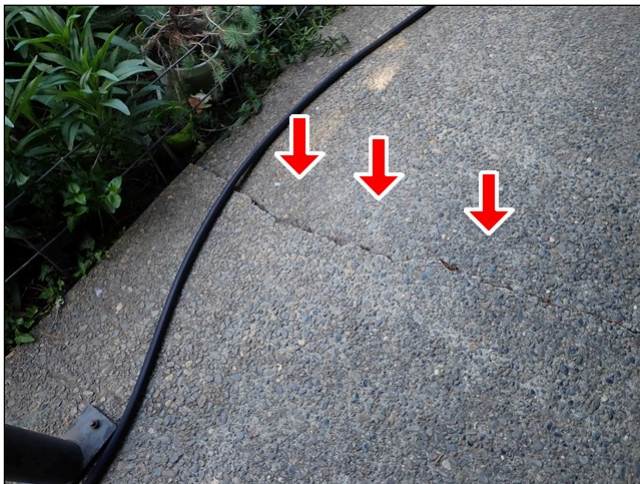
3.0 (Picture 1)

Patio is cracked and shifted at multiple locations. Most likely due to tree roots in area. Recommend repairs where needed by a qualified contractor to preclude tripping hazards.

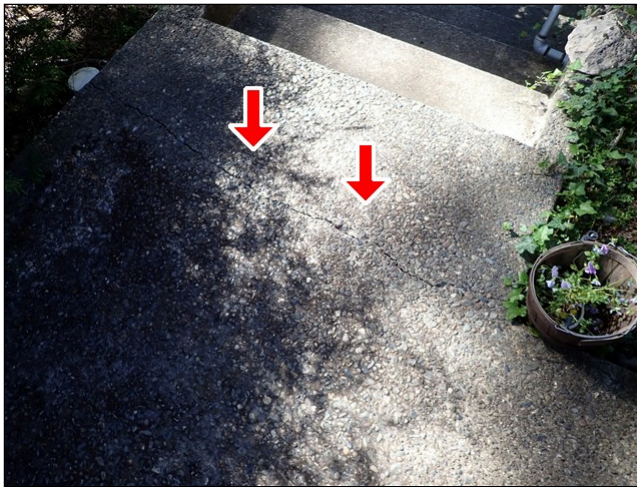
3.1 (Picture 1)

Cracking noted; recommend sealing cracks to prevent further deterioration.

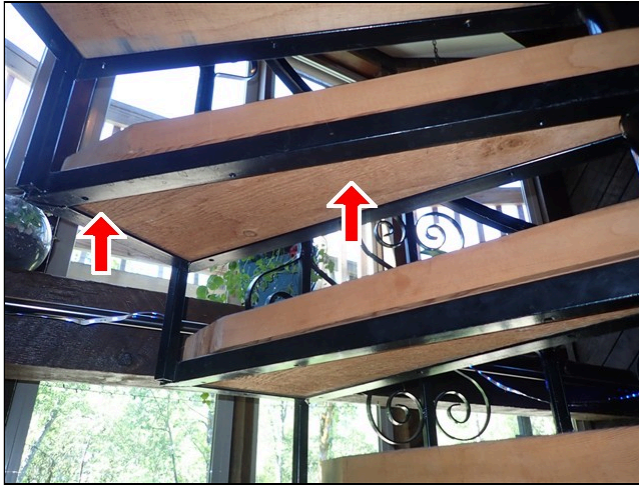
5.3 (Picture 1)

Wood treads at center stairs are loosely secured. Recommend repair as needed by a qualified contractor.

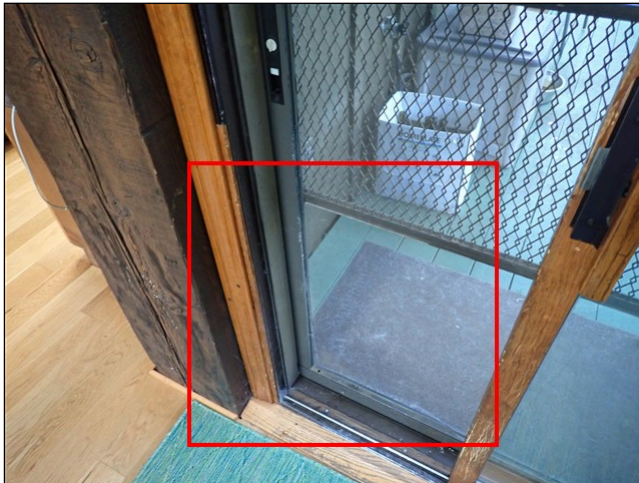
5.6 (Picture 1)

Screen door into dining room area of home is damaged. Recommend repair or replacement as needed by a qualified contractor.

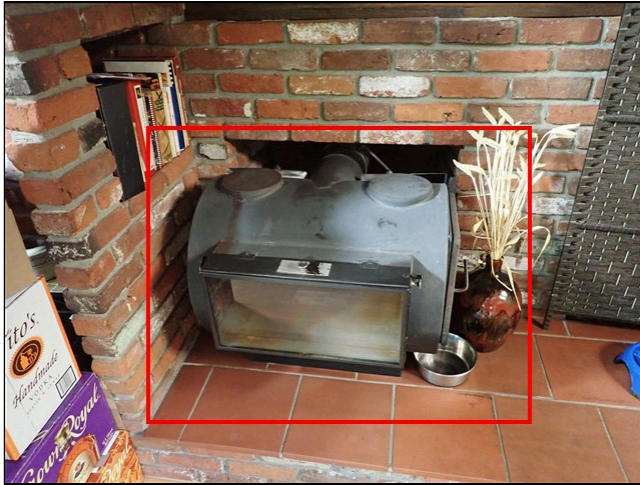
5.8 (Picture 1)

Wood burning stoves and inserts are not part of a standard home inspection due to specific installation requirements based on each manufacture. See supplemental comments for recommendations.

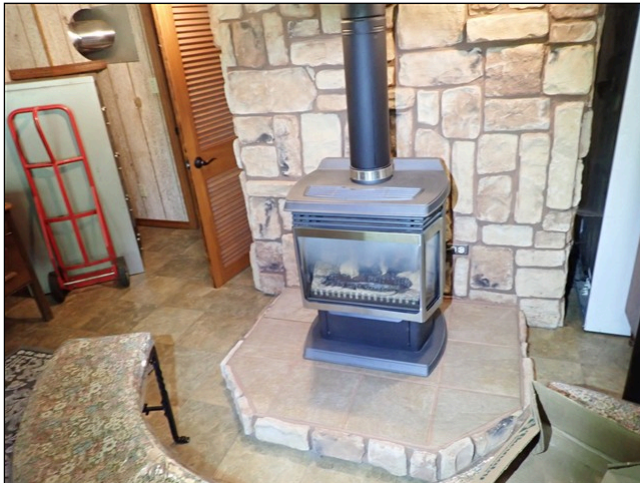
5.9 (Picture 1)

Gas fireplace in basement area of home was not operational at time of inspection. Remote temperature setting would not adjust. Recommend repair as needed by a qualified contractor.

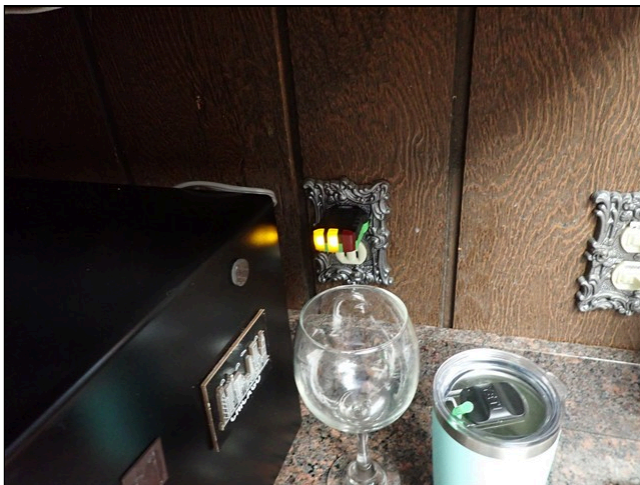
6.3 (Picture 1)

Kitchen outlets are not GFCI protected. Recommend consulting with qualified electrician for proper placement of GFCI outlets as a safety upgrade.

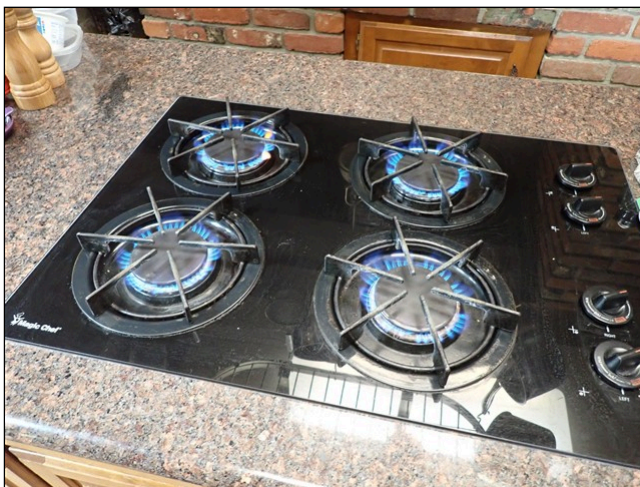
6.4 (Picture 1)

Cooktop operated satisfactorily, but is beyond its normal design life. Anticipate the need for maintenance/repairs as unit continues to age.

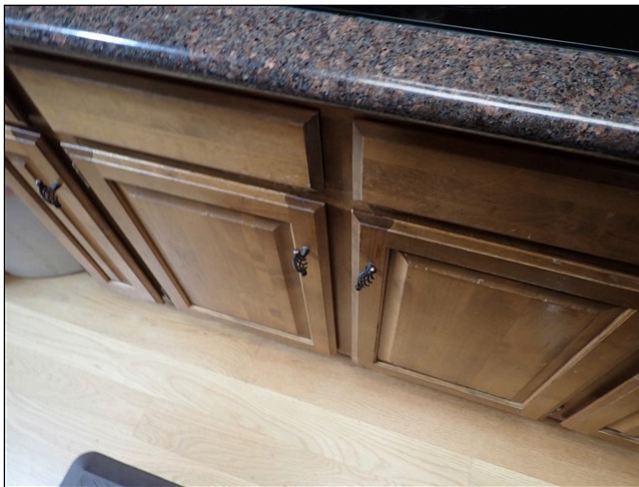
6.9 (Picture 1)

Functional with some cosmetic damage consistent with age. Refinish as desired.

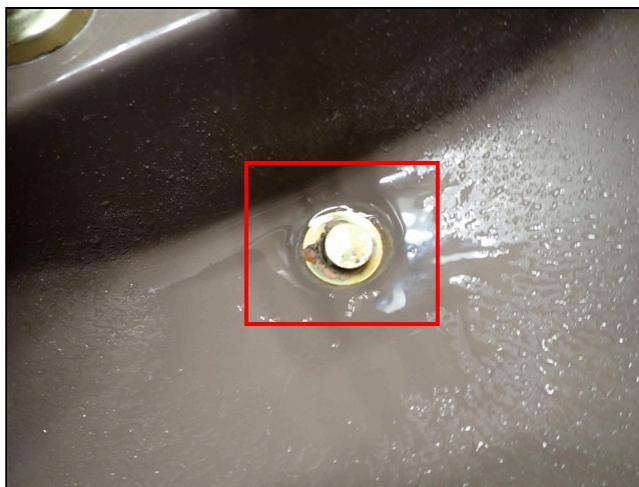
7.1.A (Picture 1)

Moderate sink surface wear or damage is generally cosmetic; if the base material has not been exposed or materially affected, the need for replacement is discretionary.

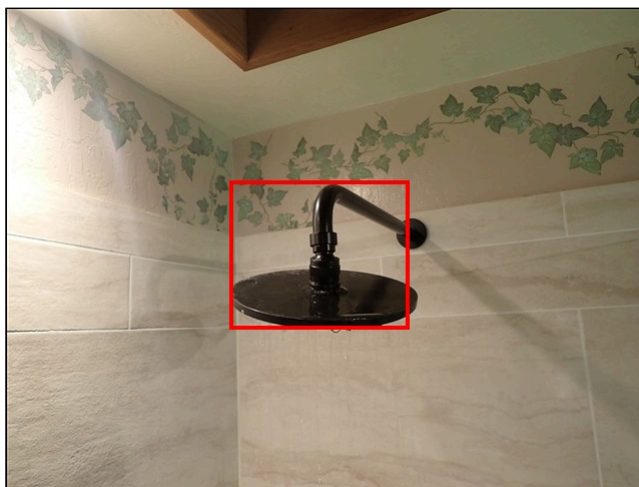
7.3.A (Picture 1)

Shower head leaks/sprays at connection to plumbing neck. A leaking showerhead should be repaired for proper operation and to prevent consequential damage from uncontrolled spray. Long-term leakage can damage finishes and structural component.

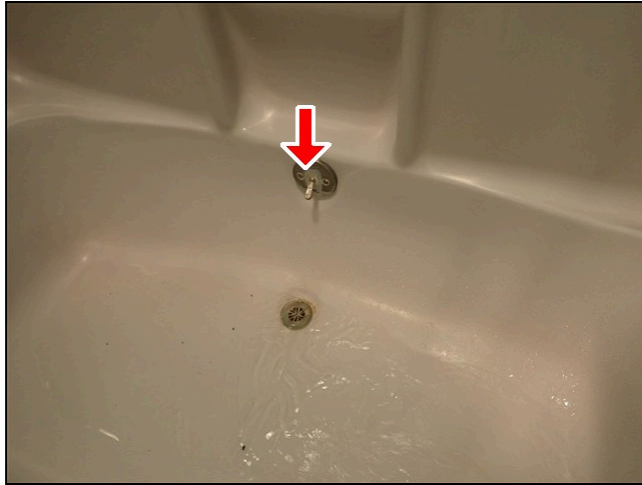
7.0.B (Picture 1)

Drain stopper linkage appears to be seized and was difficult to operate. Recommend repair or adjustment as needed by qualified plumbing contractor.

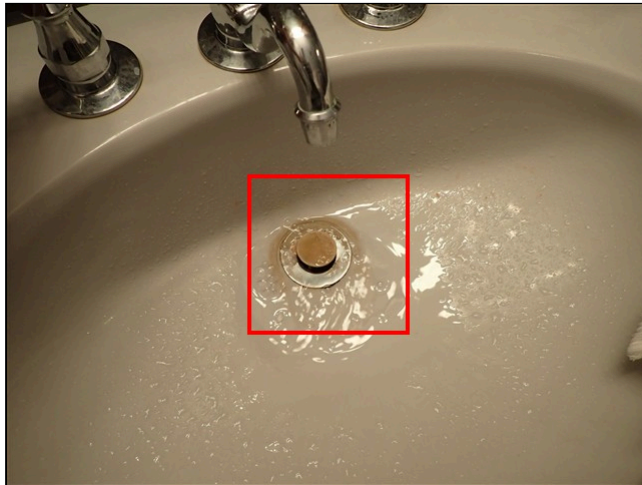
7.1.B (Picture 1)

Moderate sink surface wear or damage is generally cosmetic; if the base material has not been exposed or materially affected, the need for replacement is discretionary.

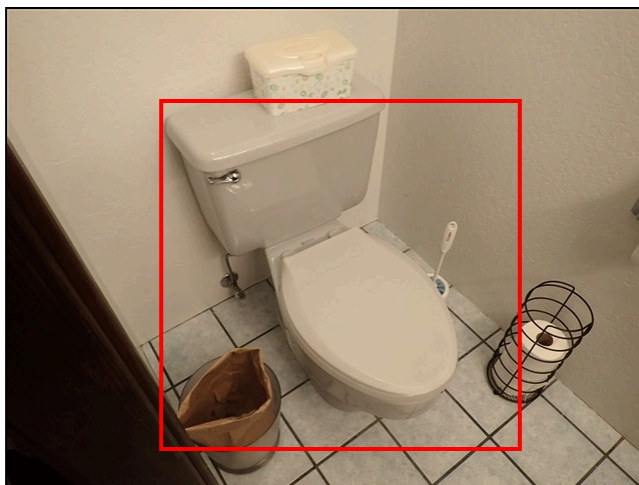
7.2.B (Picture 1)

Toilet is loose at the floor; check for leakage/damage and secure as required.

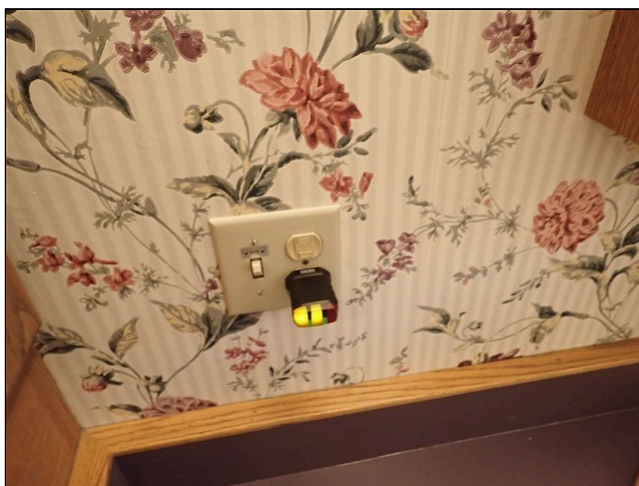
7.6.C (Picture 1)

GFCI noted, however, test operation indicated unit malfunctioned or did not work properly. All related circuitry should be inspected by a qualified electrician.

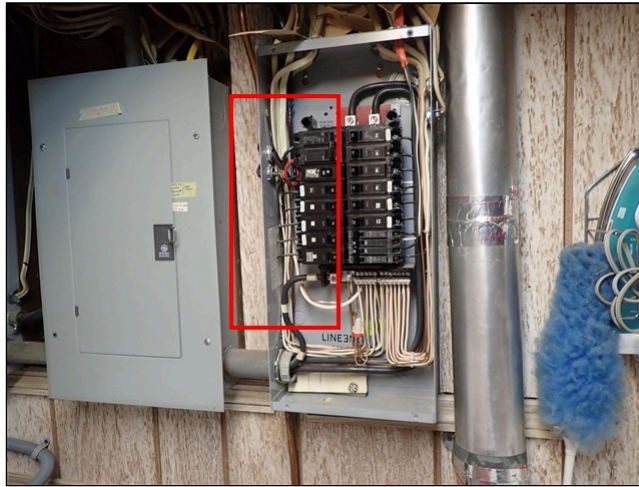
10.5 (Picture 1)

Unused wire in panel should be removed or terminated to prevent from inadvertently becoming energized. Recommend qualified electrician repair.

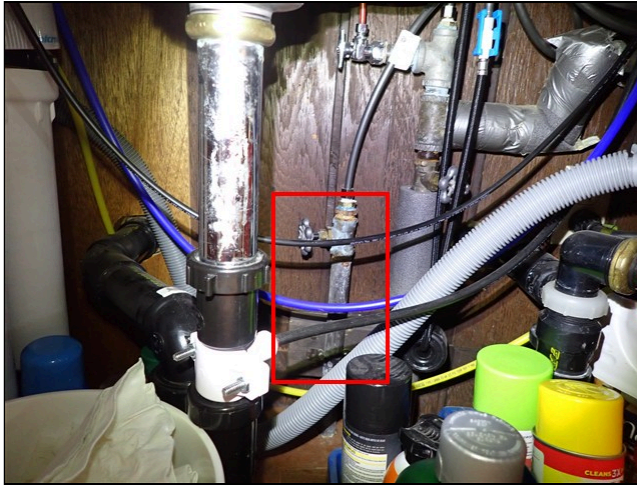
12.0 (Picture 1)

Mix of older galvanized and newer copper piping. Mix materials can cause corrosion at junctions. Anticipate need for repairs in the future.

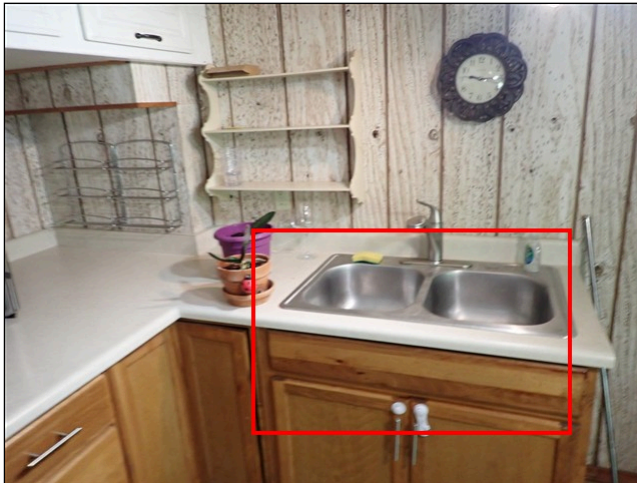
12.3 (Picture 1)

Suspect gurgling noise observed at basement sink when upper kitchen area appliances and sinks were draining. Recommend further evaluation and repair as needed by a qualified plumbing contractor.

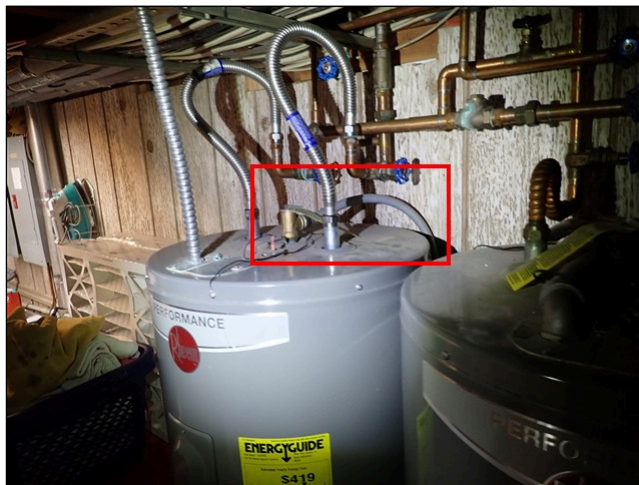
13.1 (Picture 1)

Only metal or high temperature plastic piping should be connected to the TPRV safety valve. The installed plastic pipe does not appear to be rated for high temperature applications. Recommend further inspection and repair by qualified plumber.

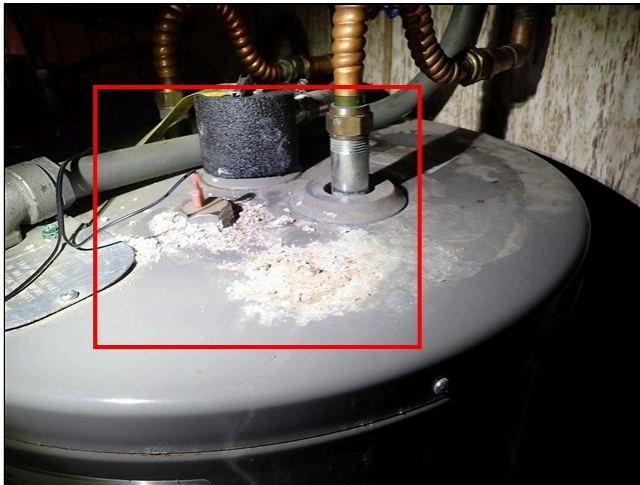
13.2 (Picture 1)

Corrosion noted around anode on top of tank. Recommend having tank checked and repaired as needed by a qualified contractor. Additionally, restraining straps are generally required on all water heaters. Straps should secure the unit to the structure. Contact a local plumber or the building department for current requirements.

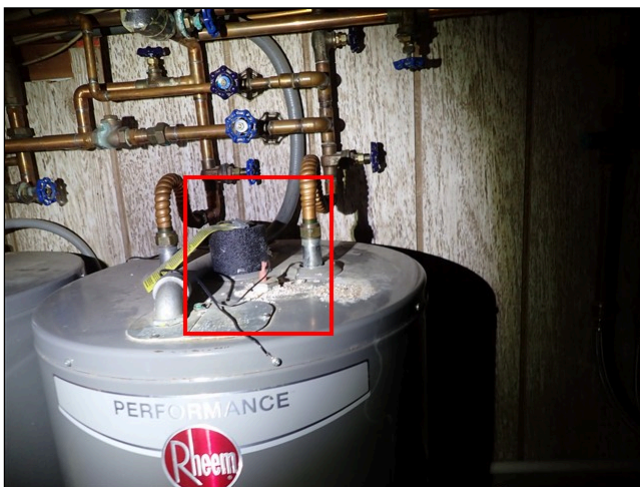
13.3 (Picture 1)

Only metal or high temperature plastic piping should be connected to the TPRV safety valve. The installed plastic pipe does not appear to be rated for high temperature applications. Recommend further inspection and repair by qualified plumber.
