157 Littrell Drive

Turn-Key Home On Rogue Valley Country Club

INSPECTION REPORT

157 Littrell Dr
Medford, OR 97504

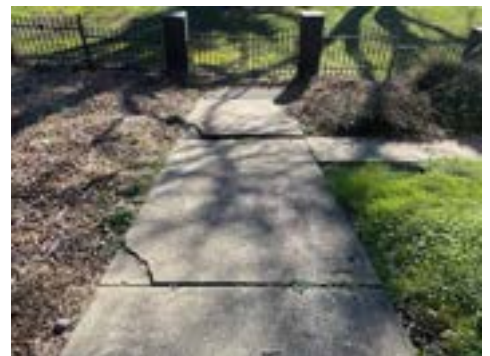
Left Of Home

CONCRETE - TRIP HAZARD

Uneven or raised areas were observed in the concrete surface, creating a potential trip hazard. Changes in elevation can increase the risk of stumbling, particularly in walking or frequently used areas. This condition may worsen over time as the concrete continues to deteriorate or shift. It is recommended that a qualified contractor evaluate the affected areas and make appropriate repairs to reduce the trip hazard and improve safety.

Recommendation

Contact a qualified professional.

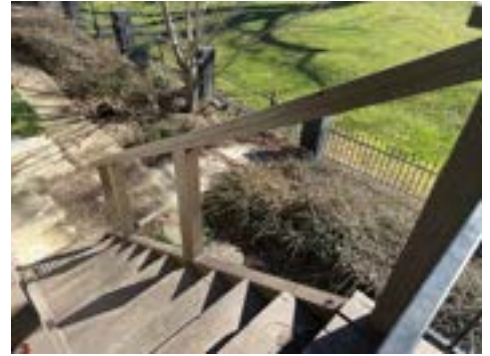
Back deck steps

RAILINGS - INFILL / BALUSTERS MISSING

There was missing infill/balusters observed at the railings. Recommend a qualified professional replace any missing infill/balusters for safety.

Recommendation

Contact a qualified professional.

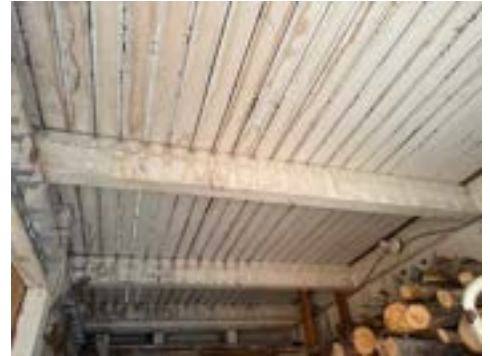
Deck framing members were observed to be overspanned, meaning the distance between supports appeared greater than intended for the size of the framing. Overspanned framing can result in excessive flexing, sagging, or long-term structural stress under normal use. This condition may reduce the overall stability and service life of the deck. It is recommended that a qualified contractor further evaluate the deck framing and add support or make modifications as needed to improve structural performance.

Recommendation

Contact a qualified deck contractor.

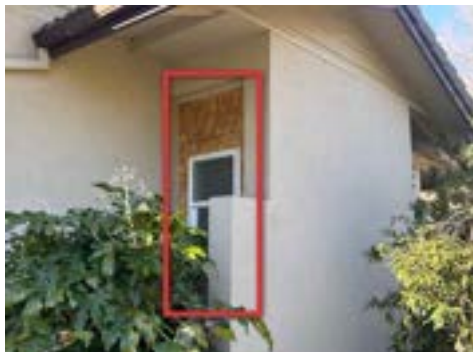
Back Left Of Home

STUCCO - REPAIRS NEEDED

The stucco is in need of repairs. This may cause or already have caused moisture intrusion and related damage. Recommend evaluation and repair as necessary by a stucco repair contractor.

Recommendation

Contact a stucco repair contractor

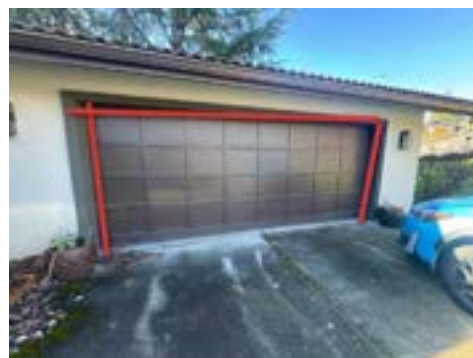
3.7.1 Garage Door Exteriors

The garage door weather stripping was substandard (damaged, missing, loose etc.) This can allow air/moisture/pest intrusion. Recommend repair/replacement as necessary by a qualified professional.

Recommendation

Contact a qualified professional.

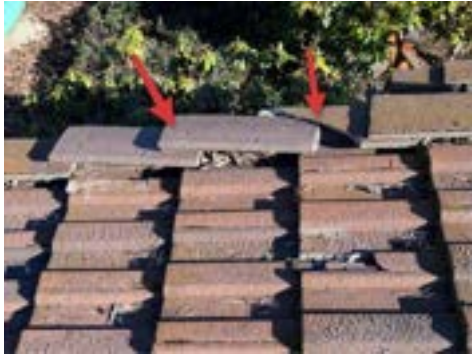
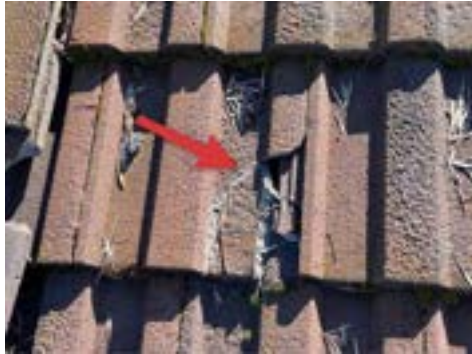
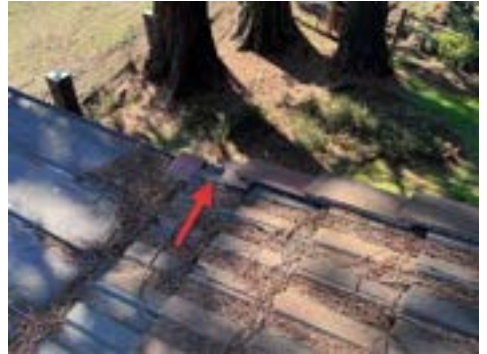
TILE - DAMAGED

There was damaged tile(s) observed at time of inspection. Recommend repair/replacement by a licensed roofing professional.

Recommendation

Contact a qualified roofing professional.

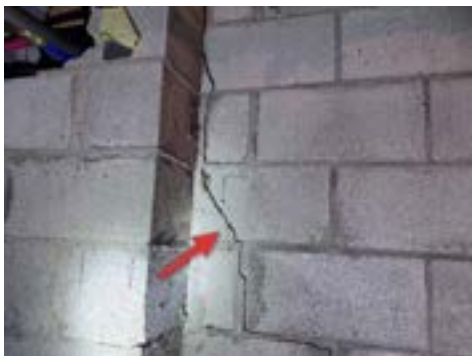
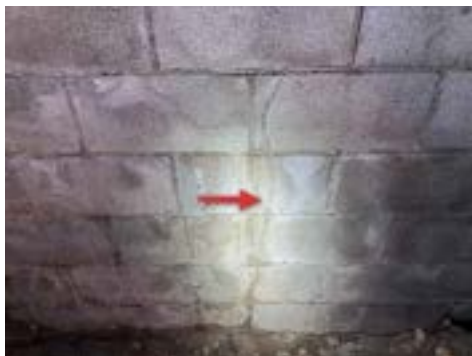
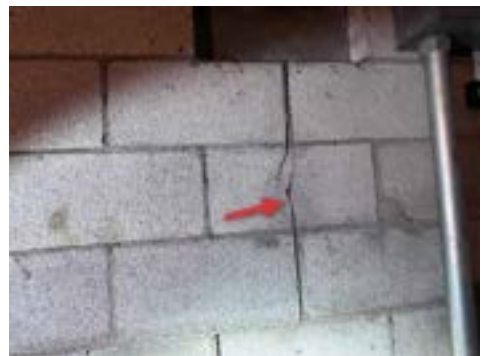
5.3.1 Foundation

FOUNDATION - CRACKS (MODERATE)

There was moderate cracking observed at the foundation. This is typically consistent with soil movement and could lead to serious damage to structural components, foundation and/or slabs in some instances. Recommend a foundation contractor evaluate to determine if repairs are needed.

Recommendation

Contact a foundation contractor.

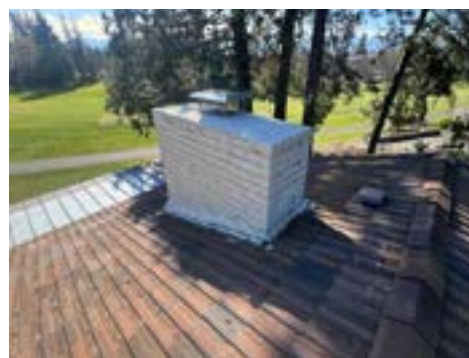
CHIMNEY - FLAKING / SPALLING

The chimney is flaking/spalling. Recommend evaluation and repair as needed by a chimney repair contractor.

Recommendation

Contact a qualified chimney contractor.

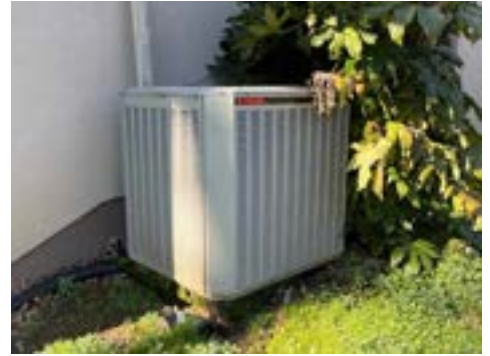
7.3.1 Air Conditioning

Moderate**AIR CONDITIONER - END OF LIFE (EVALUATE)**

Recommendation

Contact a qualified HVAC professional.

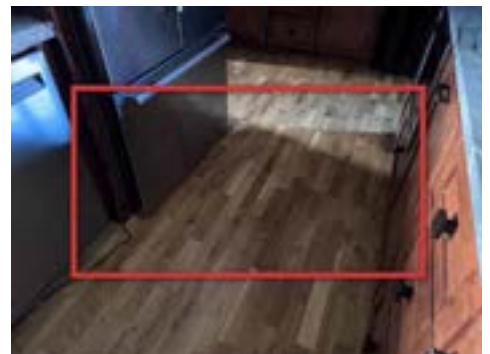
Possible refrigerator or dishwasher leak (dry at time of inspection)

Recommendation

Contact a qualified professional.

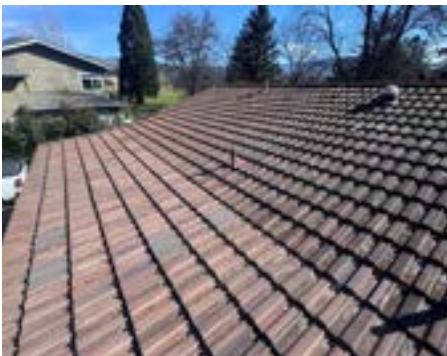
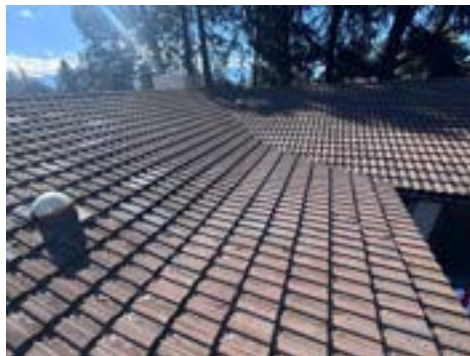
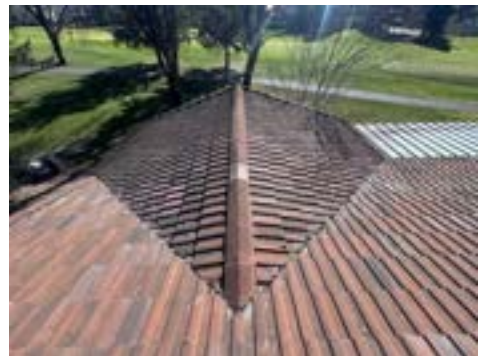
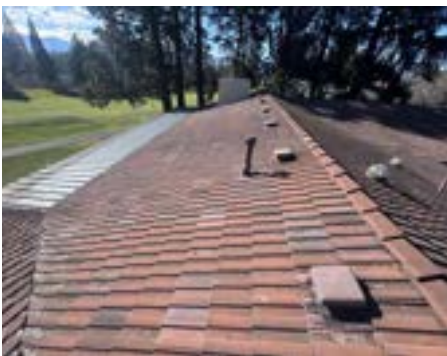
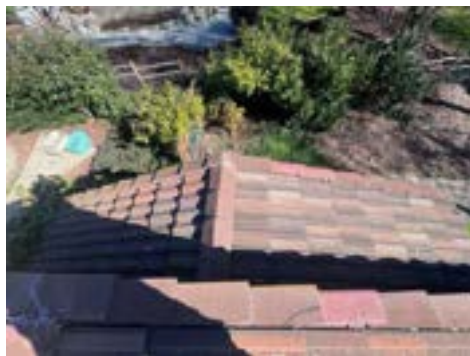
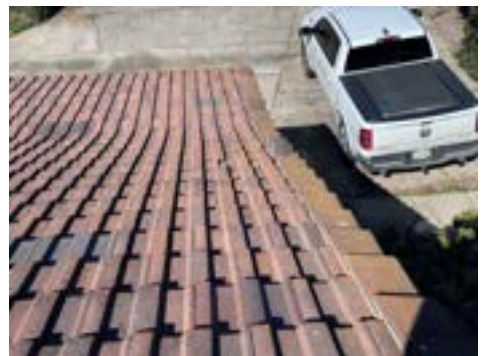
Roof Photos

The following photos are general views of the roof, taken at time of inspection for your reference.

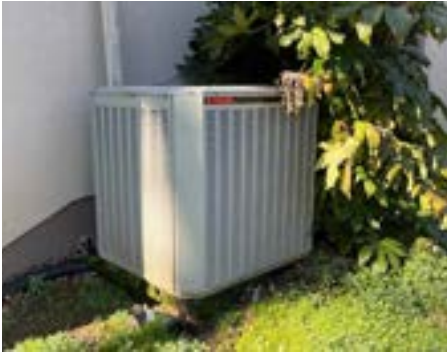
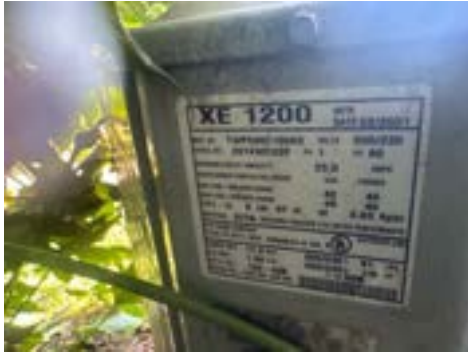
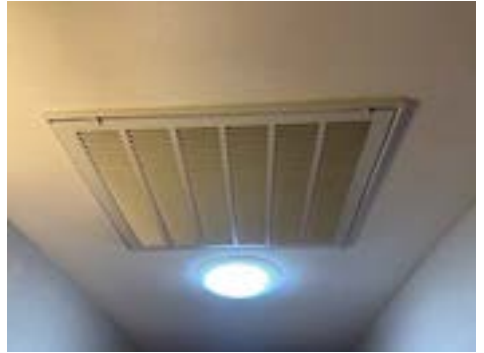
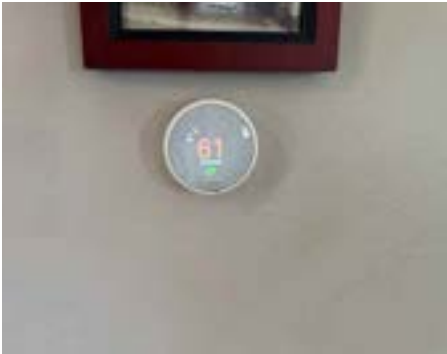
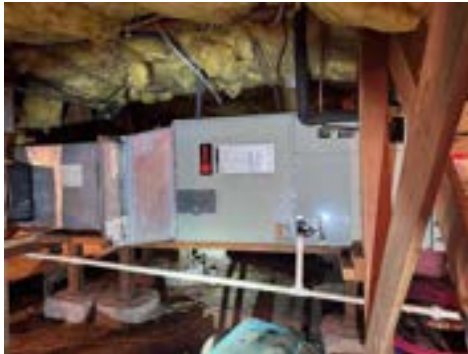
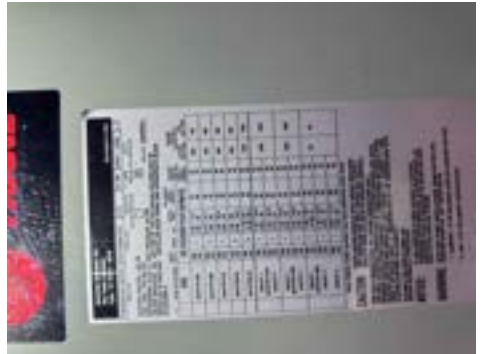
HVAC Photos

The following photos are general views of the HVAC system/components, taking at time of inspection for your reference.

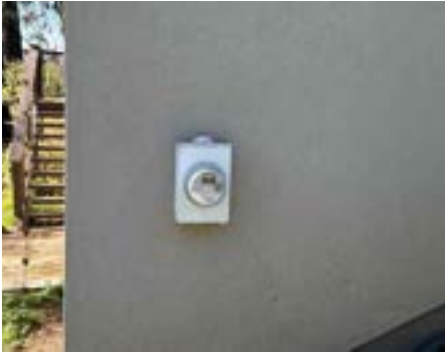
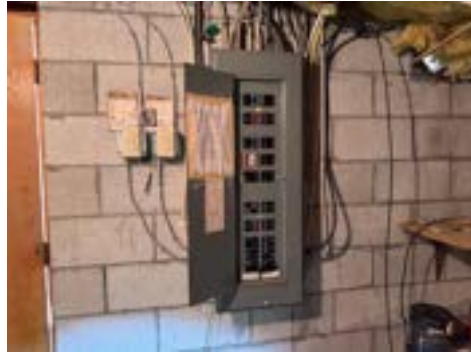
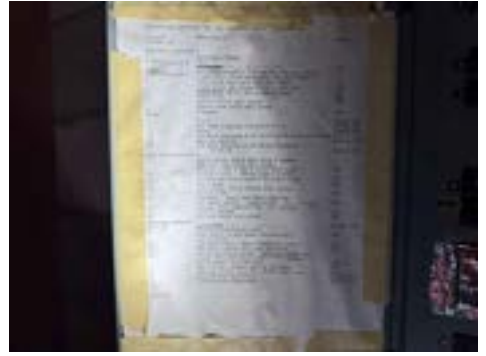
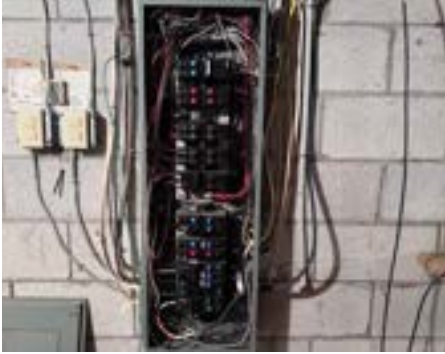
Electrical Photos

The following photos are general views of some of the electrical systems/components, taking at time of inspection for your reference.

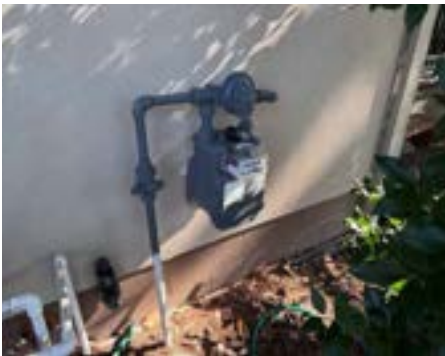
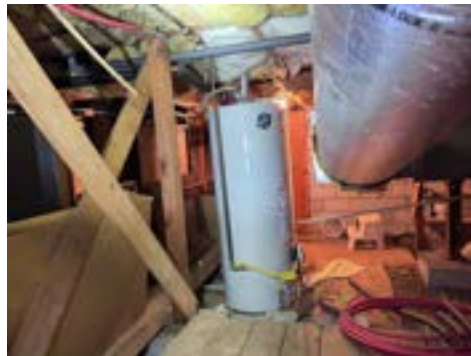
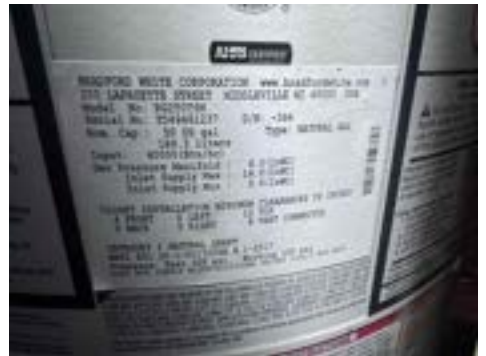
Plumbing Photos

The following photos are general views of some of the plumbing systems/components, taken at time of inspection for your reference.

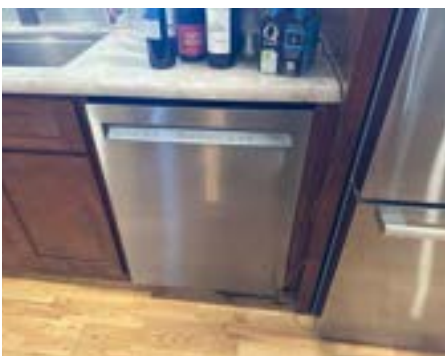
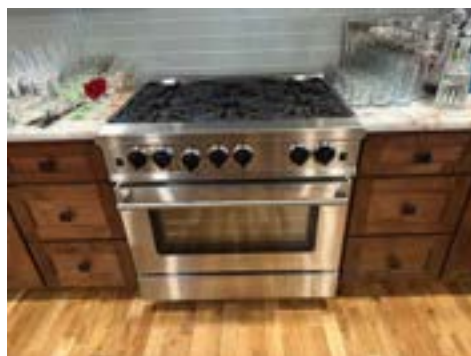
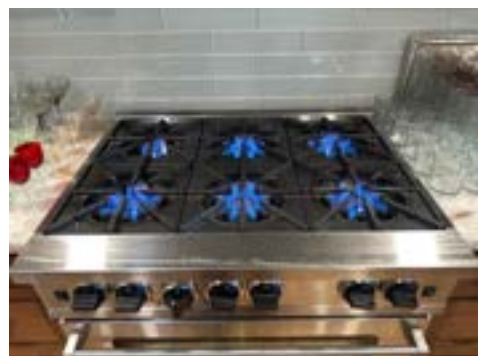
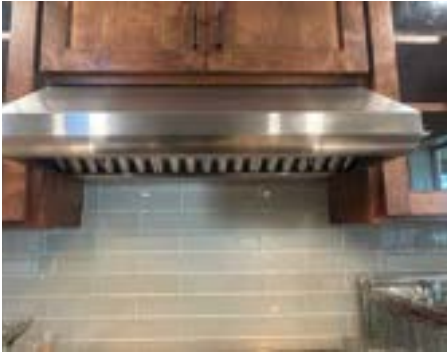
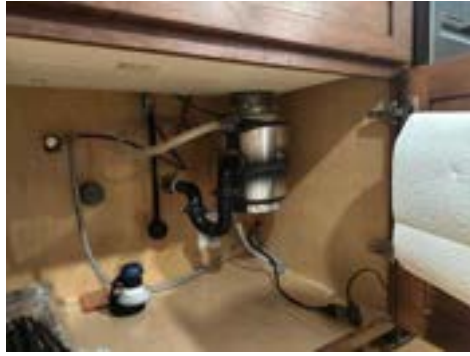
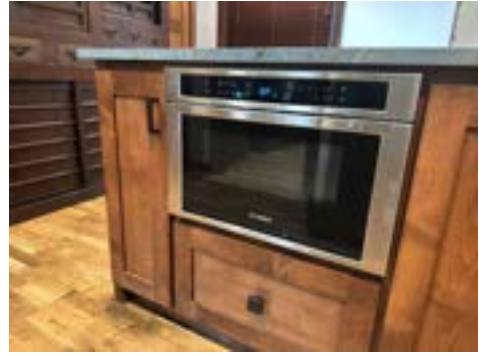
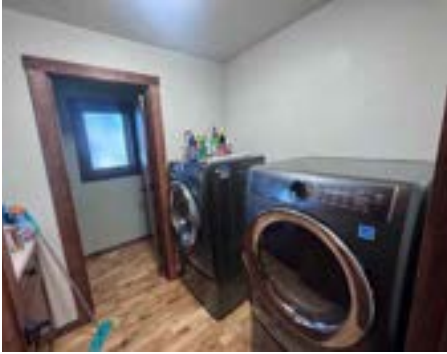
Appliance Photos

The following photos are general views of the appliances, taken at time of inspection for your reference.

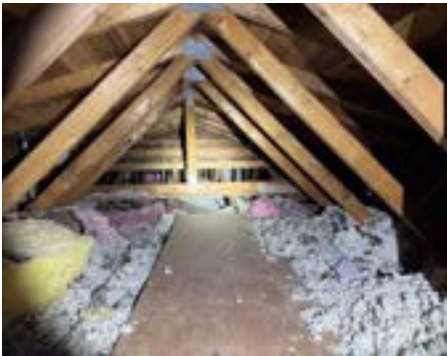
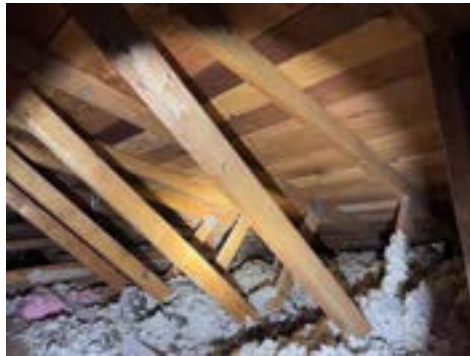
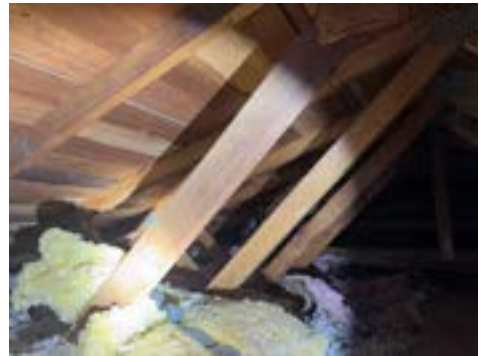
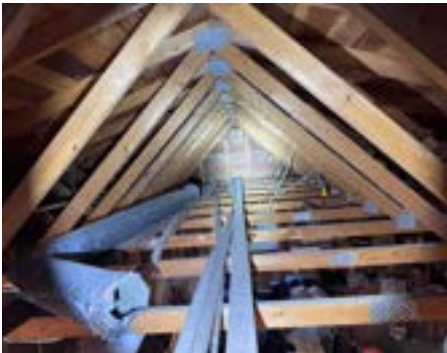
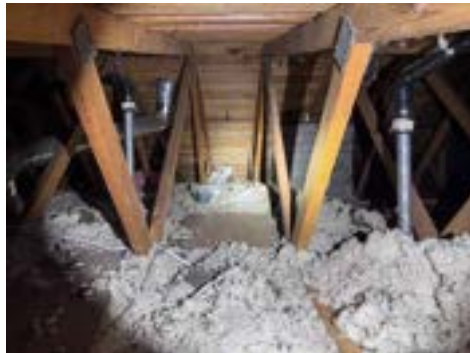
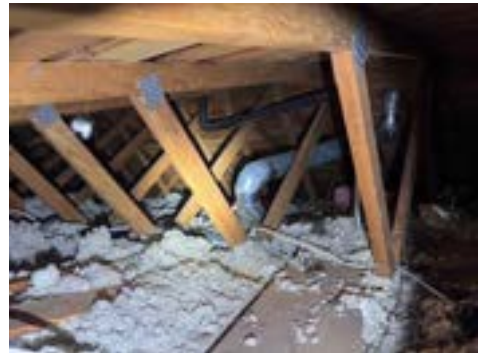
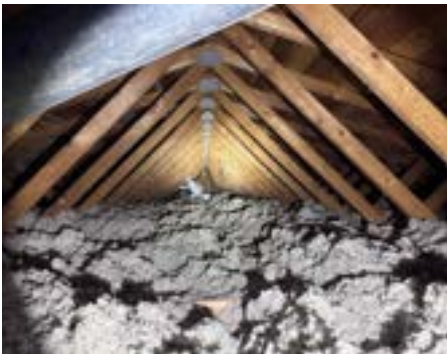
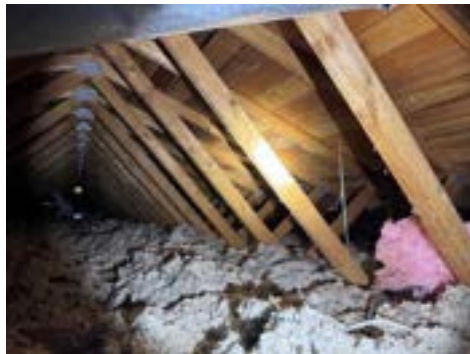
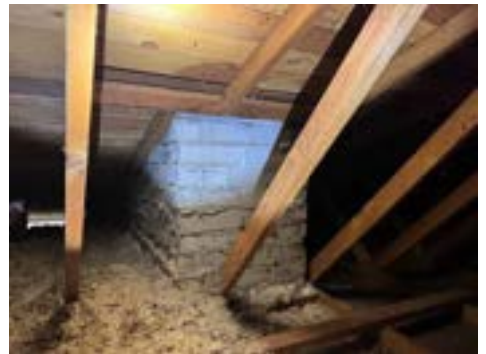
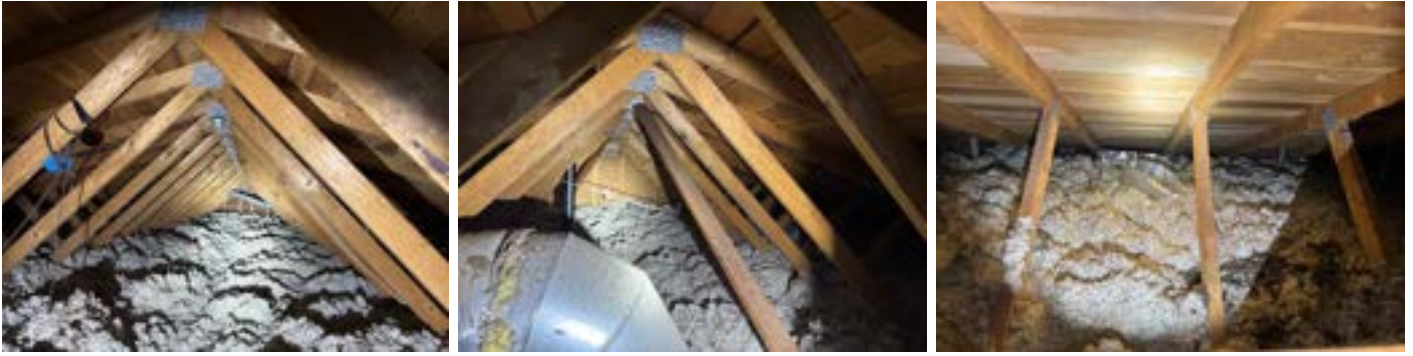
Attic Photos

The following photos are general views of the attic, taken at time of inspection for your reference.

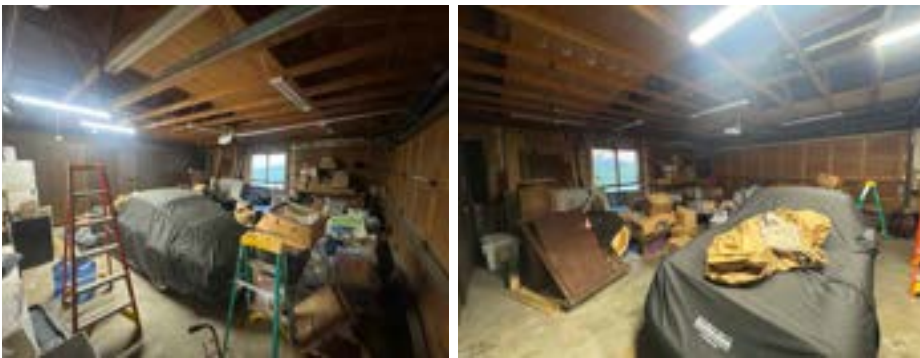
Garage Photos

The following are photos taken of the garage at time of inspection that maybe useful for your reference.
