Mapping

3850 E Antelope Rd
Oregon, AC +/-

43 NOTICE TO THE BUYER: THE FOLLOWING REPRESENTATIONS ARE MADE BY THE SELLER(S) CONCERNING THE CONDITION OF THE
44 PROPERTY LOCATED AT 3850 East Antelope Road, Eagle Point, OR 97524 (THE "PROPERTY").

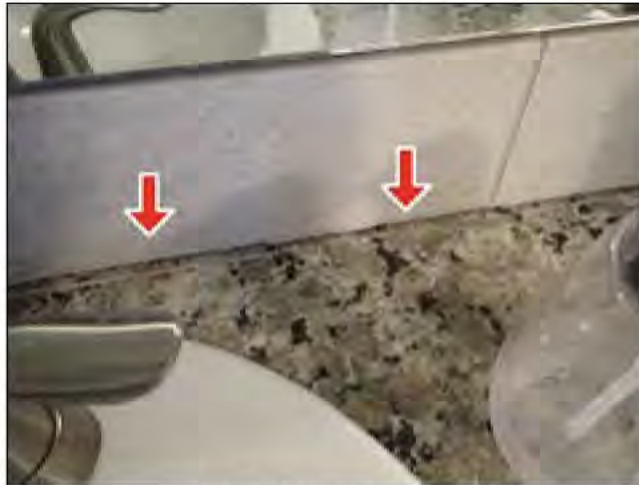
8.0.A SINK(S) (Picture 1)

●					8.0.A SINK(S) Recommend caulking at junction between countertop and back splashes to prevent moisture intrusion concerns.
●					8.1.A TOILET
●					8.2.A FLOOR(ING)
●					8.3.A WALLS / CEILING
			●		8.4.A VENTILATOR
●					8.5.A ELECTRIC / GFCI

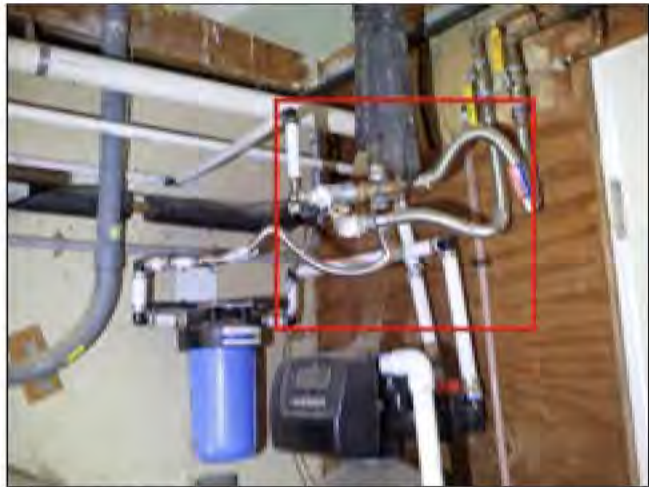
12.0 WATER SUPPLY PIPING (Picture 1)

●											<p>12.0 WATER SUPPLY PIPING</p> <p>Corrosion noted at supply piping connections in garage area of home. Dissimilar metals observed in area. Recommend further evaluation and repair as needed by qualified plumbing contractor.</p>
●											<p>12.1 DRAIN / WASTE PIPING</p> <p>Satisfactory where visible.</p>
●											<p>12.2 GAS PIPING</p>

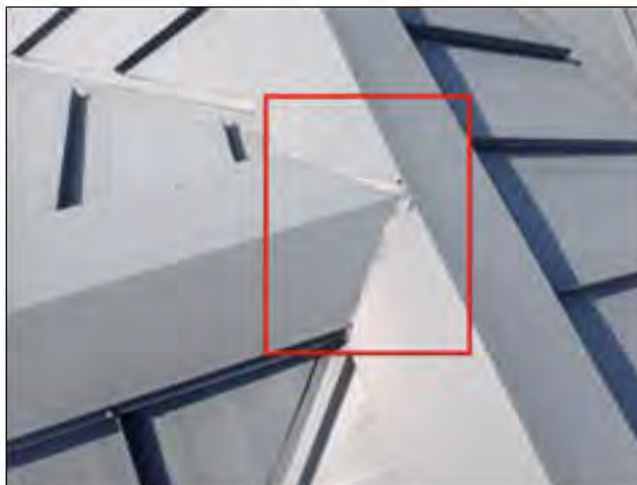
1.0 (Picture 2)

Metal roofing is rated in fair condition based on age and general wear. Surface damage observed on edges of material at multiple locations. Additionally, some sealant at ridge connection seams is starting to crack. Recommend seal and paint as needed to preclude additional damages or deterioration. Conditions should be further evaluated by a qualified roofing contractor.

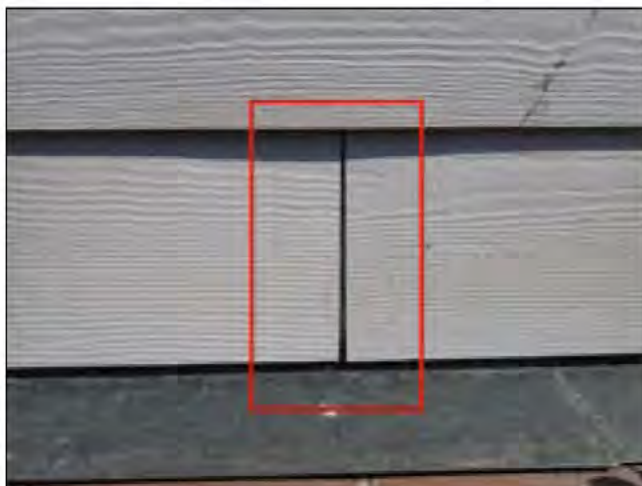
2.0 (Picture 1)

Concrete lapped siding is rated in fair condition based on age and general wear. Gaps observed between cut ends. Recommend prep, prime and paint to ensure proper protection. Additionally, trim back all loose vegetation to preclude moisture absorption issues.

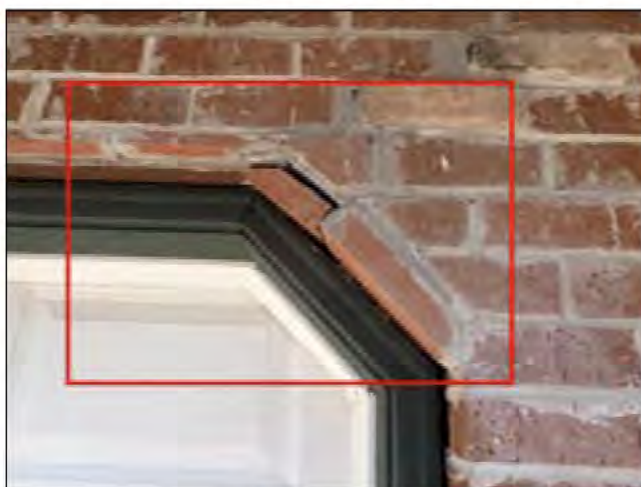
2.1 (Picture 1)

Excessive cracking and shifting observed on brick work at front of home and over garage area. See related comments in Section 9. Recommend having area checked and repaired as needed by a qualified contractor.

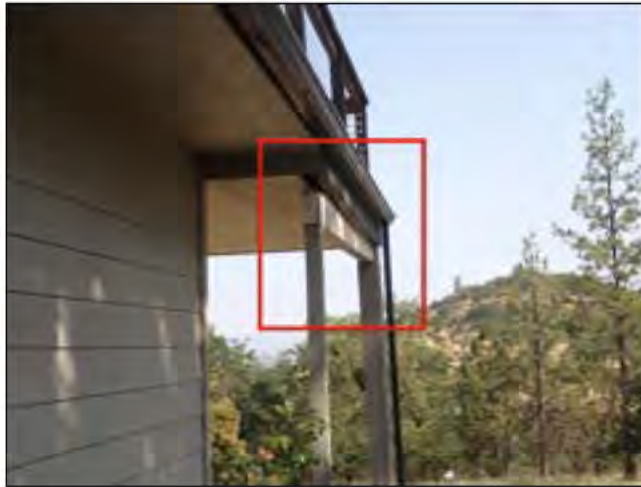
2.4 (Picture 1)

inspection. Gap and separation observed at beam and support on right side of deck. Several step stringers are cracked and damaged. Some separation observed on decking. Additionally, membrane material is torn at top of steps. Due to current conditions, recommend having all deck structures further evaluated by a qualified contractor to determine repairs needed and associated cost.

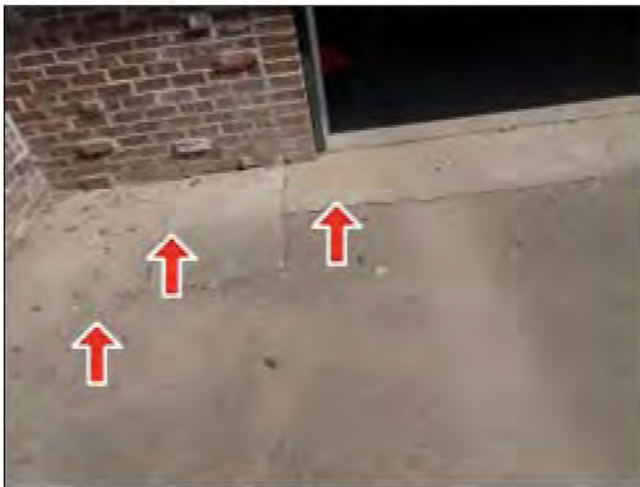
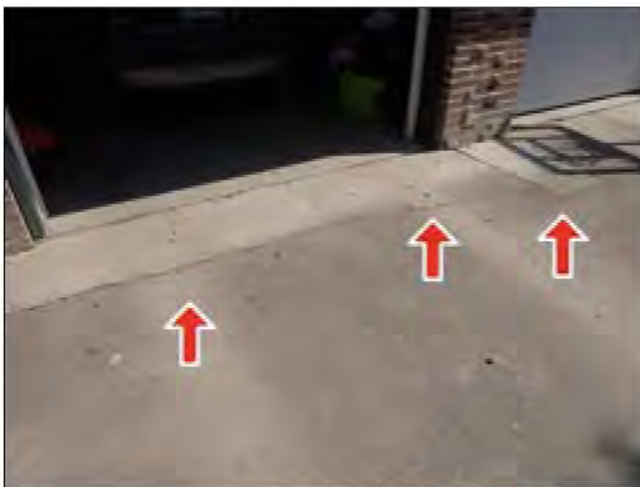
3.1 (Picture 1)

Cracking noted on driveway surface at multiple locations. It appears that some sections of driveway drain towards foundation of home and garage area. This could cause moisture absorption issues if not corrected. Recommend having slab checked and repaired as needed by a qualified contractor.

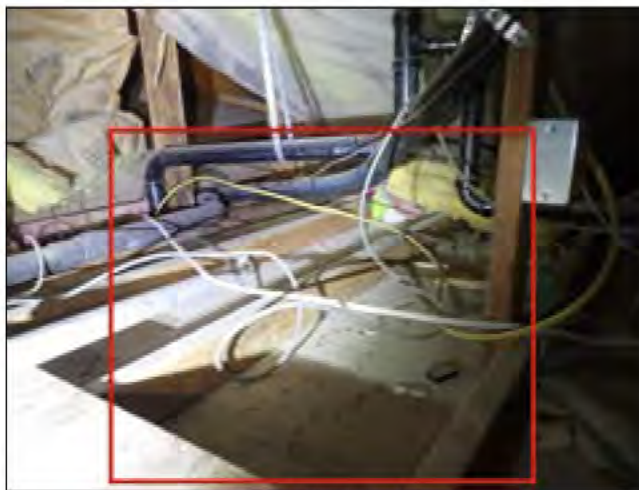
5.3 (Picture 1)

Limited insulation observed over right side of home. Recommend adding to ensure best efficiency.

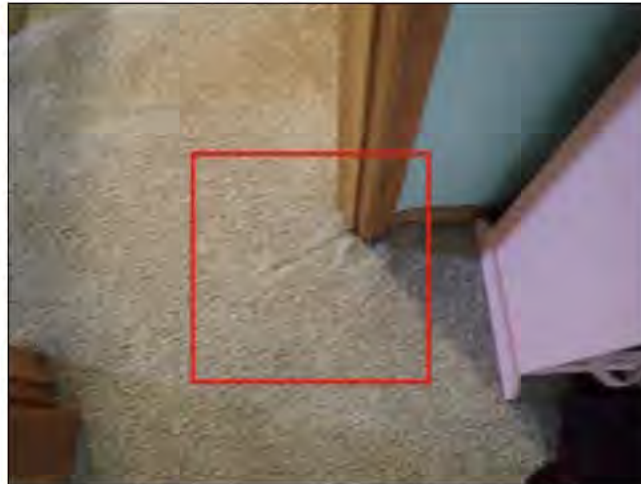
6.2 (1) General wear noted on carpets in upper level of home. Recommend repair or replacement as needed by a qualified contractor.

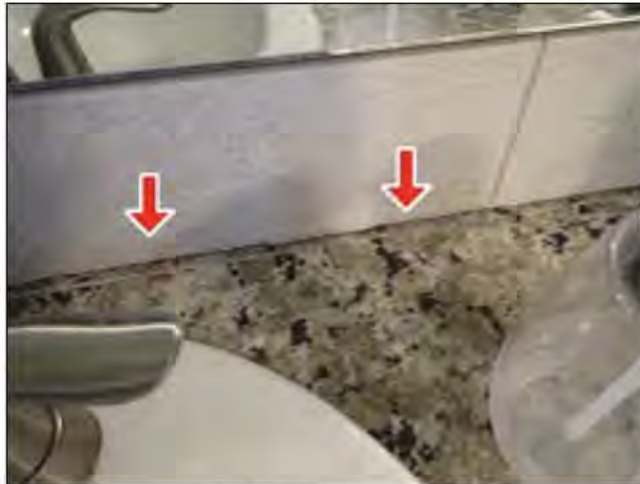
8.0.A (Picture 1)

Recommend caulking at junction between countertop and back splashes to prevent moisture intrusion concerns.

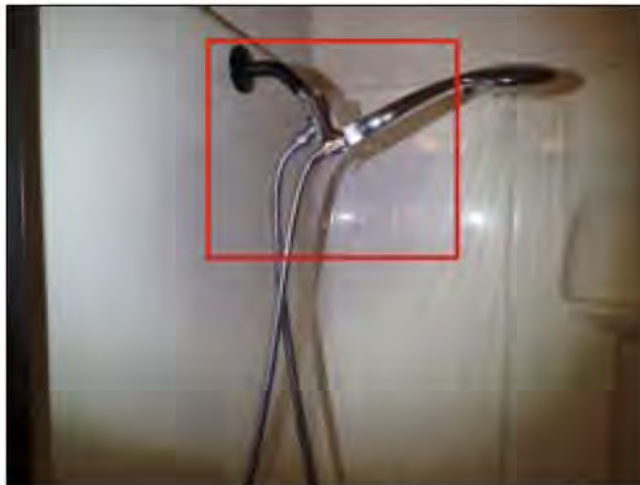
8.0.B (Picture 1)

Shower head leaks/sprays at connection to plumbing neck. Recommend repair to preclude damages to surrounding area.

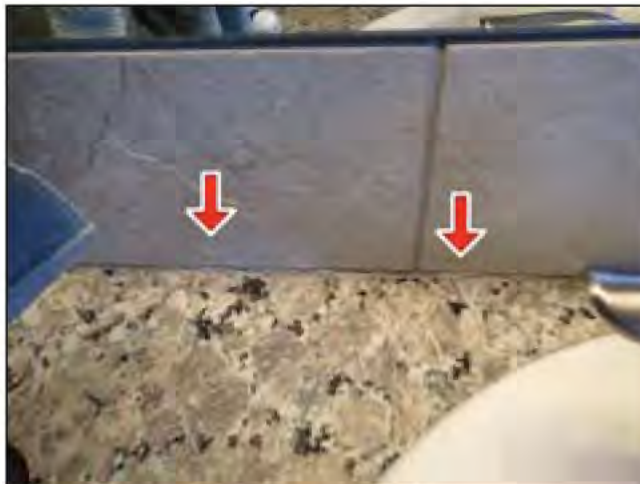
8.0.C (Picture 1)

Recommend caulking at junction between countertop and back splashes to prevent moisture intrusion concerns.

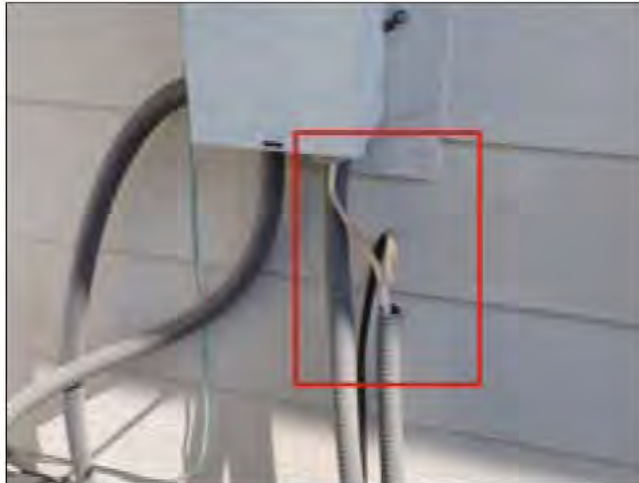
10.7 (Picture 1)

Loose conduit noted below upper level sub panel at front of home. Recommend securing as needed by a qualified electrician.
