# Table of Contents

Mapping.....	2-8
Tax Records & Title Report.....	9-19
Floor Plan.....	20-22
Seller's Property Disclosures.....	23-24
Home Inspection.....	25-81
Well Information.....	82-92
Septic Information.....	93-138

### 1321 Falcon Crest Ln. Merlin, OR Josephine County

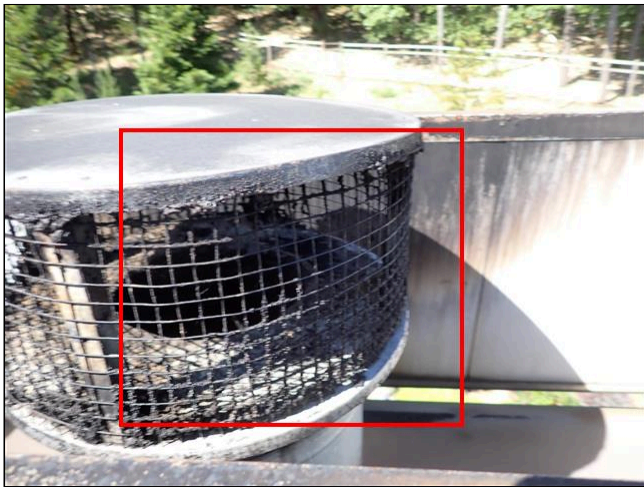
1.1(2) CHIMNEY (Picture 1)

1.1 (1) Siding around chimney enclosure is rated in fair condition due to numerous gaps and worn paint. Recommend repairs where needed by a qualified contractor. Prep, prime and paint to ensure proper protection.

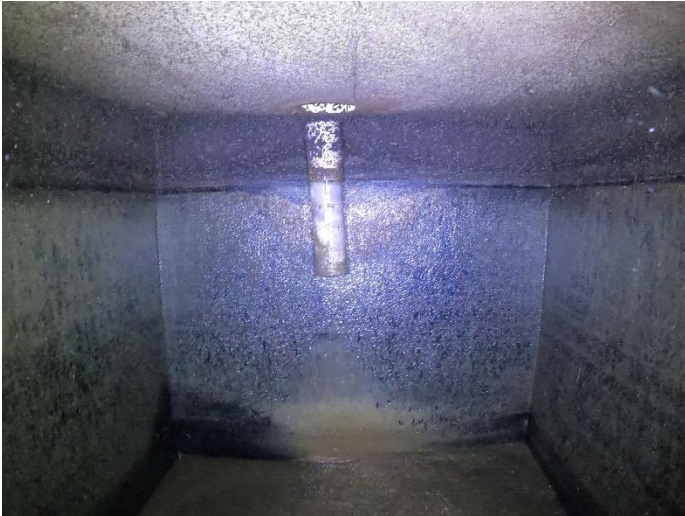
**Inlet Baffle**

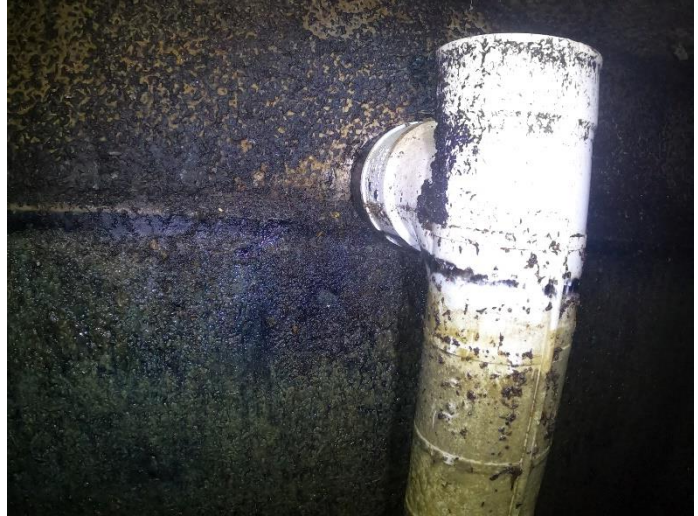
**Outlet Baffle**

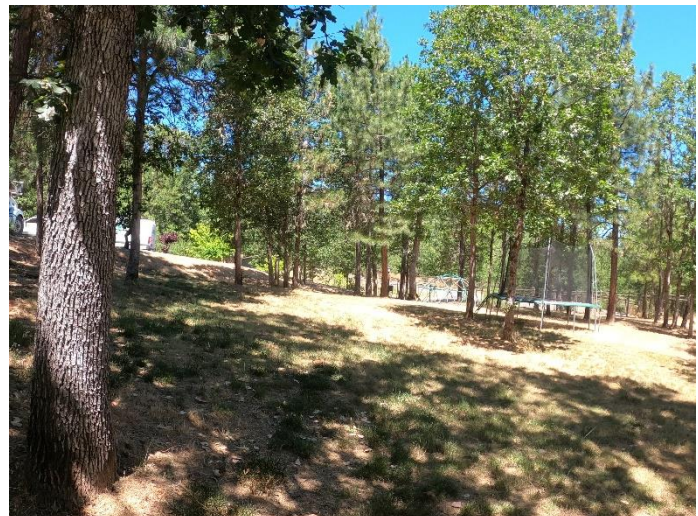
**View of Drain Field (tank to left)**
