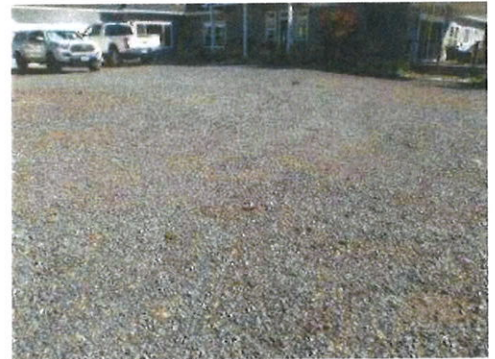
Gravel with concrete near the garage.

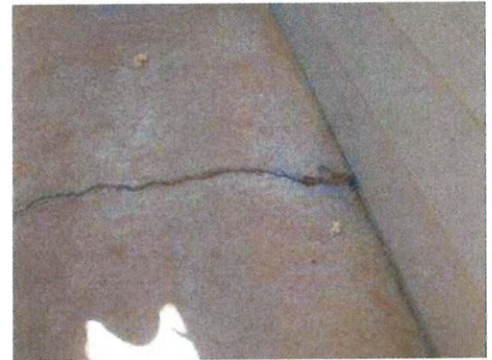
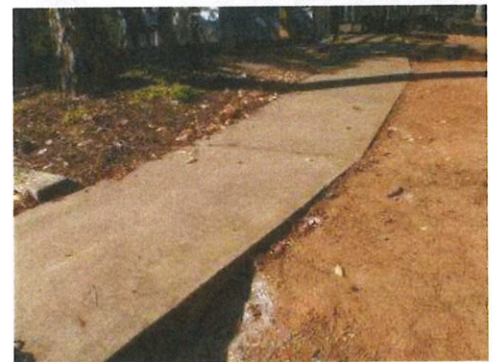
Concrete at the left side of the garage shows some cracking and deflection. I recommend that the condition be monitored and remedied if needed. The rear walkway was good.

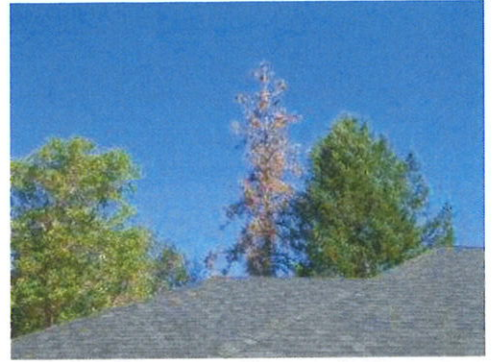
No adverse conditions were noted regarding the landscaping in relation to the structure. I did see a dead tree behind the garage though. It will eventually need to be removed.

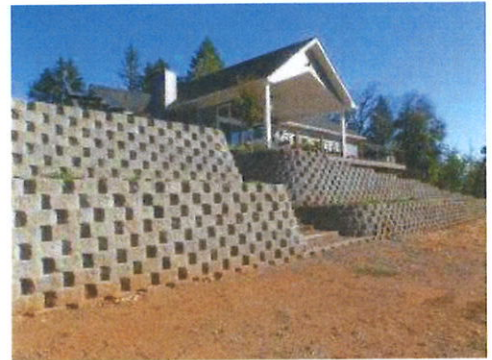
Concrete block & Timber

Properly installed and good condition.

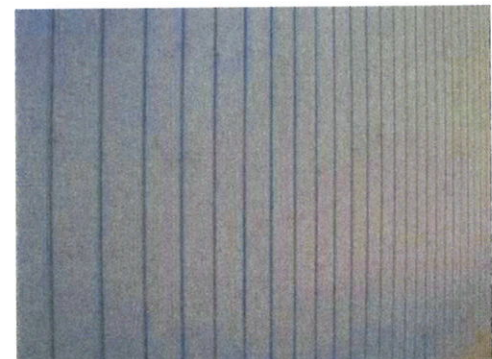
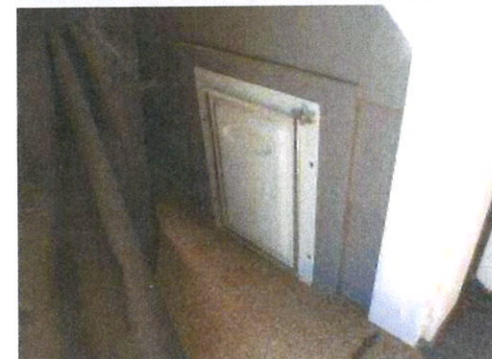
The siding is properly installed and is in good condition with no defects or unsealed penetrations. There is a pet door installed into the laundry room. If it will not be used consider replacing the door or having a permanent cover installed.

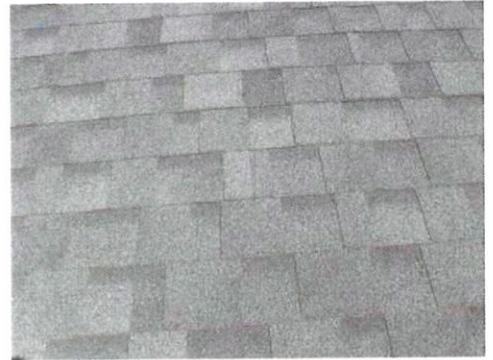
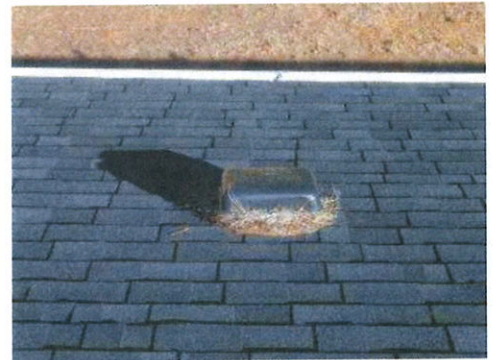
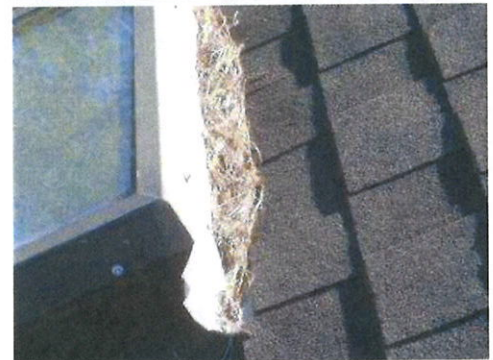
The roofing is properly installed and in good condition. There was a little bit of debris at a roof vent near the skylight and at the skylight. I recommend that it be removed.

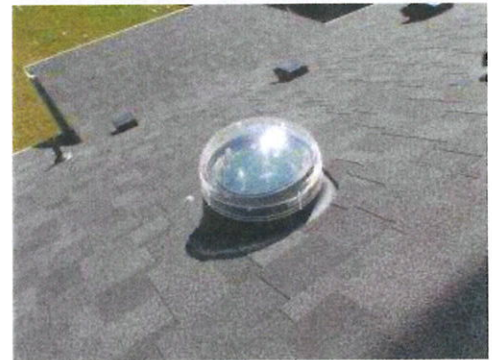
There are no signs of leaks at this time. A Solatube (tubular skylight) product looks to be properly installed.

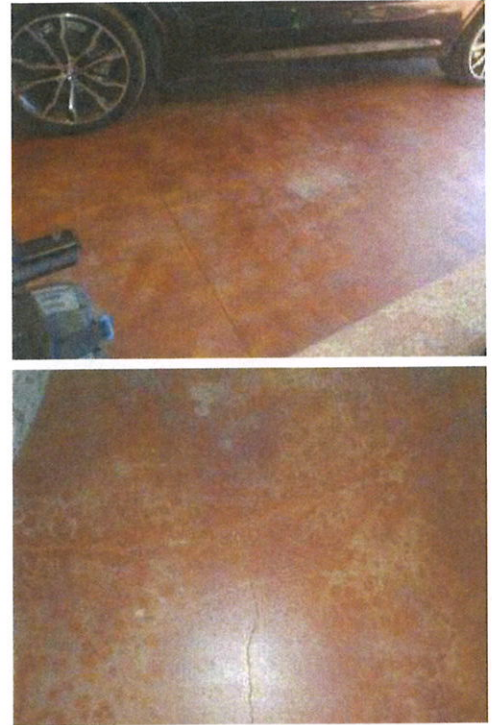
Good - With no significant cracks. Minor cracking was noted.

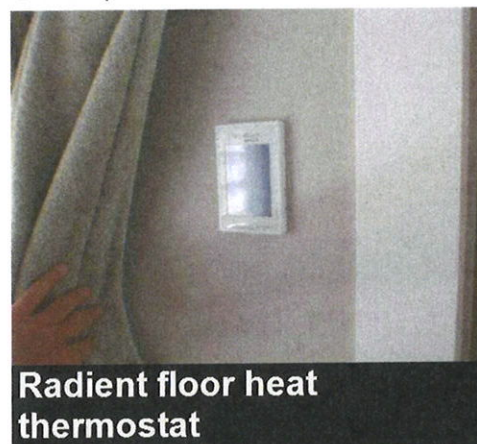
**Radiant floor heat thermostat**

Radiant floor heating is installed in the master bathroom. It was said to be functioning properly. It was not tested due to temperatures on the day of the inspection and the amount of time needed for the system to reach a detectable temperature.

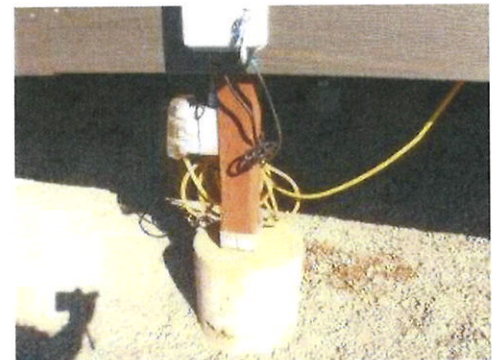
An extension cord is being used to provide power to the hot tub. Extension cords are not rated for permanent installations. If power is required to this location on a permanent basis I recommend that it be installed by an electrician using acceptable materials.

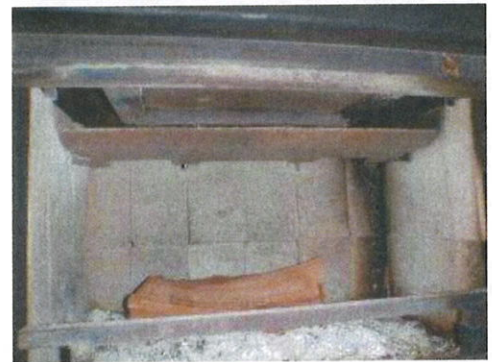
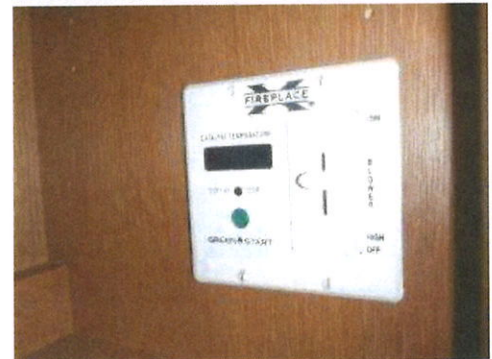
The wood stove is in good condition with a good rope seal and no cracked firebrick. The installation was proper. The stove was not tested for proper operation. Igniting solid fuels is outside the scope of a home inspection. Note: Some wood stove issues may only be detectable during operation. This one has an automatic ignition and a blower.

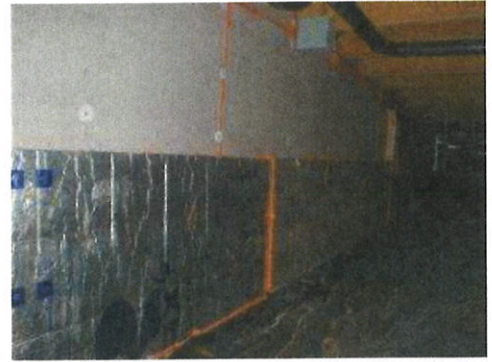
Poured concrete - In good condition with no significant cracks. The crawl space side is not visible due to insulation.
