# Mapping

3583 Ross Lane  
Oregon, AC +/-

## INSPECTION REPORT

3583 Ross Ln  
Central Point, OR 97502

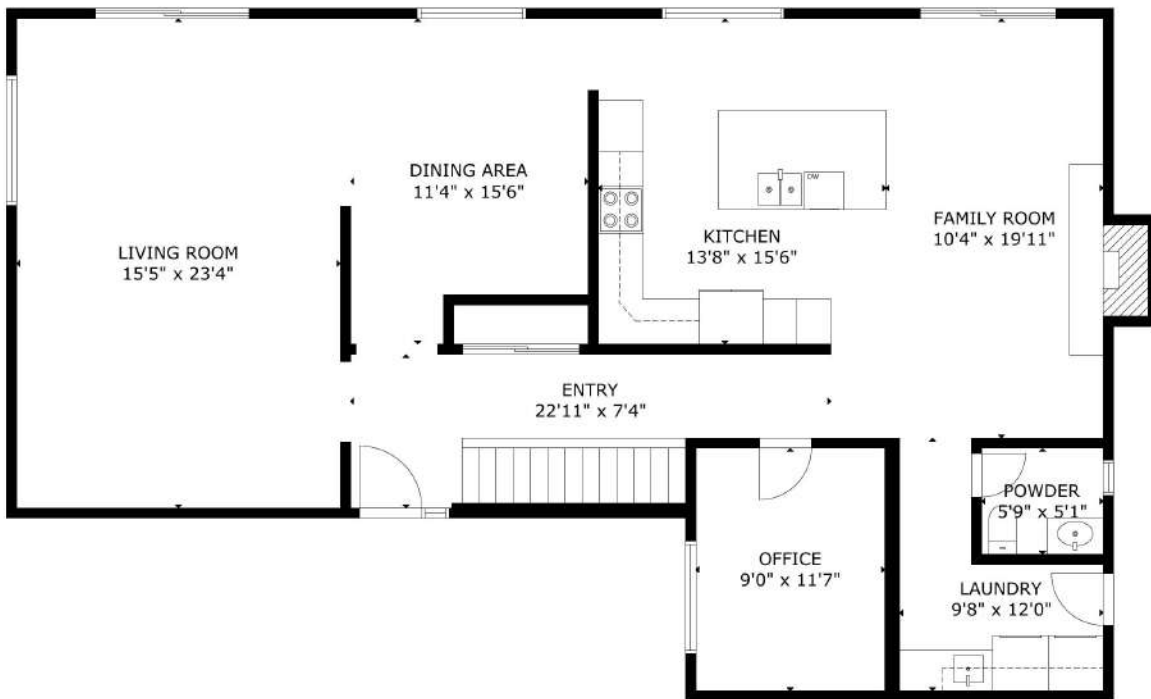
MAIN FLOOR

GROSS INTERNAL AREA  
TOTAL: 2,710 sq.ft  
LOWER FLOOR: 1,331 sq.ft, MAIN FLOOR: 1,379 sq.ft  
SIZE AND DIMENSIONS ARE APPROXIMATE, ACTUAL MAY VARY

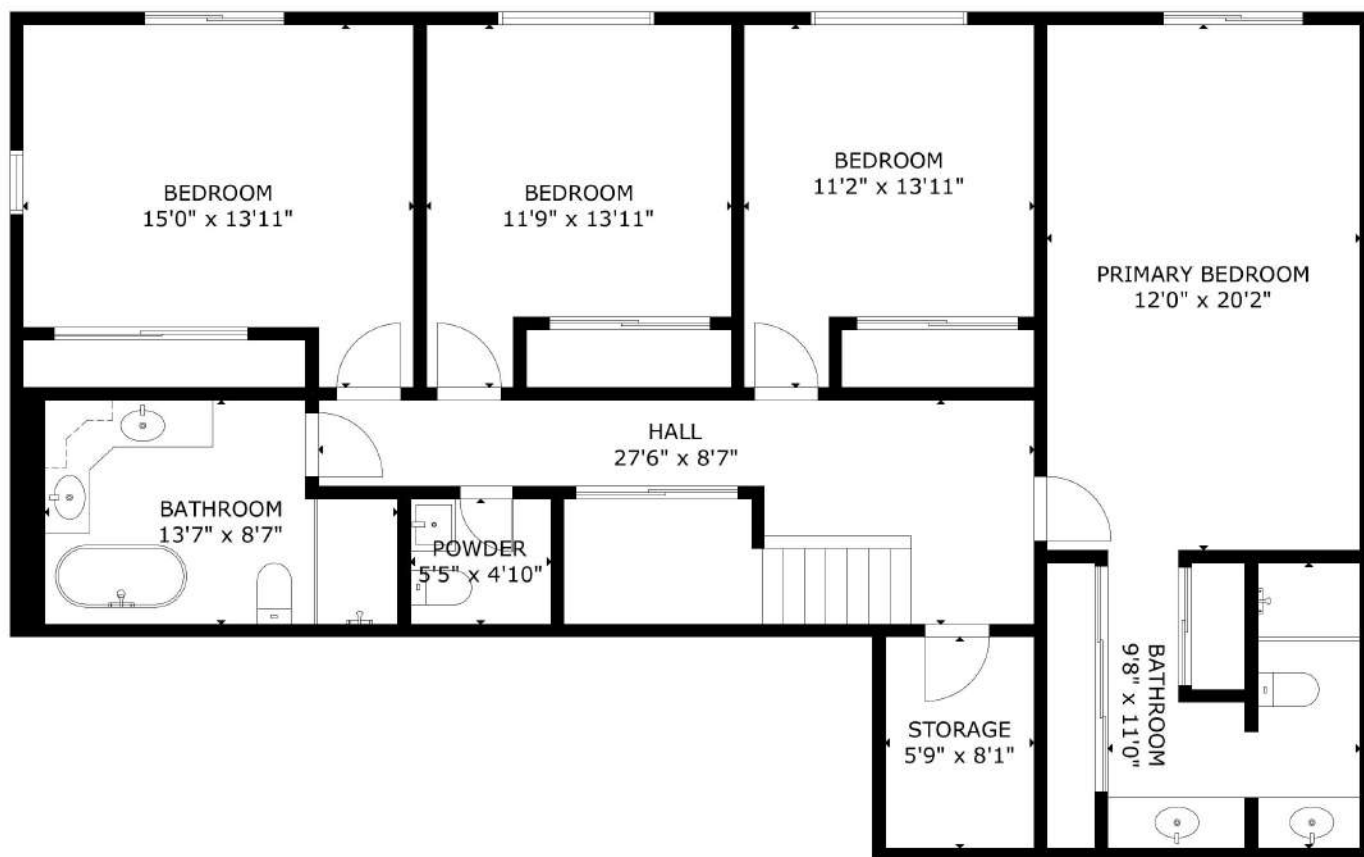
LOWER FLOOR

GROSS INTERNAL AREA  
TOTAL: 2,710 sq.ft  
LOWER FLOOR: 1,331 sq.ft, MAIN FLOOR: 1,379 sq.ft  
SIZE AND DIMENSIONS ARE APPROXIMATE, ACTUAL MAY VARY

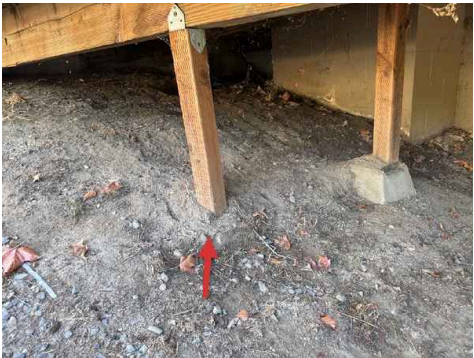
One or more deck support posts were observed to be in direct contact with soil. Wood posts in soil contact are more susceptible to moisture exposure and deterioration over time, which can reduce their strength and service life. This condition may contribute to premature decay and affect the stability of the deck structure. It is recommended that a qualified contractor evaluate the affected posts and make appropriate repairs or modifications to separate the wood from soil contact and improve durability.

Recommendation  
Contact a qualified professional.

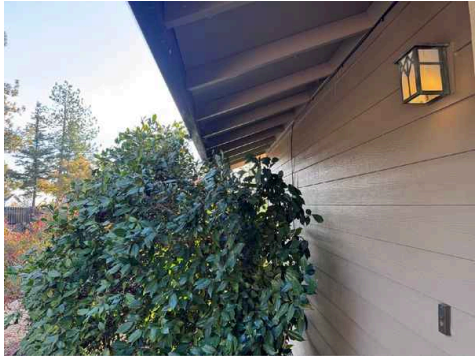
Front Of Home

There was vegetation (trees, shrubs, vines, bushes, grass) in contact or close contact to the exterior. This can cause moisture and pest related issues. Recommend all vegetation be trimmed to be at least 6 inches away from the exterior.

Recommendation

Recommended DIY Project

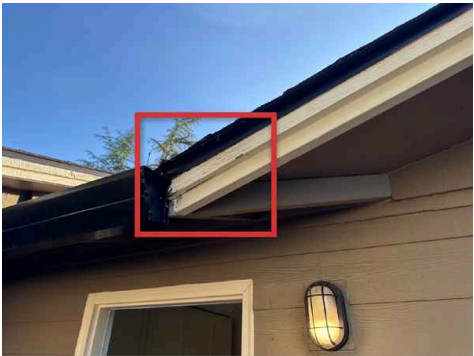
Right Of Home

There was areas observed at the eaves that needed touchup paint. Recommend painting these areas to help prevent moisture related damage.

Recommendation

Contact a handyman or DIY project

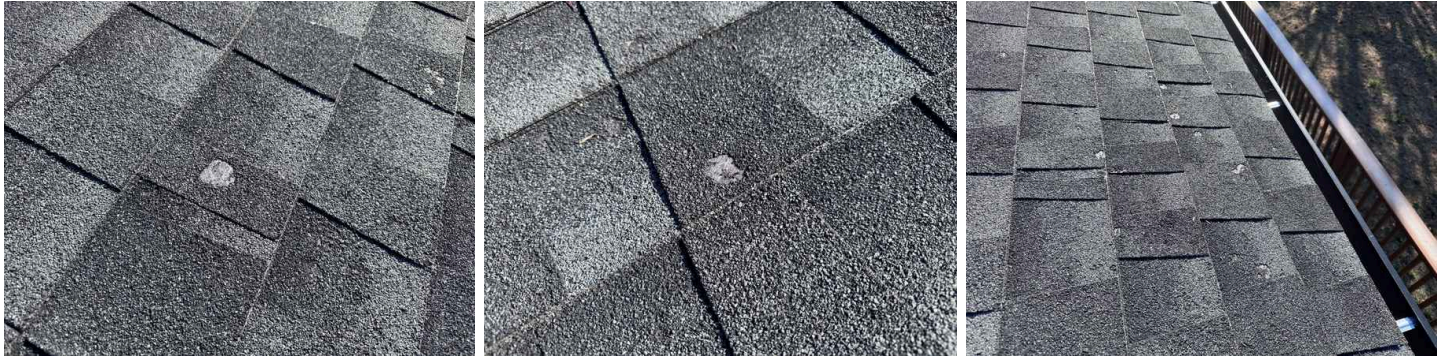
**SHINGLE - DAMAGE (MONITOR)**

There was minor damage observed at the roof shingle(s). This damage does not appear to effect the performance of the roof covering and no leaks were observed at time of inspection. Recommend monitoring for now.

Recommendation

Recommend monitoring.

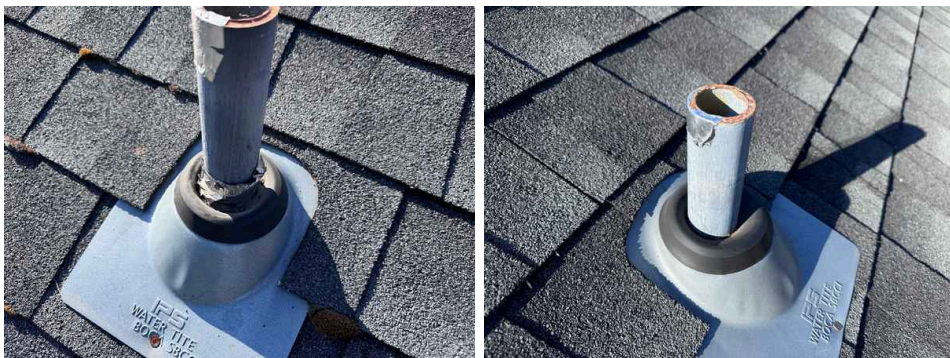
**VENT BOOT - INVERTED**

The vent boot(s) on the roof were inverted. This can create a pool of water around the seal and increase the risk of leaks. Recommend repair by a qualified person to prevent deterioration and leaks.

Recommendation

Contact a qualified professional.

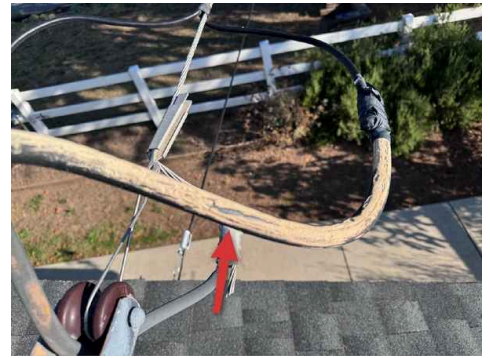
## 8.3.1 Electrical Wiring

**WIRING - EXTENSION CORD**

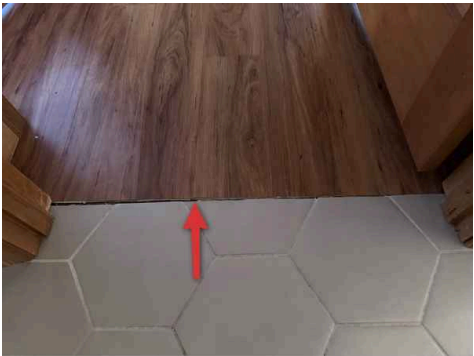
Basement Bathroom

The transition strip(s) was missing at time of inspection. Recommend installation by a qualified professional.

Recommendation  
Contact a handyman or DIY project

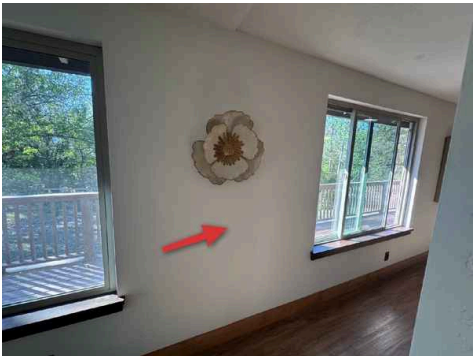
Dining Room to Kitchen Wall

Minor cracks were observed in one or more locations on the interior drywall/surfaces. These cracks do not appear to be a structural concern. Recommend patching.

Recommendation  
Contact a qualified drywall contractor.

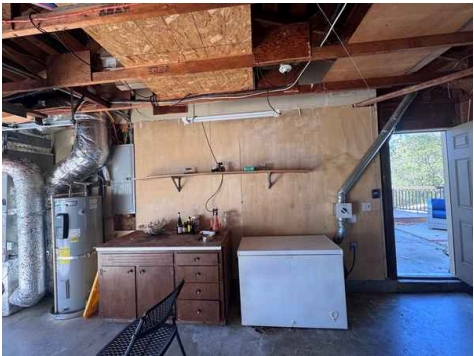
10.6.1 Fire Separation

Areas of the fire separation wall/ceiling in between the garage and living space are compromised due to damaged/missing drywall. Fire separation standards are to slow a fire from spreading from the garage into the living space, and to prevent harmful gases from entering the living space through the garage. In order to maintain a fire separation wall, I recommend having the areas evaluated and repaired by a qualified contractor.

Recommendation  
Contact a qualified drywall contractor.

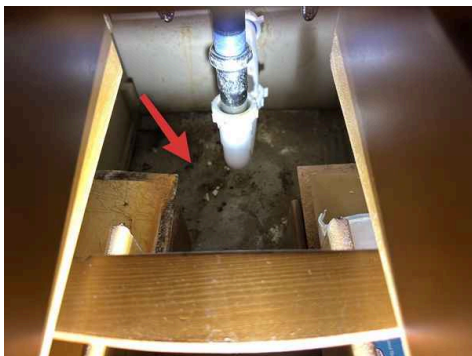
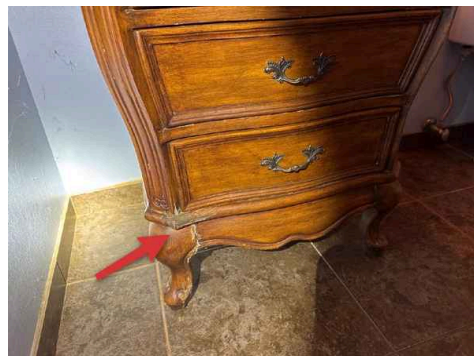
**CABINET - PREVIOUS WATER DAMAGE/STAINS**

The cabinet base under the plumbing systems show signs of water damage/stains. there were no active leaks at the time of inspection and the damage/stains are old. Recommend repair as desired.

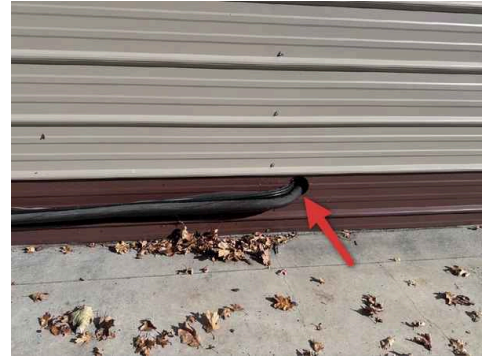
### 13.2.1 ROOF & GUTTER

#### DOWNSPOUTS - DRAIN NEAR FOUNDATION

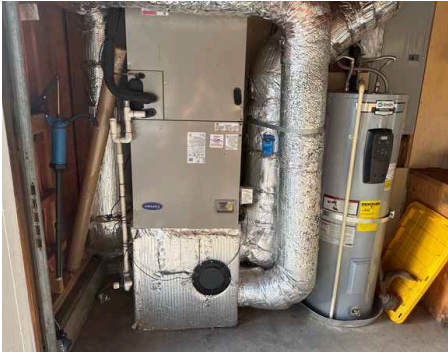
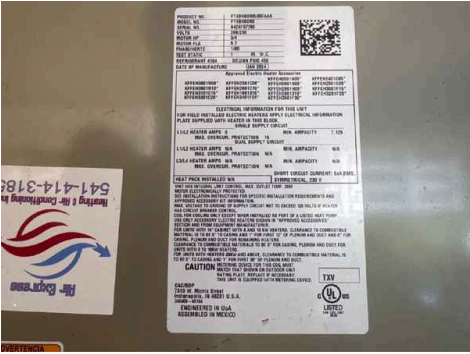
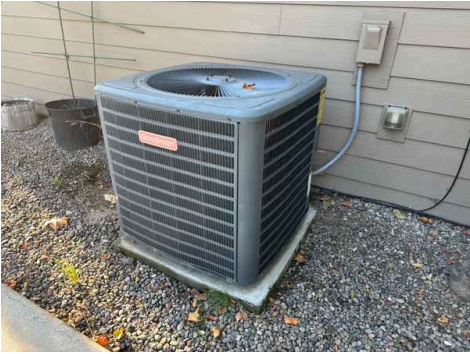
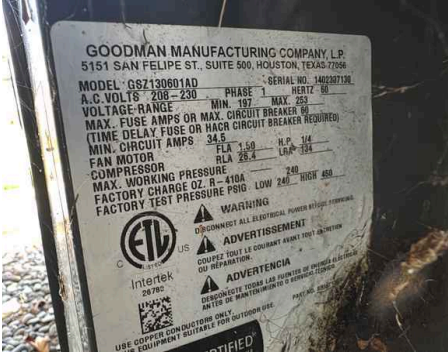
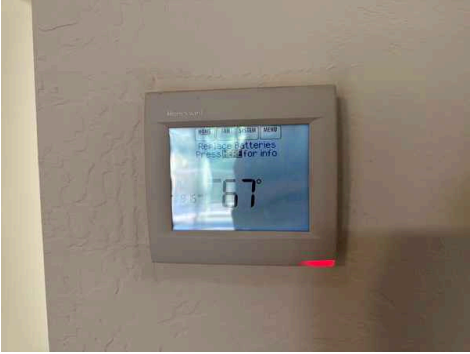
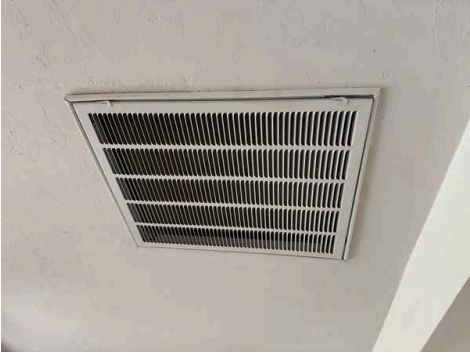
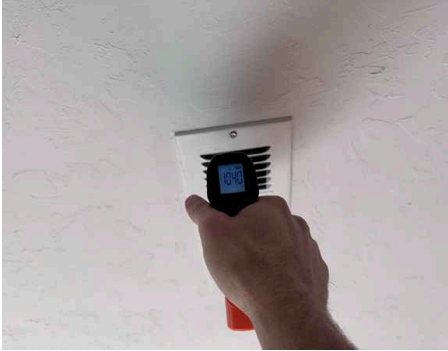
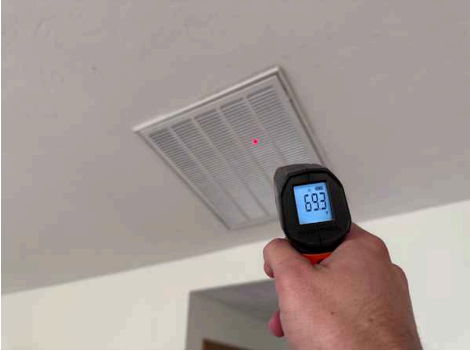
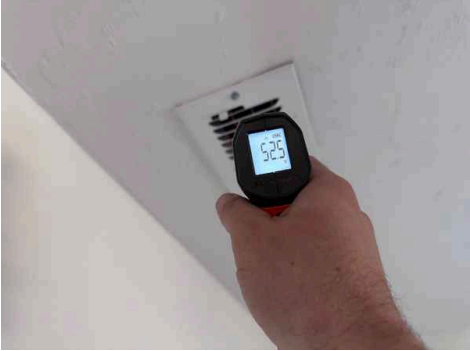
## HVAC Photos

The following photos are general views of the HVAC system/components, taking at time of inspection for your reference.

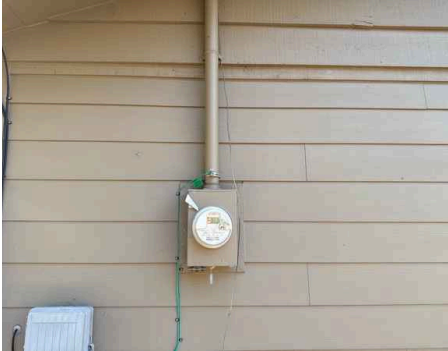
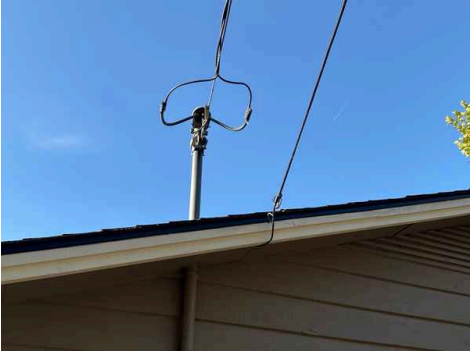
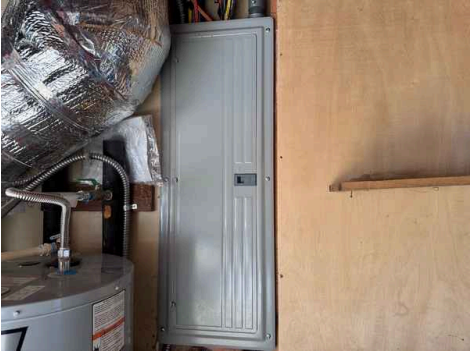
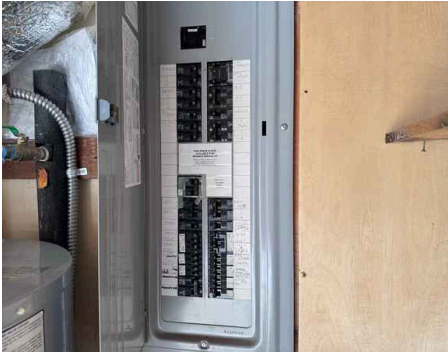
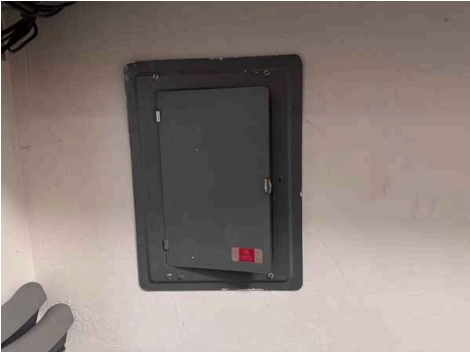
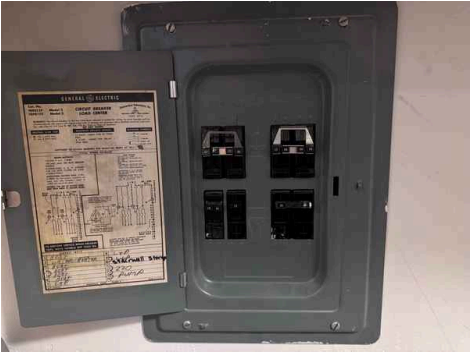
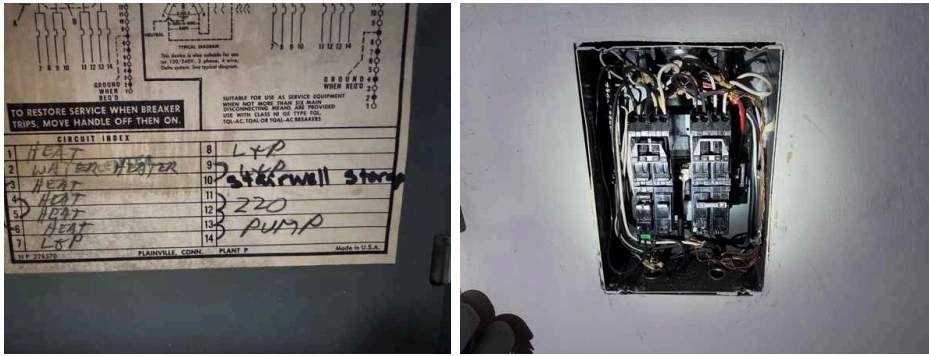
Electrical Photos

The following photos are general views of some of the electrical systems/components, taking at time of inspection for your reference.

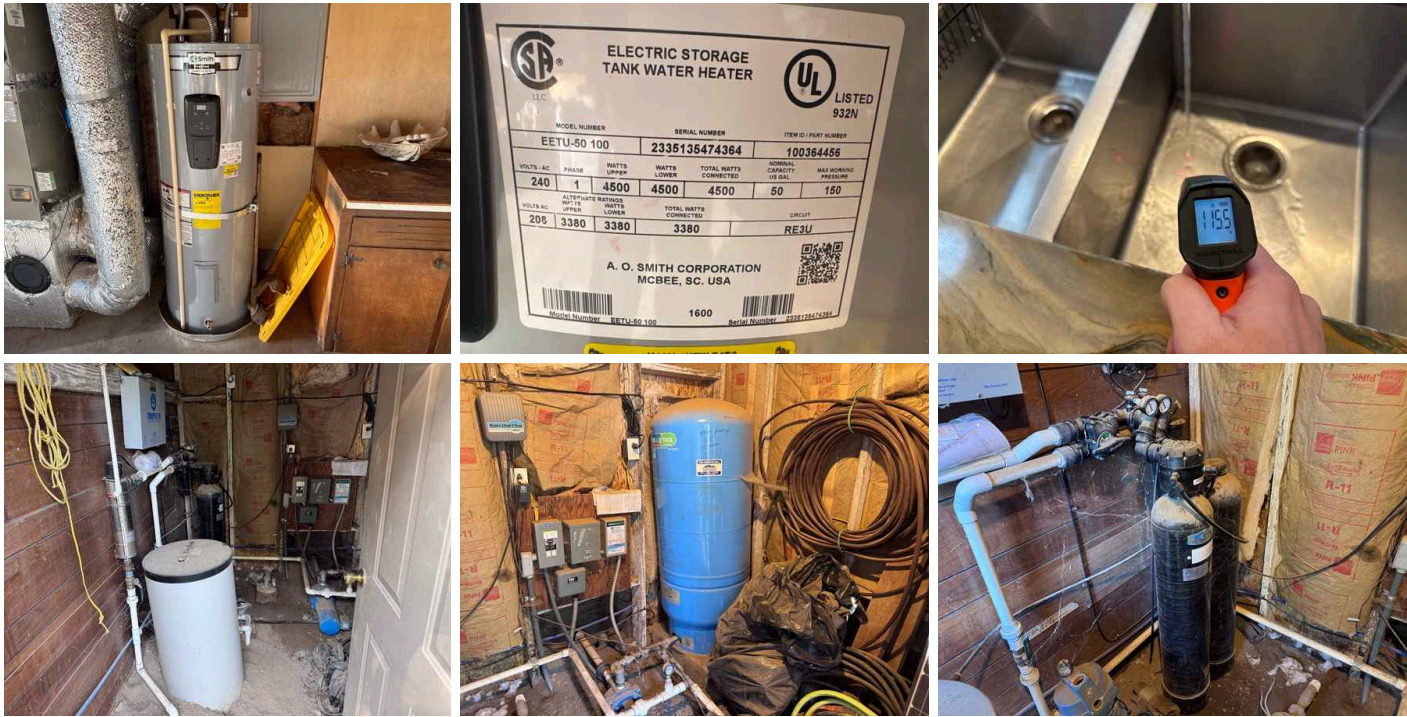
Plumbing Photos

The following photos are general views of some of the plumbing systems/components, taking at time of inspection for your reference.

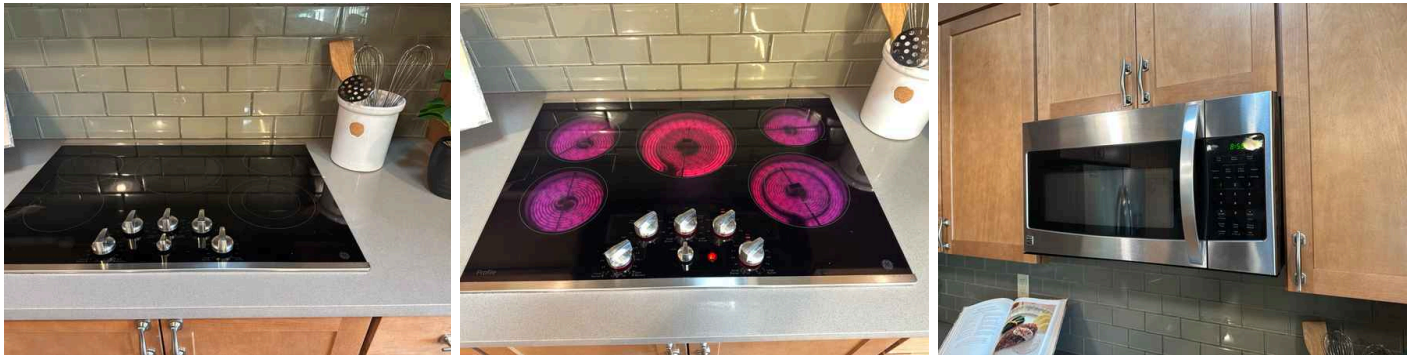
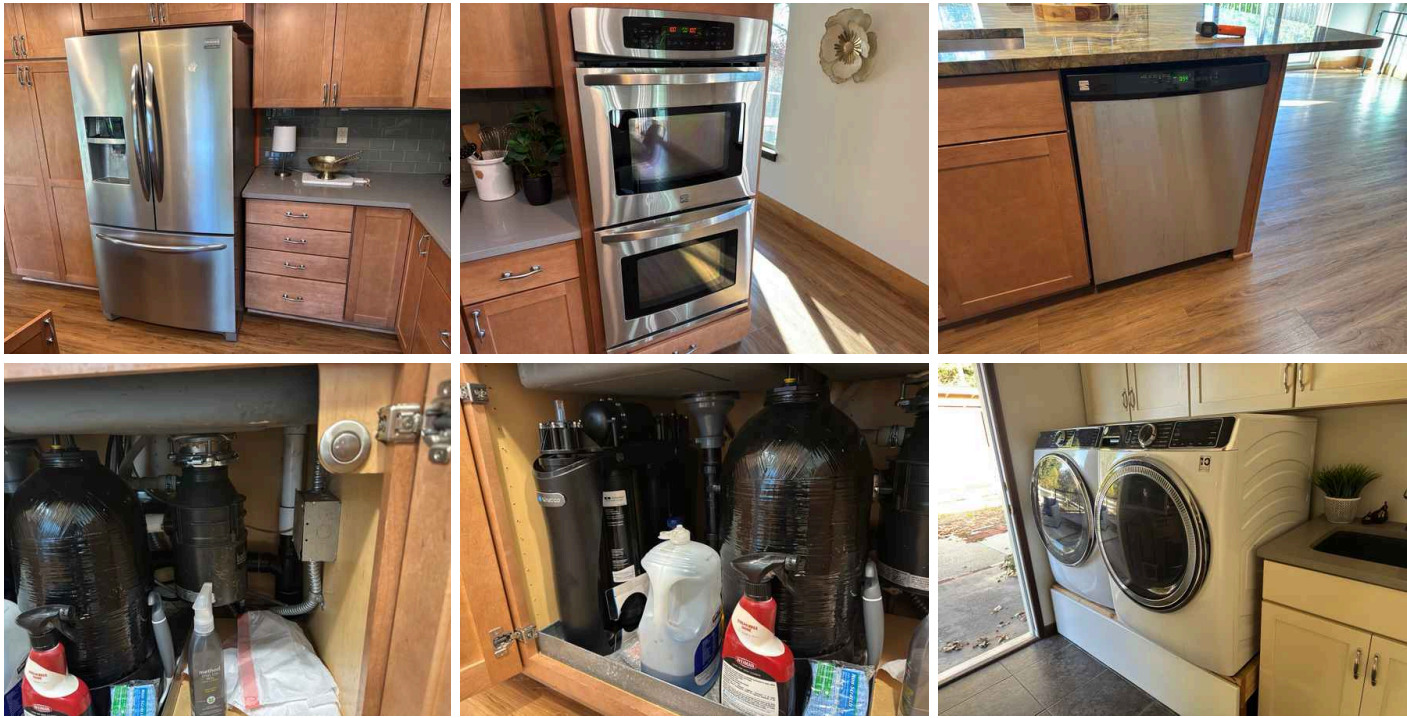
Appliance Photos

The following photos are general views of the appliances, taken at time of inspection for your reference.

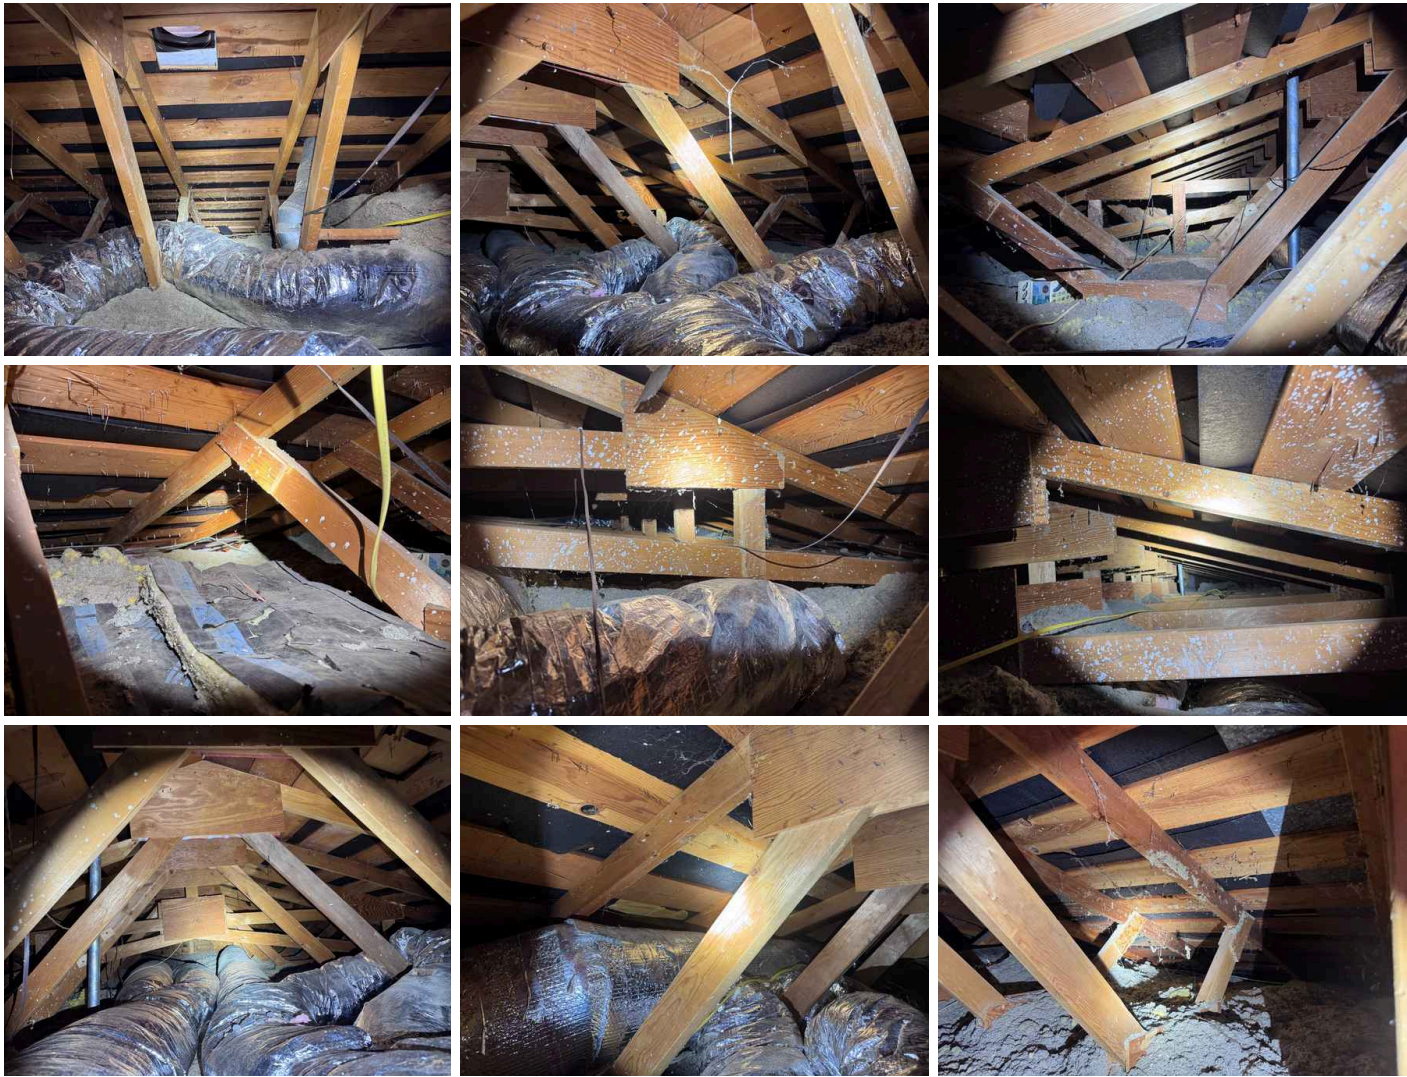
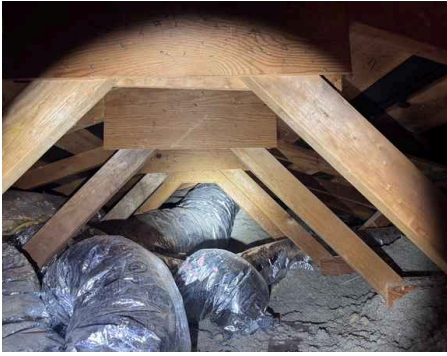
Attic Photos

The following photos are general views of the attic, taken at time of inspection for your reference.

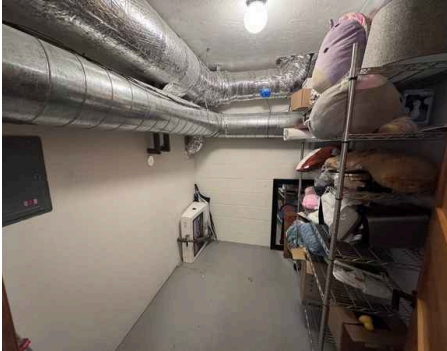
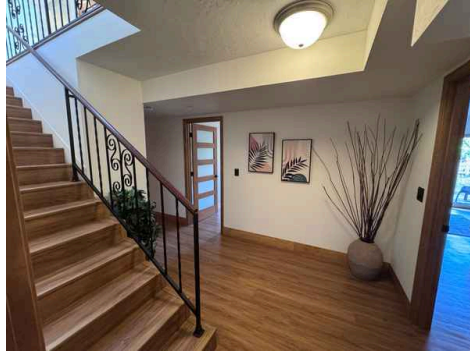
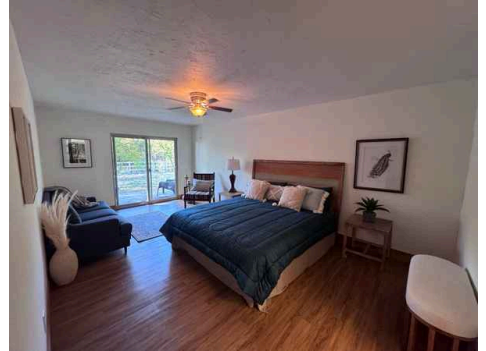
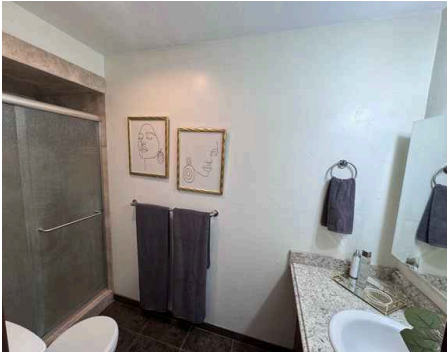
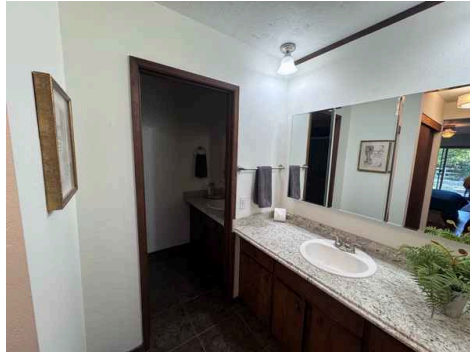
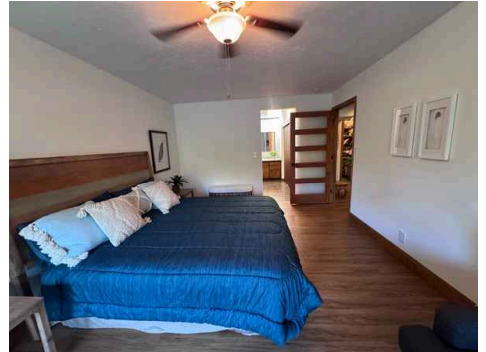
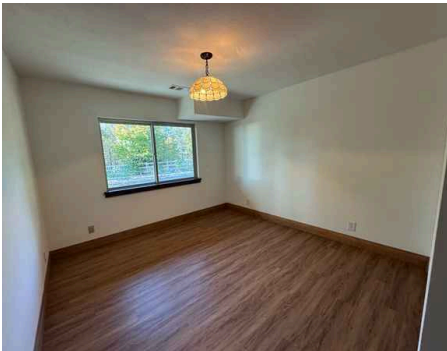
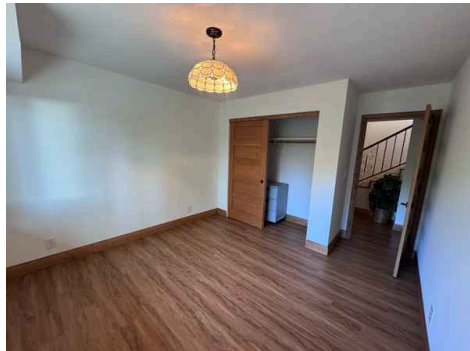
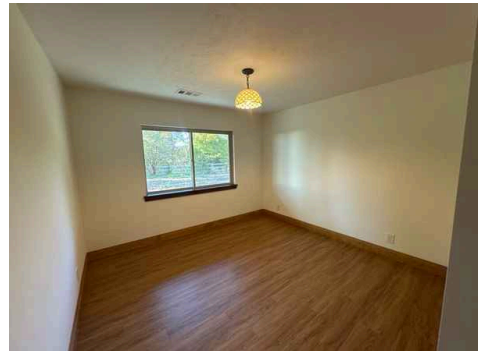
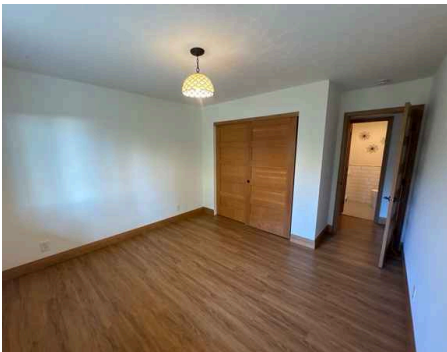
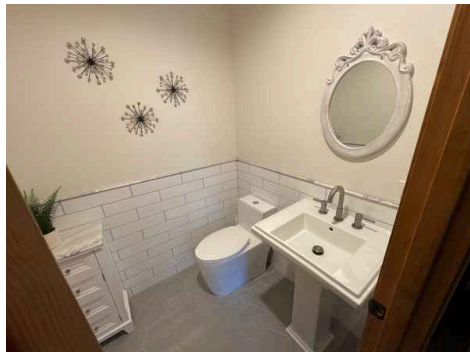
## Basement Photos

The following photos are general views of the basement, taken at time of inspection for your reference.

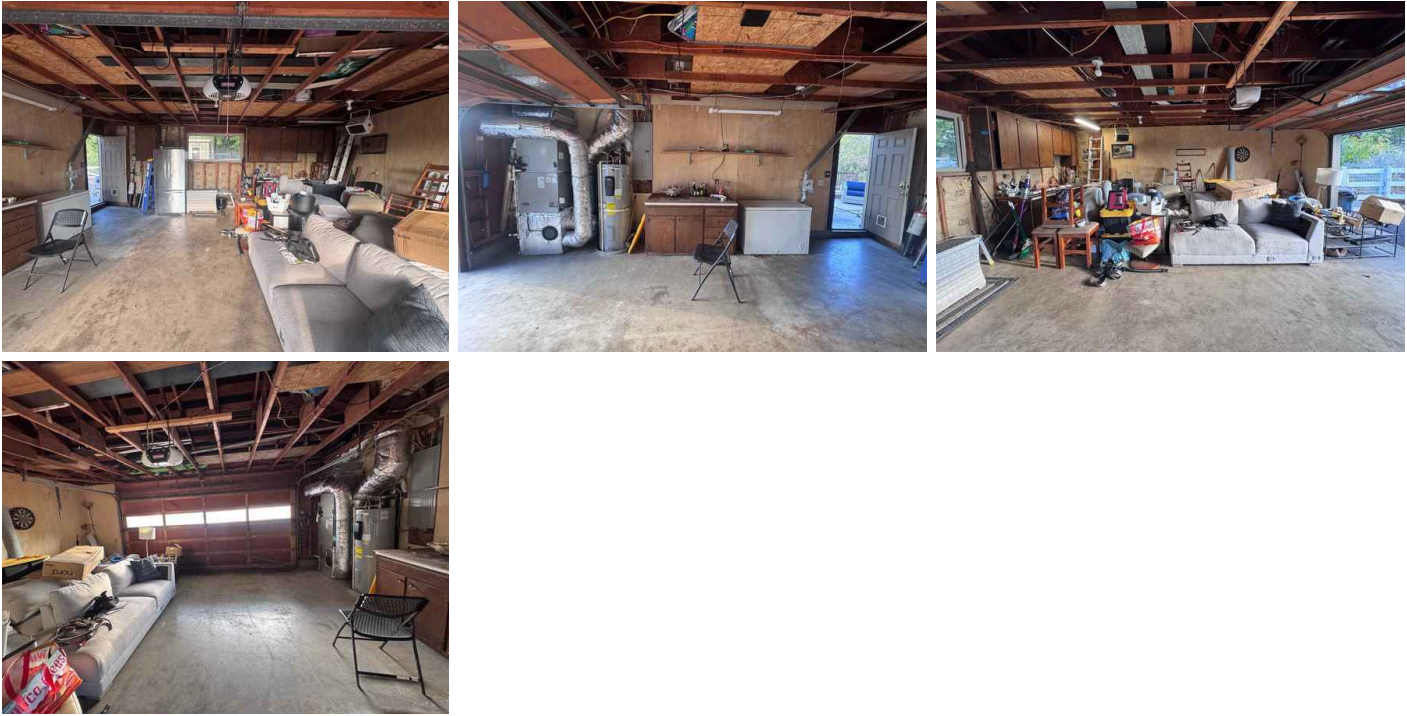
## Garage Photos

The following are photos taken of the garage at time of inspection that maybe useful for your reference.

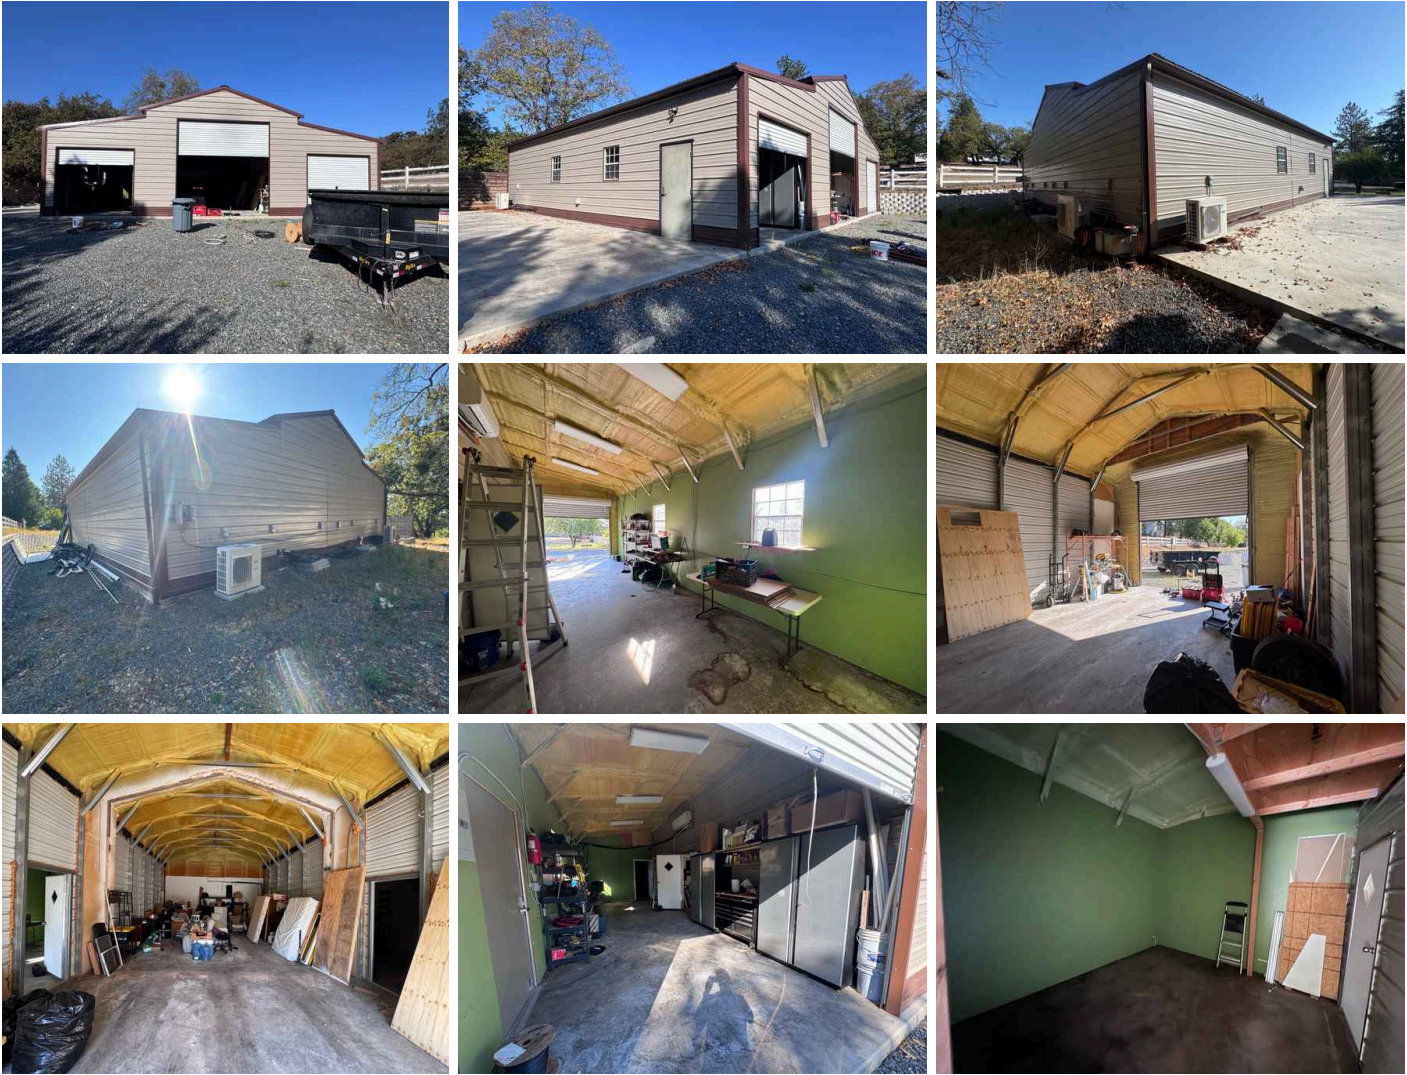
Outbuilding Photos

The following are photos taken of the outbuilding at time of inspection that maybe useful for your reference.

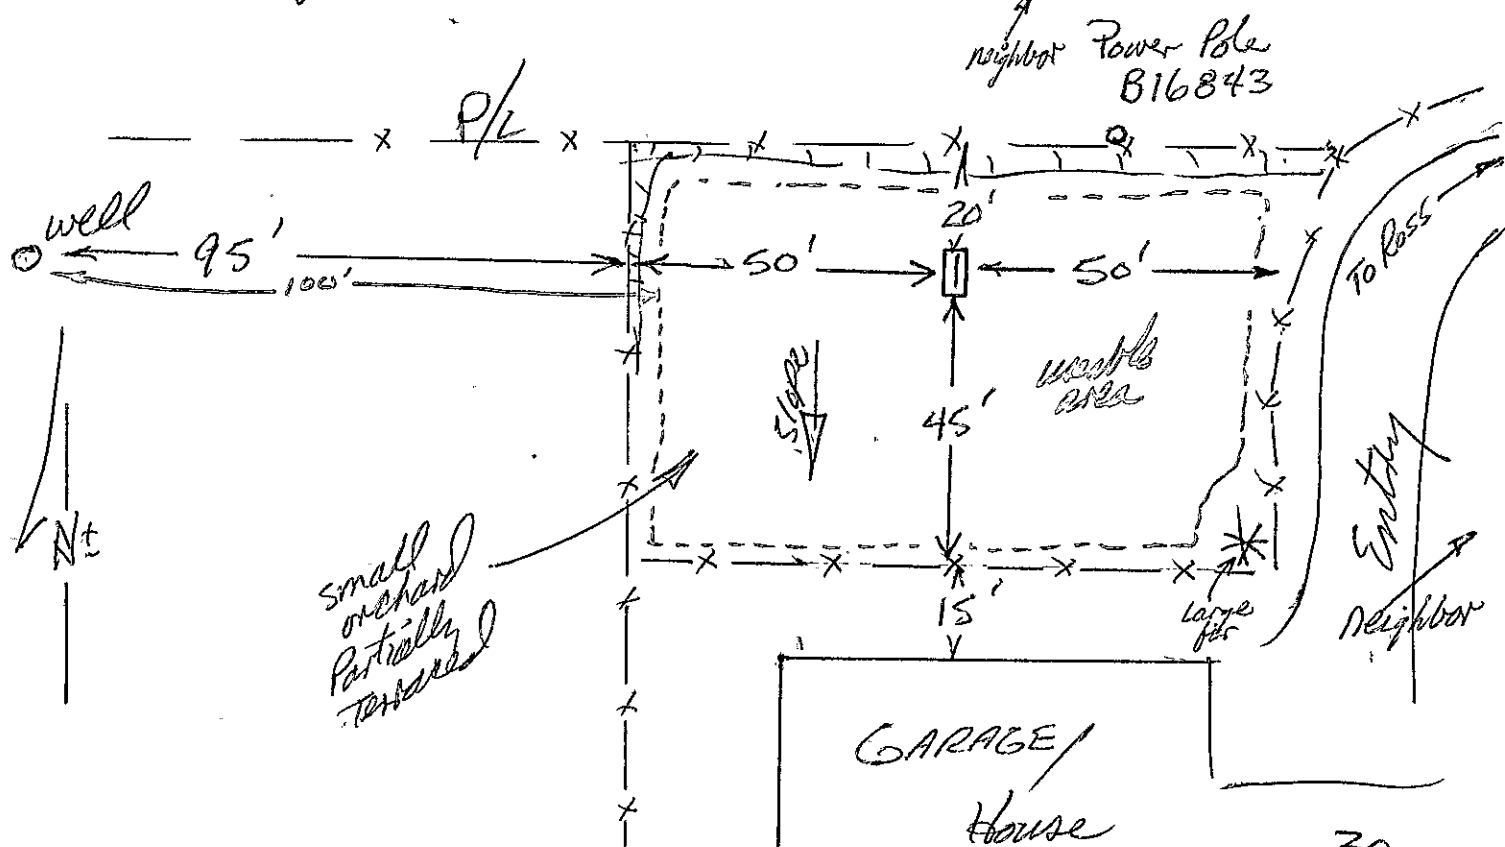
Potential Permit Recommendations: (See Permit For Specifics) Gallons Per Day (GPD) 450 Linear Feet Per 150 GPD \_\_\_\_\_ Total Linear Feet \_\_\_\_\_  
Trench Depth \_\_\_\_\_ W/ \_\_\_\_\_ Rock Cap \_\_\_\_\_ Curtain Drain \_\_\_\_\_ W/ \_\_\_\_\_ Rock \_\_\_\_\_  
Other Must be 100' from Any well & electrical permit needed for pump
