Table of Contents

3850 E Antelope Rd
Oregon, AC +/-

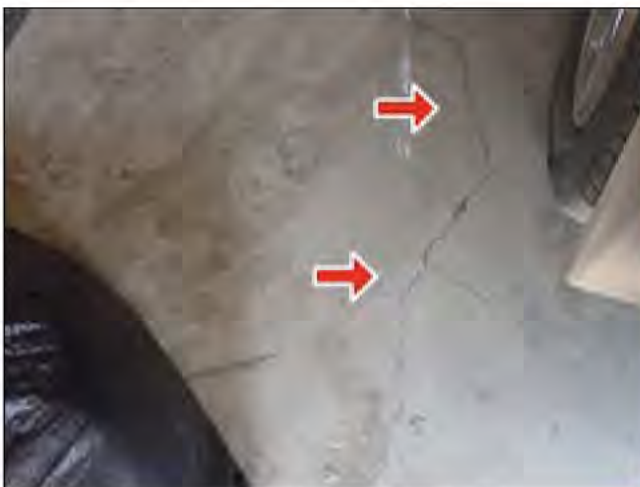
4.1 FLOOR SLAB (Picture 1)

●				4.0 EXPOSED FRAMING
	●			4.1 FLOOR SLAB Cracking of floor slab noted; recommend sealing to prevent further deterioration.
	●			4.2 WALLS / CEILINGS Any openings in the wall or ceiling between the house and garage should be covered with the proper fire-rated assemblies or materials.
●				4.3 VEHICLE DOOR
	●			4.4 DOOR OPERATOR Despite significant resistance, neither of the two garage doors automatically reversed. In order to prevent personal injury or equipment damage, automatic door operators should stop and retract the door upon meeting reasonable resistance. This function should be checked on a regular basis and adjusted/corrected as needed.
	●			4.5 ELECTRIC / GFCI Recommend replacing outlet covers as a general safety upgrade.
	●			4.6 HOUSE / SERVICE DOOR Deadbolt lock was difficult to engage. Additionally weather stripping is worn. Recommend repair or adjustment as needed by a qualified contractor.

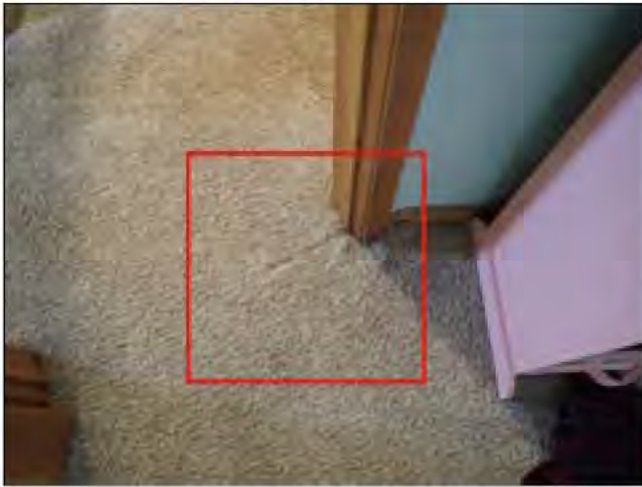
6.2(1) FLOORS (Picture 1)

●					6.0 CEILINGS
●					6.1 WALLS
	●				6.2 FLOORS (1) General wear noted on carpets in upper level of home. Recommend repair or replacement as needed by a qualified contractor. (2) Gap noted between tile flooring and wall in dining room area of home. See related comments on siding and foundation. Recommend having area checked and repaired as needed by a qualified contractor.
●					6.3 STAIRS
	●				6.4 WINDOWS Evidence of the failure of the seal on insulated window in upper level bathroom. While not readily apparent at the time of inspection, other insulated-glass units may have also failed. Recommend a check of all units to determine extent of repair/replacement work required.
●					6.5 ROOM DOORS
●					6.6 SLIDER
●					6.7 DETECTORS
			●		6.8 FIREPLACE Wood burning stoves and inserts are not part of a standard home inspection due to specific installation requirements based on each manufacture. See supplemental comments for recommendations.

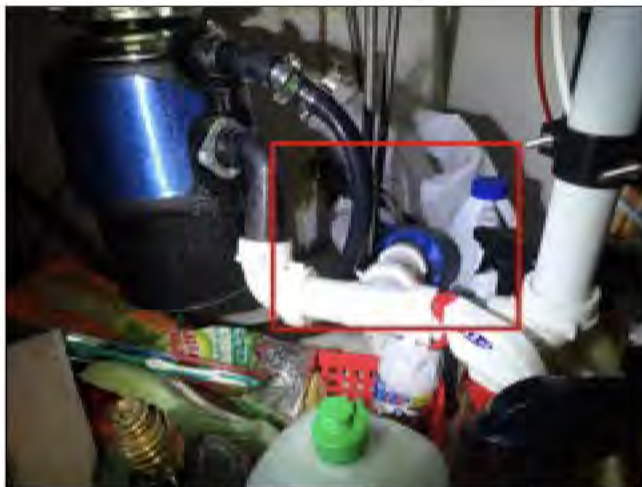
7.0 PLUMBING / SINK (Picture 1)

●				7.0 PLUMBING / SINK Flex line used for under sink drain line; recommend replacing with solid wall piping to reduce potential for blockage.
●				7.1 WALLS / CEILING Gap noted between ceiling and cabinetry. This could be the result of settlement issues in area. See related comments on siding and foundation. Recommend conditions be further evaluated by a qualified contractor to determine repair needs and associated cost.
●				7.2 ELECTRIC / GFCI
●				7.3 RANGE
●				7.4 DISHWASHER
●				7.5 DISPOSAL
●				7.6 VENTILATOR
●				7.7 CABINETRY Functional with some cosmetic damage consistent with age. Refinish as desired.
●				7.8 COUNTERTOP Gaps between countertop and back splash noted. Recommend caulking to prevent water intrusion.

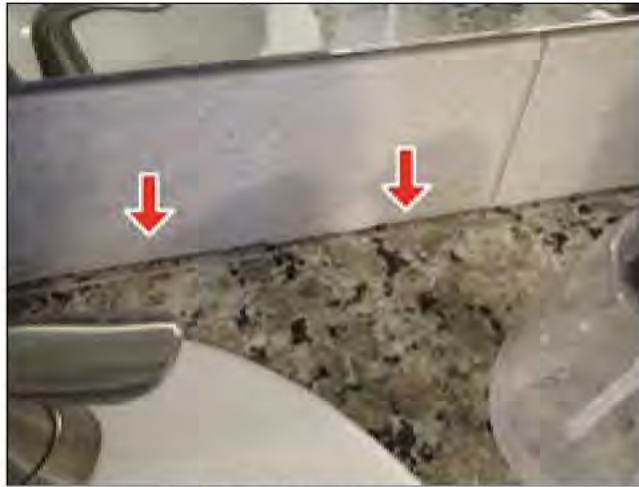
8.0.A SINK(S) (Picture 1)

●					8.0.A SINK(S) Recommend caulking at junction between countertop and back splashes to prevent moisture intrusion concerns.
●					8.1.A TOILET
●					8.2.A FLOOR(ING)
●					8.3.A WALLS / CEILING
			●		8.4.A VENTILATOR
●					8.5.A ELECTRIC / GFCI

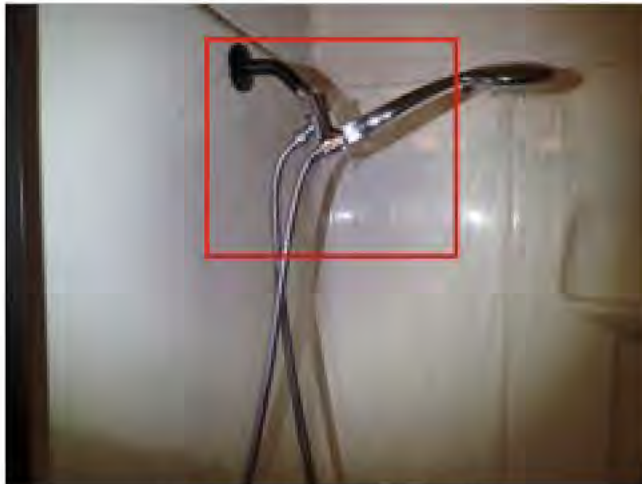
8.0.B BATHTUB (Picture 1)

●				8.0.B BATHTUB Shower head leaks/sprays at connection to plumbing neck. Recommend repair to preclude damages to surrounding area.
	●			8.1.B SINK(S) Left side sink was not operational at time of inspection. Recommend restoring water pressure and testing prior to close.
●				8.2.B TOILET
●				8.3.B FLOOR(ING)
●				8.4.B WALLS / CEILING
●				8.5.B VENTILATOR
●				8.6.B ELECTRIC / GFCI

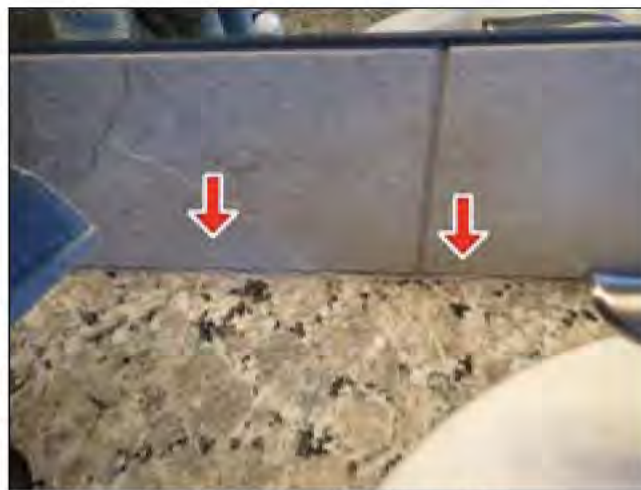
8.0.C SINK(S) (Picture 1)

●					8.0.C SINK(S) Recommend caulking at junction between countertop and back splashes to prevent moisture intrusion concerns.
●					8.1.C TOILET
●					8.2.C STALL SHOWER
●					8.3.C SURROUND / ENCLOSURE
●					8.4.C FLOOR(ING)
●					8.5.C WALLS / CEILING
●					8.6.C VENTILATOR
●					8.7.C ELECTRIC / GFCI

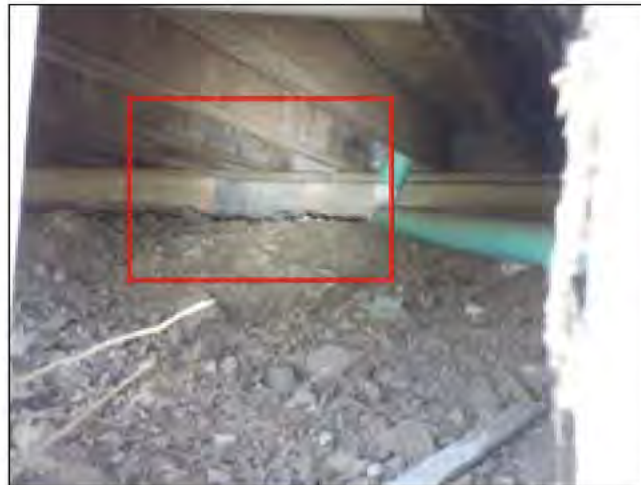
9.0 SLAB EXTERIOR / EDGE (Picture 1)

<ul style="list-style-type: none"> ● 9.0 SLAB EXTERIOR / EDGE Due to home design, most of slab exterior was not visible at time of inspection. However, area of slab has been notched out under back of house utility room. Framing in area is not properly supported. Recommend having slab and framing further evaluated and repaired as needed by a qualified contractor.
											<ul style="list-style-type: none"> ● 9.1 HOUSE FLOOR SLAB Due to home design and floor coverings, most of slab was not visible at time of inspection. However, cracking and settlement issues were noted on exterior siding and interior walls and cabinets. Recommend having foundation further evaluated by a qualified contractor to determine repairs needs and associated cost.

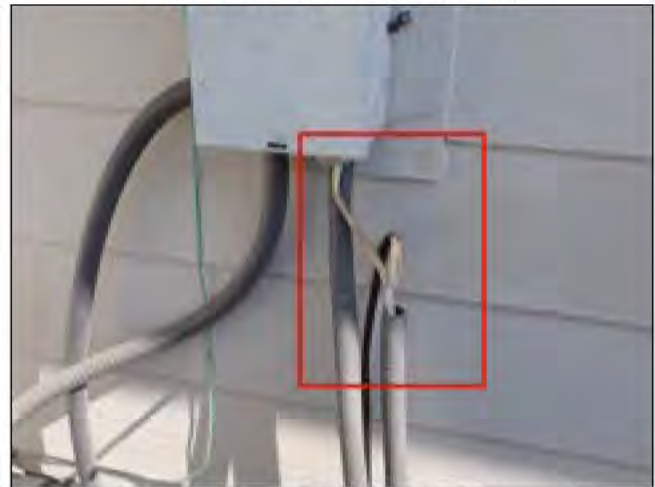
10.7 WIRING / CONDUCTORS (Picture 1)

●		10.7 WIRING / CONDUCTORS Loose conduit noted below upper level sub panel at front of home. Recommend securing as needed by a qualified electrician.

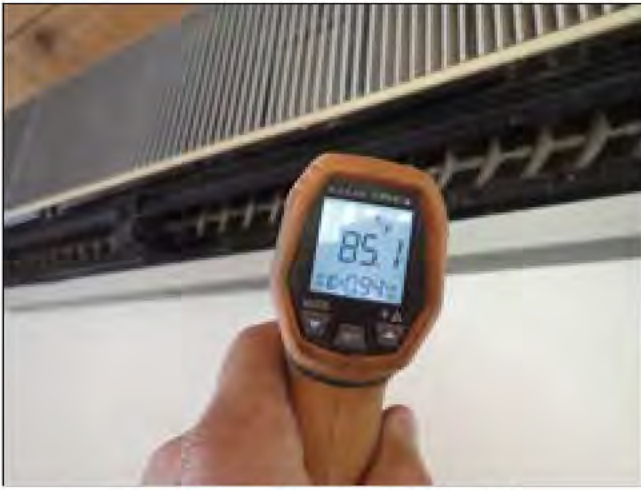
11.3 HEAT PUMP 2 (Picture 1)

●					11.0 HEAT PUMP 1
●					11.1 OUTDOOR UNIT
●					11.2 AIR HANDLER
	●				11.3 HEAT PUMP 2 Minimal temperature split noted at air handler. System is older and past it normal design life. Recommend conditions be evaluated by a qualified HVAC contractor to determine remedial action required and associated costs.
	●				11.4 OUTDOOR UNIT See 11.3, insulation on coolant lines is deteriorated. Recommend repair or replacement to ensure best operation.
	●				11.5 AIR HANDLER See 11.3, filter is dirty, recommend cleaning as needed.
●					11.6 HEAT PUMP 3 Heat pump system was operational but is older. Recommend having unit checked and serviced as needed by a qualified HVAC contractor.
	●				11.7 OUTDOOR UNIT Fan on exterior unit did not turn when system was operating. Additionally coolant line installation is missing. Recommend further evaluation and repair as needed by a qualified HVAC contractor.
●					11.8 AIR HANDLER

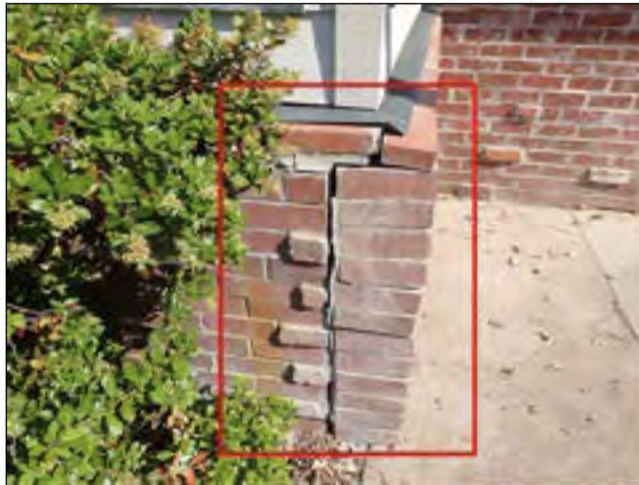
2.1 (Picture 2)

Excessive cracking and shifting observed on brick work at front of home and over garage area. See related comments in Section 9. Recommend having area checked and repaired as needed by a qualified contractor.

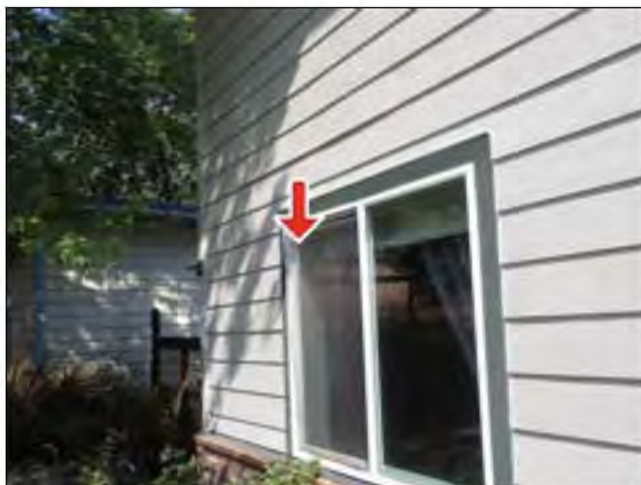
2.2 (Picture 2)

Several windows are missing screens around home. Additionally, some units are damaged. Recommend having all screens added or repaired as needed to ensure proper operation.

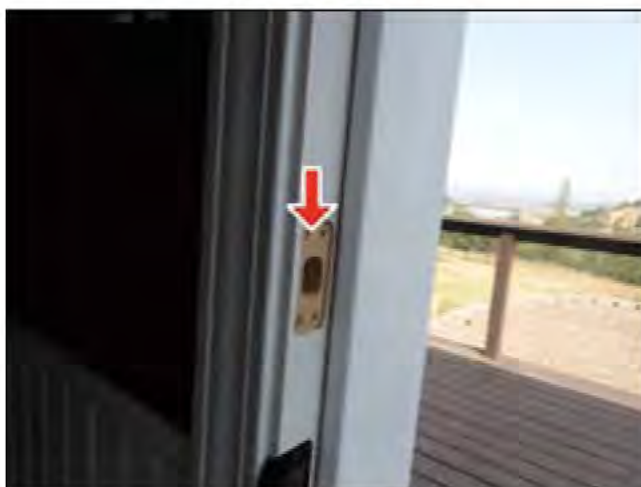
2.3 (Picture 2)

Strike plates are missing on multiple entry doors. Recommend adding as needed to ensure proper operation and safety.

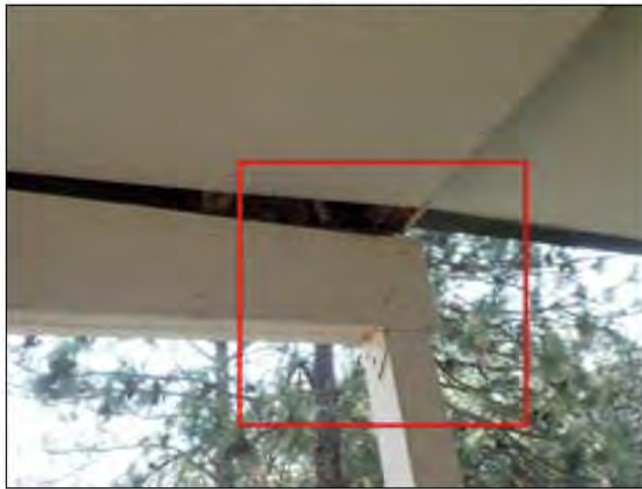
2.4 (Picture 2)

Deck structure at back of home is rated in poor condition due to multiple structural issues observed at time of

inspection. Gap and separation observed at beam and support on right side of deck. Several step stringers are cracked and damaged. Some separation observed on decking. Additionally, membrane material is torn at top of steps. Due to current conditions, recommend having all deck structures further evaluated by a qualified contractor to determine repairs needed and associated cost.

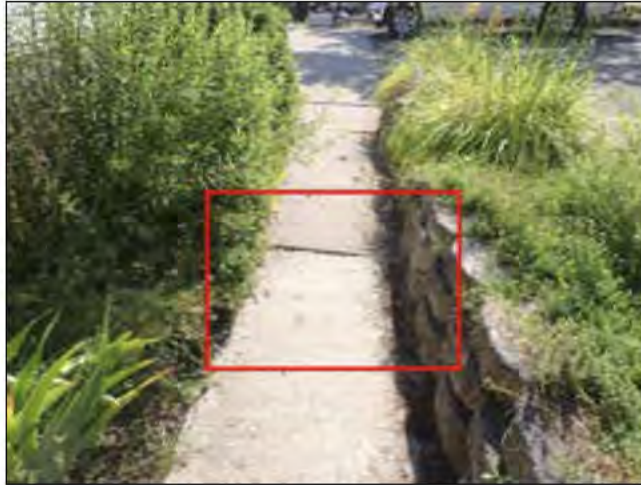
3.0 (Picture 2)

Walkways have cracked and settled at multiple locations. Some areas are considered a tripping hazard. Recommend repair and seal as needed by a qualified contractor.

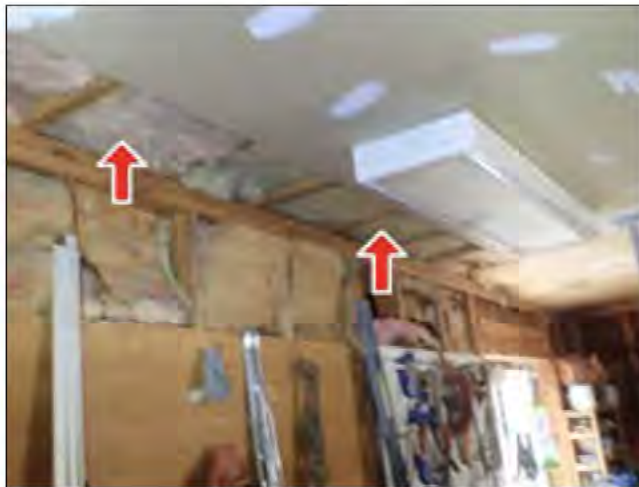
4.2 (Picture 1)

Any openings in the wall or ceiling between the house and garage should be covered with the proper fire-rated assemblies or materials.

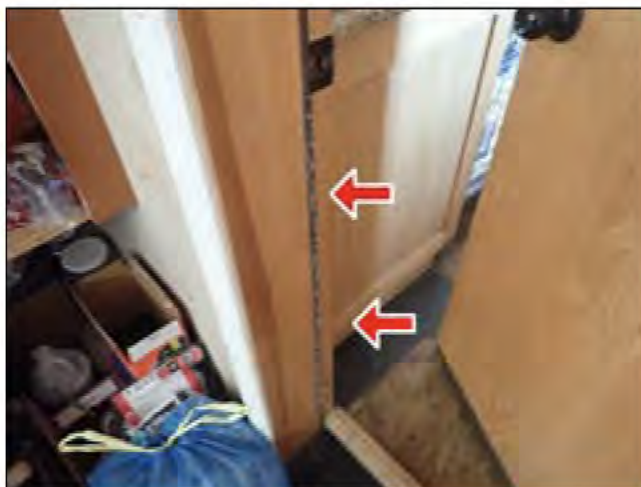
4.6 (Picture 2)

Deadbolt lock was difficult to engage. Additionally weather stripping is worn. Recommend repair or adjustment as needed by a qualified contractor.

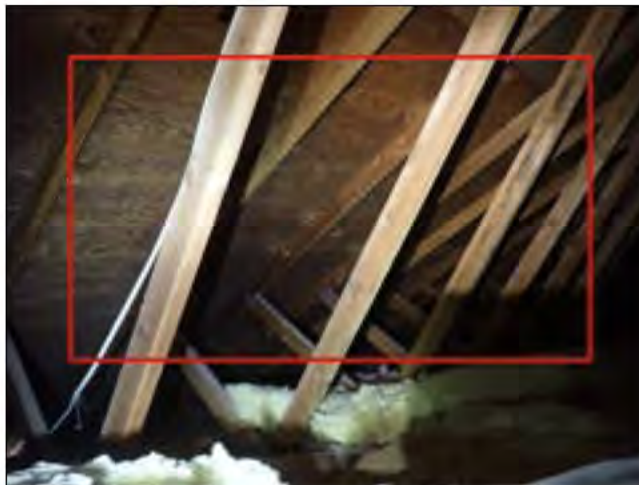
5.2 (Picture 2)

Evidence of suspect mold is present on ceiling in several areas in attic over right side of home. We did not inspect, test or determine if this is a health hazard/structural concern. Recommend contacting a qualified mold inspector or expert for investigation or correction if needed.

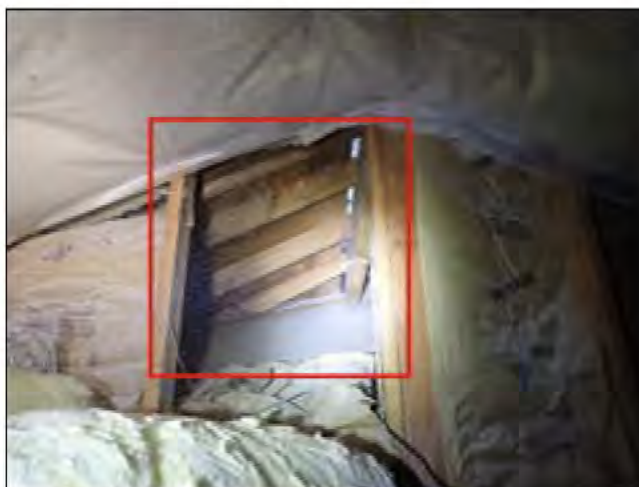
5.3 (Picture 2)

Limited insulation observed over right side of home. Recommend adding to ensure best efficiency.

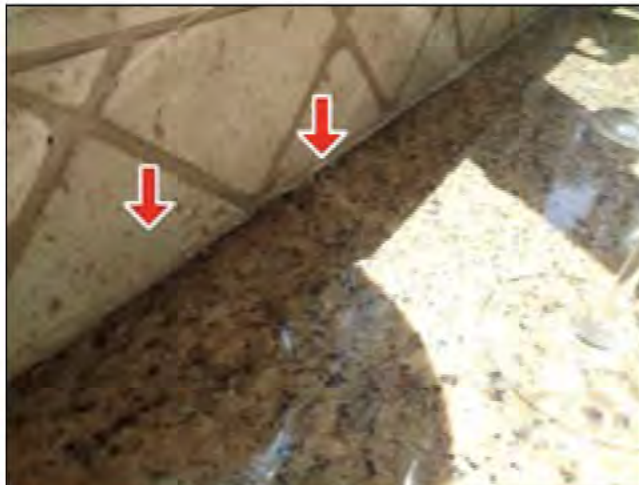
7.8 (Picture 2)

Gaps between countertop and back splash noted. Recommend caulking to prevent water intrusion.
