Mapping

1321 Falcon Crest
Oregon, AC +/-

Cover Page	1
Table of Contents	2
Intro Page	3
1 ROOFING	6
2 EXTERIOR ELEMENTS	10
3 SITE ELEMENTS	12
4 GARAGE	13
5 ATTIC	15
6 INTERIOR ELEMENTS	16
7 KITCHEN	18
8(A) BATHROOM 1	20
8(B) BATHROOM 2	22
8(C) BATHROOM 3	23
8(D) BATHROOM 4	25
9 FOUNDATION / SUBSTRUCTURE	26
10 FOUNDATION AREA WATER PENETRATION	28
11 ELECTRIC SYSTEM	31
12 HEAT PUMPS	33
13 PLUMBING SYSTEM	34
14 HOT WATER SUPPLY	35
General Summary	36
Invoice	55
Attachments	56

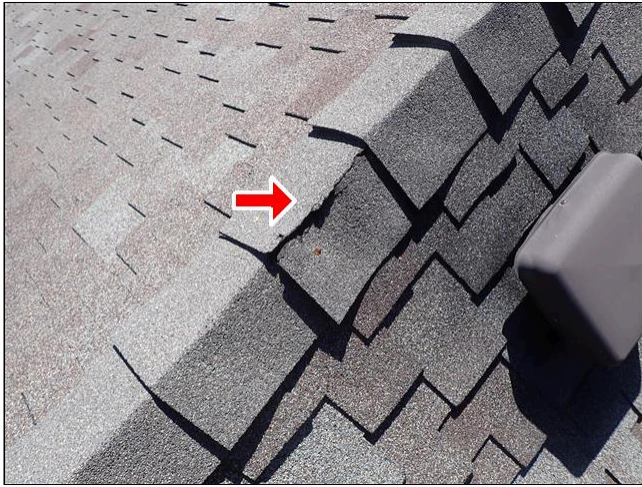
1.0 ROOF COVERING (Picture 3)

1.0 (Picture 3)

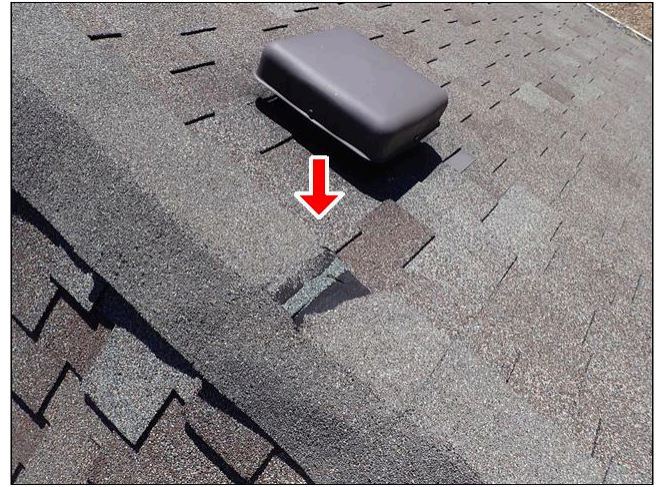
1.0 ROOF COVERING (Picture 4)

1.0 (Picture 4)

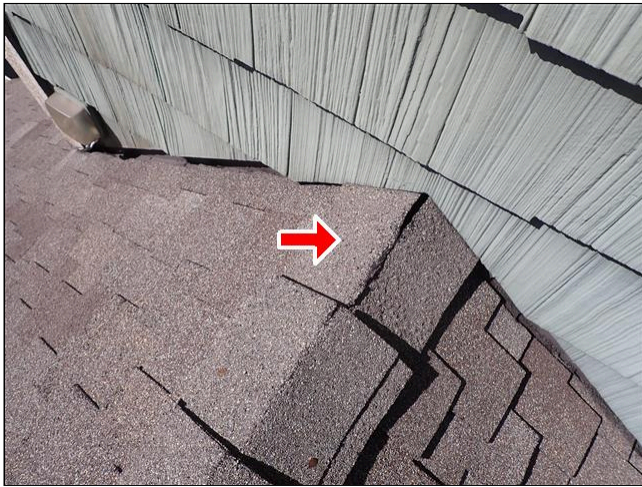
1.0 ROOF COVERING (Picture 5)

1.0 (Picture 5)

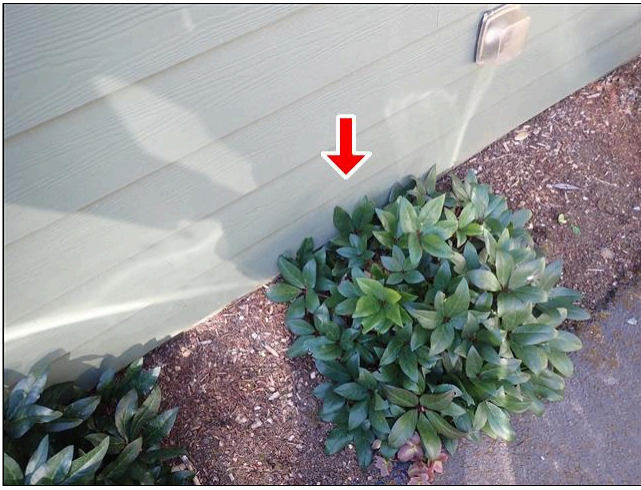
2.0 SIDING (Picture 3)

2.0 (Picture 3)

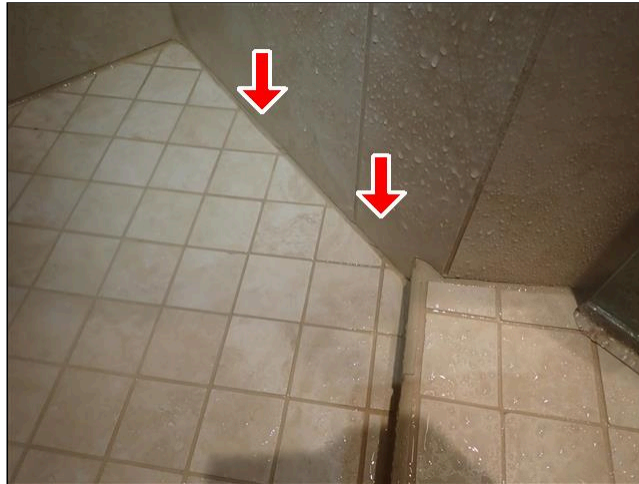
8.3.B SURROUND / ENCLOSURE (Picture 1)

●					8.0.B SINK(S)
●					8.1.B TOILET
●					8.2.B STALL SHOWER
	●				8.3.B SURROUND / ENCLOSURE Deteriorated grout/caulking; recommend repair to prevent water intrusion concerns.
●					8.4.B FLOOR(ING)
●					8.5.B WALLS / CEILING
	●				8.6.B VENTILATOR Heat setting on ventilator was not operational. Recommend repair as needed by a qualified contractor.
●					8.7.B ELECTRIC / GFCI

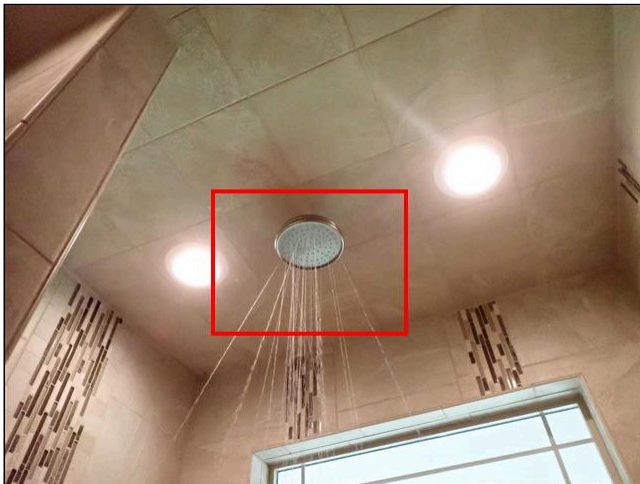
8.3.C STALL SHOWER (Picture 1)

●					8.0.C BATHTUB
●					8.1.C SINK(S)
●					8.2.C TOILET
	●				8.3.C STALL SHOWER Shower spray is irregular. Recommend cleaning or replacement to return back to normal pattern.
	●				8.4.C SURROUND / ENCLOSURE Caulking and/or grouting work is required to maintain the watertightness of tile and the shower enclosure. Check for substrate damage if surface damage or leakage is present, and when performing regular maintenance.
●					8.5.C FLOOR(ING)
●					8.6.C WALLS / CEILING
●					8.7.C VENTILATOR
●					8.8.C ELECTRIC / GFCI

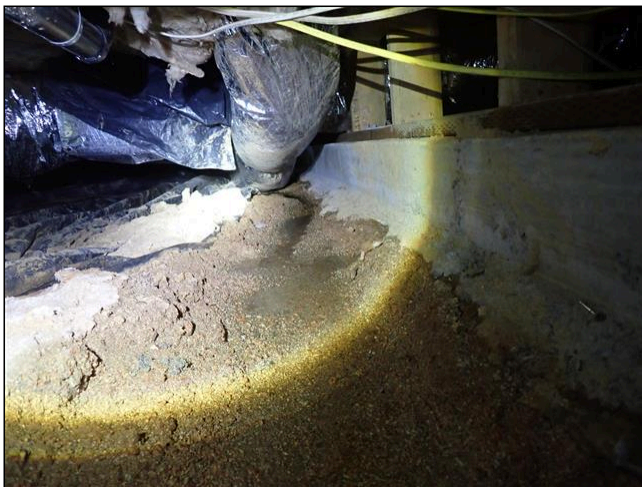
9.2 CRAWLSPACE FLOOR (Picture 1)

●					9.0 FOUNDATION/ FRAMING
●					9.1 FLOOR FRAMING
	●				9.2 CRAWLSPACE FLOOR Vapor barrier is displaced in multiple locations due to water in areas. See related comments in Section 10. Advise adding or redistributing barrier to help control moisture levels in living area.
	●				9.3 CRAWLSPACE VENTILATION PROVISIONS Several crawlspace vents are full of debris. Recommend checking and clearing all vents to ensure best provisions are in place.

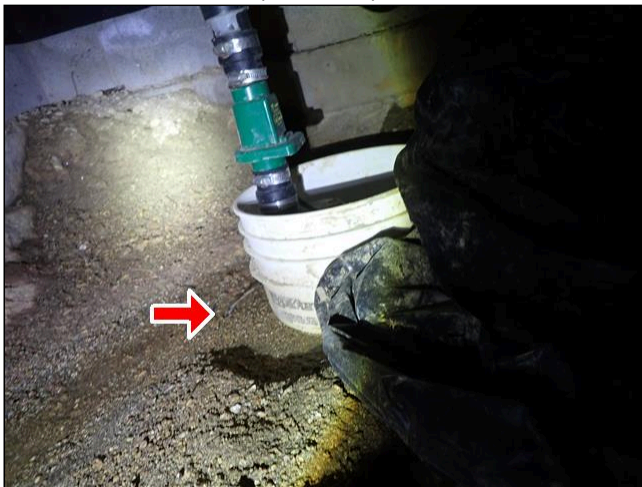
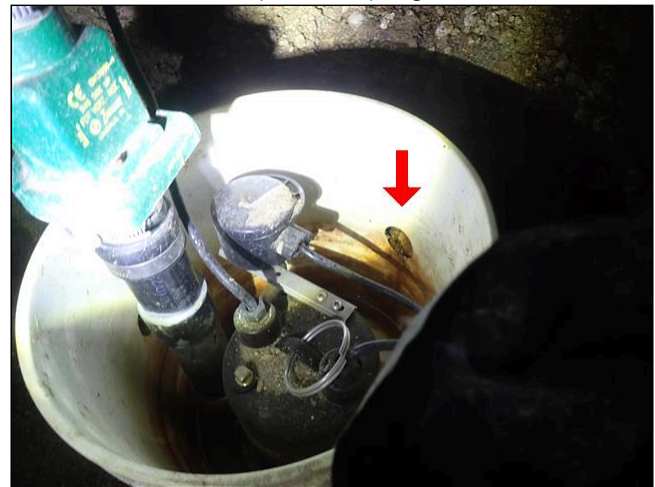
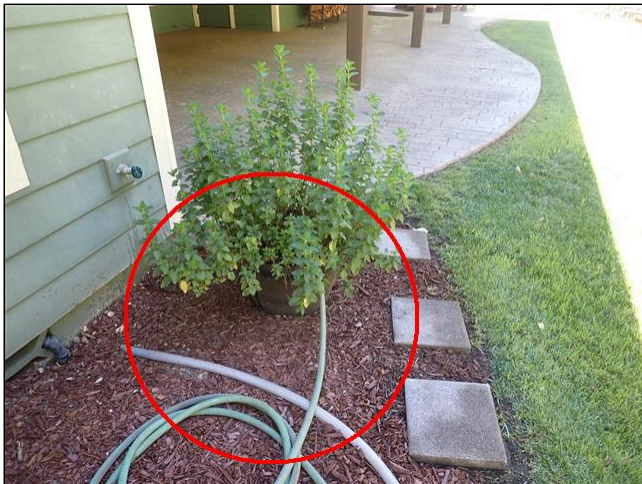
10.2 SUMP PUMP (Picture 1)

Sump Pump Discharge - Sump pump discharge should be directed away from the foundation to minimize any backflow and recurring seepage or damage.

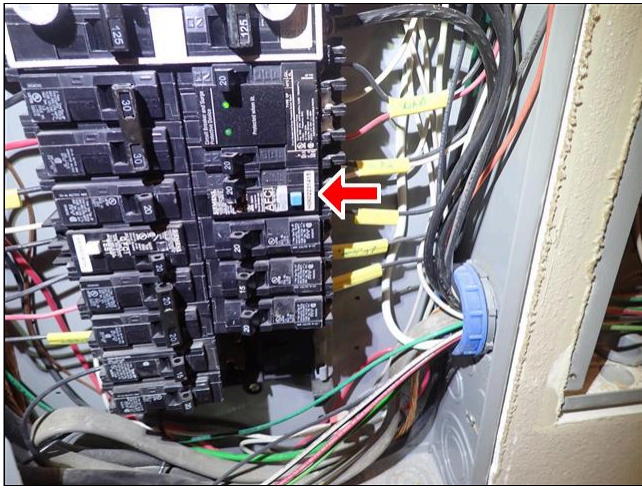
11.1 DISTRIBUTION PANEL(S) (Picture 1)

●					11.0 SERVICE PANEL / ENTRANCE LINE Service line is underground and therefore not inspected.
●					11.1 DISTRIBUTION PANEL(S) This home is equipped with Arc-fault Circuit Interrupters (AFCIs) located in the distribution panel. These provide additional safety measures for the home. There was a recall of AFCIs with blue test buttons. Unit in left side panel did not trip at time of inspection. As a precaution, recommend further evaluation and repair as necessary by qualified electrician.
●					11.2 MAIN DISCONNECT(S)
●					11.3 SUBPANEL 1
●					11.4 SERVICE GROUNDING PROVISIONS
●					11.5 DEVICES Several lights were not operable. Any inoperative unit may be due to a defective fixture or bulb. Replace bulbs as first action; contact qualified electrician if issue persists.
●					11.6 WIRING / CONDUCTORS
●					11.7 GFCI TEST

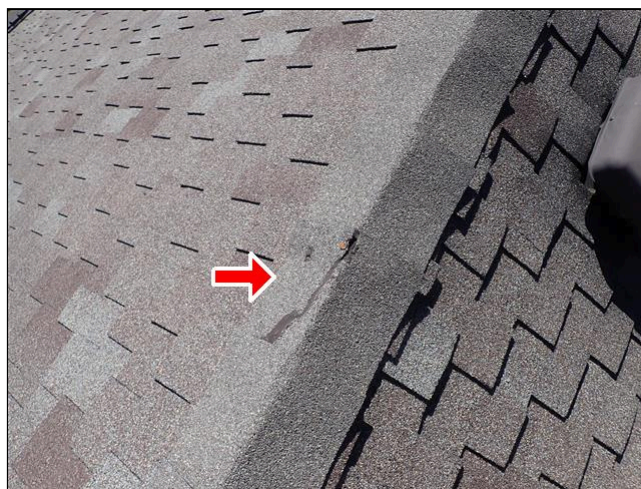
1.0 (Picture 2)

Roof covering is rated in fair condition based on age and general wear. Some granular loss observed. Additionally, multiple ridge caps are cracked and damaged. Due to current conditions, recommend having roof further evaluated and repaired as needed by a qualified roofing contractor.
