INSPECTION REPORT

2564 Old Military Rd
Central Point, OR 97502

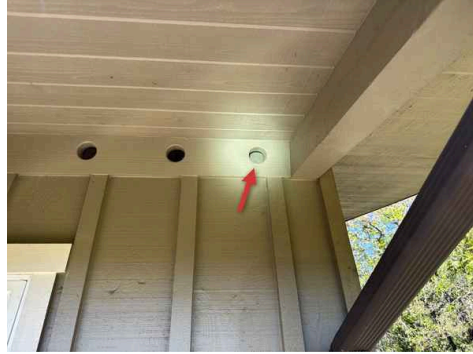
Back Of Home

SOFFIT VENT - DAMAGE

The were damaged soffit vent(s) observed. Recommend repair/replacemend to help prevent pests from entering the attic.
