# Table of Contents

Mapping.....	2-11
Tax Records & Title Report.....	12-30
Floor Plan.....	31-32
Seller's Property Disclosures.....	33-34
Home Inspection.....	35-88
Well Information.....	89-93
Septic Information.....	94-102
Water Rights.....	103-111
Solar Reports.....	112-113

# 8489 Redwood Hwy Oregon, AC +/-

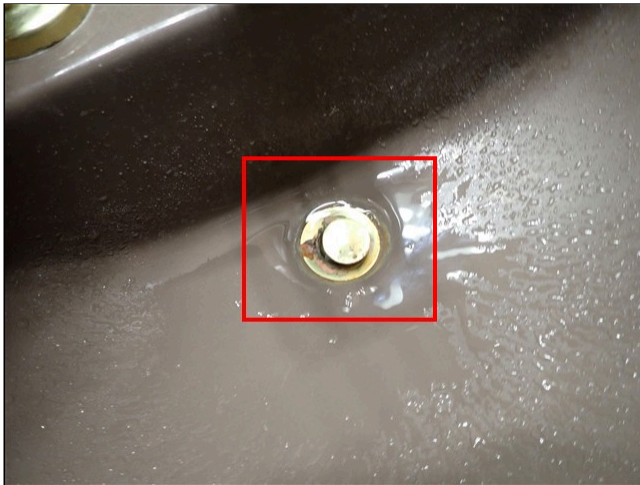
7.1.A SINK(S) (Picture 1)

●					<b>7.0.A BATHTUB</b>
	●				<b>7.1.A SINK(S)</b> Moderate sink surface wear or damage is generally cosmetic; if the base material has not been exposed or materially affected, the need for replacement is discretionary.
●					<b>7.2.A TOILET</b>
	●				<b>7.3.A STALL SHOWER</b> Shower head leaks/sprays at connection to plumbing neck. A leaking showerhead should be repaired for proper operation and to prevent consequential damage from uncontrolled spray. Long-term leakage can damage finishes and structural component.
●					<b>7.4.A SURROUND / ENCLOSURE</b>
●					<b>7.5.A FLOOR(ING)</b>
●					<b>7.6.A WALLS / CEILING</b>
●					<b>7.7.A VENTILATOR</b>
●					<b>7.8.A ELECTRIC / GFCI</b>

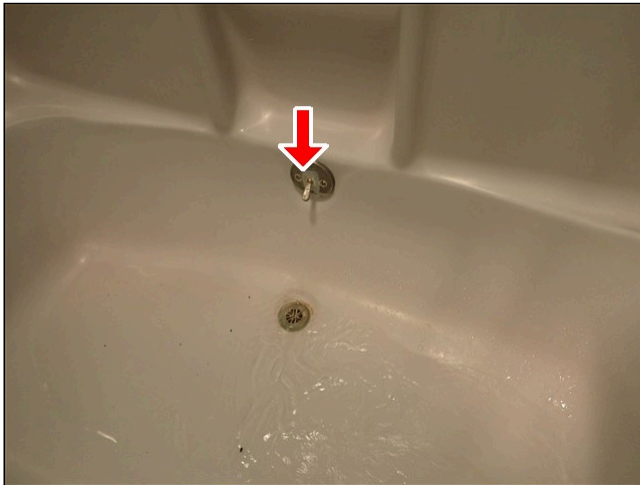
7.0.B BATHTUB (Picture 1)

●				<b>7.0.B BATHTUB</b> Drain stopper linkage appears to be seized and was difficult to operate. Recommend repair or adjustment as needed by qualified plumbing contractor.
●				<b>7.1.B SINK(S)</b> Moderate sink surface wear or damage is generally cosmetic; if the base material has not been exposed or materially affected, the need for replacement is discretionary.
●				<b>7.2.B TOILET</b> Toilet is loose at the floor; check for leakage/damage and secure as required.
●				<b>7.3.B FLOOR(ING)</b>
●				<b>7.4.B WALLS / CEILING</b>
●				<b>7.5.B VENTILATOR</b>
●				<b>7.6.B ELECTRIC / GFCI</b>

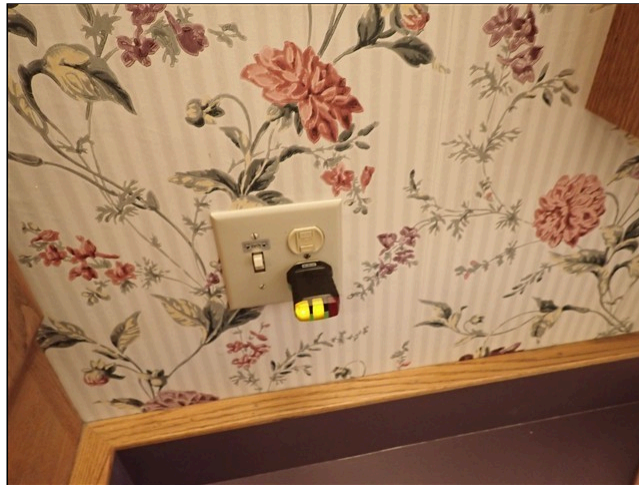
7.6.C ELECTRIC / GFCI (Picture 1)

●					<b>7.0.C BATHTUB</b>
●					<b>7.1.C SINK(S)</b>
●					<b>7.2.C TOILET</b>
●					<b>7.3.C FLOOR(ING)</b>
●					<b>7.4.C WALLS / CEILING</b>
●					<b>7.5.C VENTILATOR</b>
	●				<b>7.6.C ELECTRIC / GFCI</b> GFCI noted, however, test operation indicated unit malfunctioned or did not work properly. All related circuitry should be inspected by a qualified electrician.

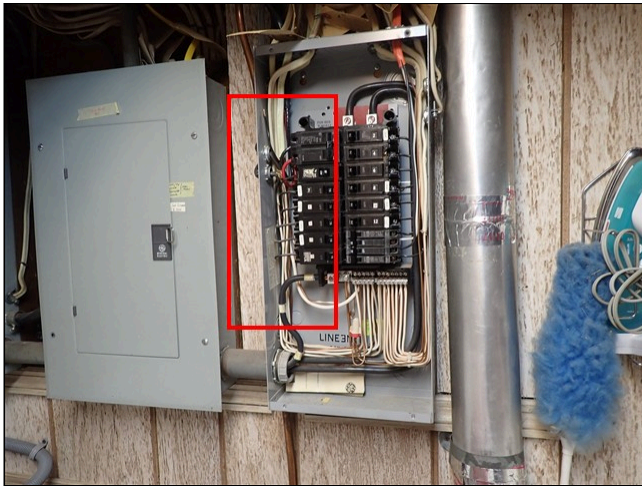
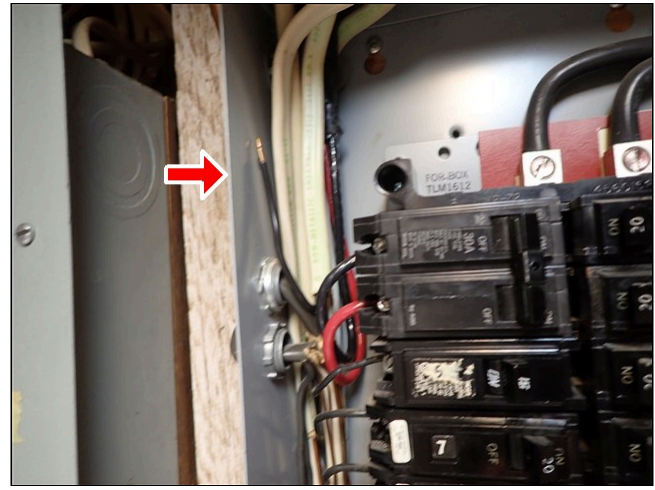
10.5 SUBPANEL 3 (Picture 1)

●					<b>10.0 SERVICE PANEL / ENTRANCE LINE</b>
●					<b>10.1 DISTRIBUTION PANEL</b>
●					<b>10.2 MAIN DISCONNECT</b>
●					<b>10.3 SUBPANEL 1</b>
●					<b>10.4 SUBPANEL 2</b>
●					<b>10.5 SUBPANEL 3</b> Unused wire in panel should be removed or terminated to prevent from inadvertently becoming energized. Recommend qualified electrician repair.
●					<b>10.6 SERVICE GROUNDING PROVISIONS</b>
●					<b>10.7 DEVICES</b>
●					<b>10.8 WIRING / CONDUCTORS</b>

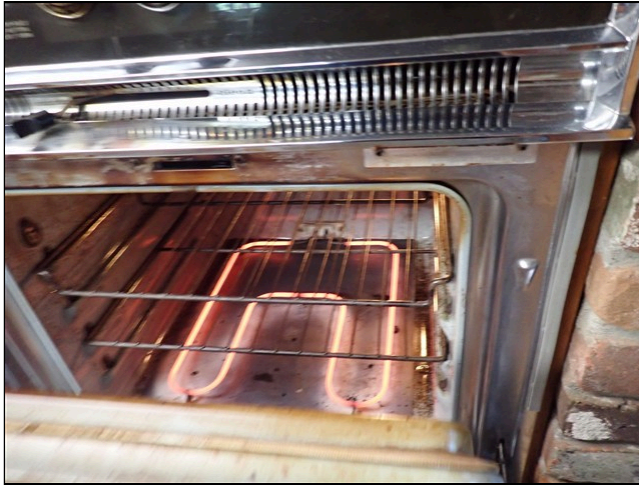
6.5 (Picture 1)

Oven operated satisfactorily, but is beyond its design life. Anticipate need for servicing.

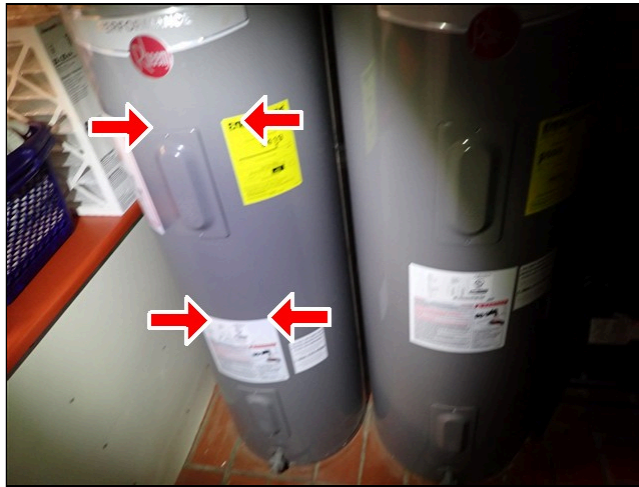
13.0 (Picture 1)

Restraining straps are generally required on all water heaters. Straps should secure the unit to the structure. Contact a local plumber or the building department for current requirements.
